# HYUNDAI

## Technical Service Bulletin

GROUP <b>ENGINE</b>	NUMBER <b>21-EM-008H</b>
DATE <b>June, 2021</b>	MODEL(S) Tucson (TL) Santa Fe Sport (AN) Santa Fe (TM) Sonata (LF) Veloster N (JSN)

**SUBJECT:** INTAKE MANIFOLD VCM DIAGNOSIS AND REPAIR GUIDELINES

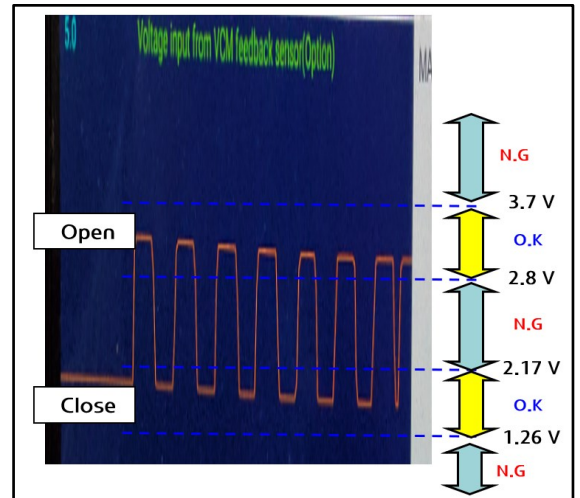
4. Check the Voltage input from VCM feedback sensor. If the Voltage is not within the ideal sensor range, replace the VCM Motor. **Do not replace the entire Intake Manifold Assembly.**

Position	Ideal Sensor Output Range (V)	
	2.4GDI	2.0T-GDI
VCM Close	1.26~2.17	1.306~2.246
VCM Open	2.8~3.7	2.534~3.474

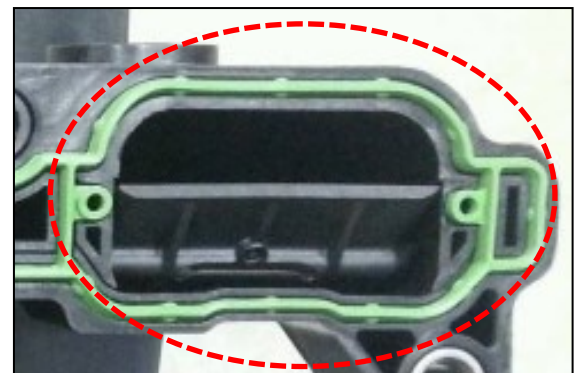
6. For VCM Motor, linkage or flap related code:
- Check for obstructions in the port flap.
  - In addition, check for any protrusions of the installed metal dividers of the cylinder head intake ports which may interfere with VCM port flap movement. Reinsert any protruding port dividers fully into the cylinder head intake port if necessary.

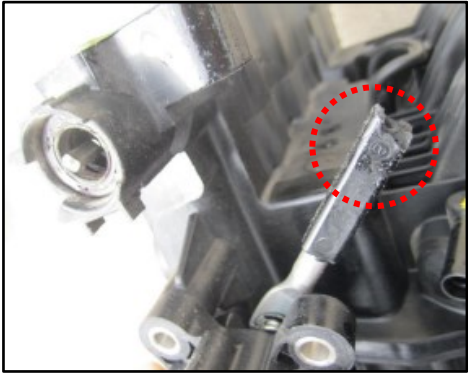
7. Check for damage, deformation, rust, and obstructions on the VCM Rod and Lever Arm Assembly. Ensure that the assembly is not stuck in place.

DAMAGED ROD	DAMAGED LEVER ARM	DEFORMED ROD

<p>Prevent damage to the Rod by not twisting it during removal.</p>	<p>Prevent Lever Arm damage by ensuring it is disassembled before removing the VCM</p>	<p>Prevent Rod-Side pivot ball post damage by removing the Lever Arm from the vehicle side first.</p>

**(For 2.4L only)**  
 If the Rod or Lever Arm Assembly is damaged, replace it by using the VCM Service Kit.  
 Do not replace the entire Intake Manifold Assembly.
