MITSUBISHI MOTORS

TECH TALK - VOLUME 262

May & June 2021

TECHNICAL INFORMATION

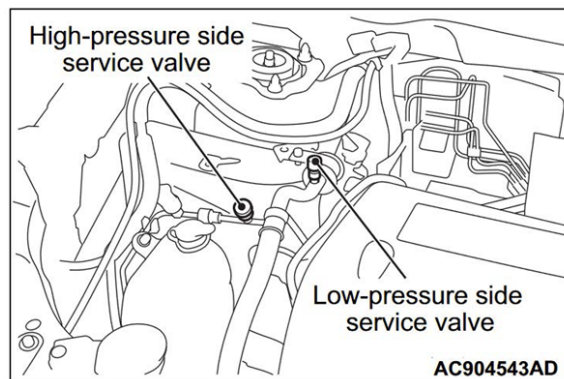
Low Refrigerant Charge

If you encounter a vehicle with a very low or no refrigerant charge during PDI, or at very low mileage, please verify that the valve cores within the service valves are torqued to the correct specification (3-5 in-lbs). A few vehicles exhibiting this concern have been found to have refrigerant leaks due to loose valve cores. Please check the static high and low side pressures (AC not operating) and record them on the Repair Order. Follow the Charging and Refrigerant Gas Pressure Check procedures in the Service Manual and verify no leaks are present after correcting a low charge concern.

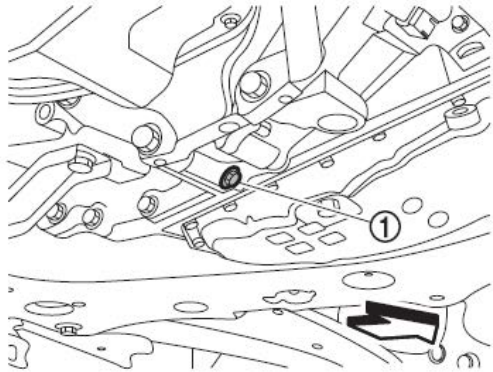
CF100A57AA00USA

- PN-J-52611 (Charge Pipe Release)
- PN-J-28431 (CVT Stand Pipe Adapter Kit)
- Place vehicle in park ("P" position)
- Start the engine
- Monitor CVT "Fluid Temp" using MUT3SE
- Leave vehicle idling to warm until fluid temp reaches approximately 104° F
- While depressing brake pedal, shift the transmission into drive ("D" position) for 5 seconds and then return to park ("P" position)
- Leave vehicle idling
- Lift vehicle and inspect for leaks
- Remove overflow plug "1" from converter housing:

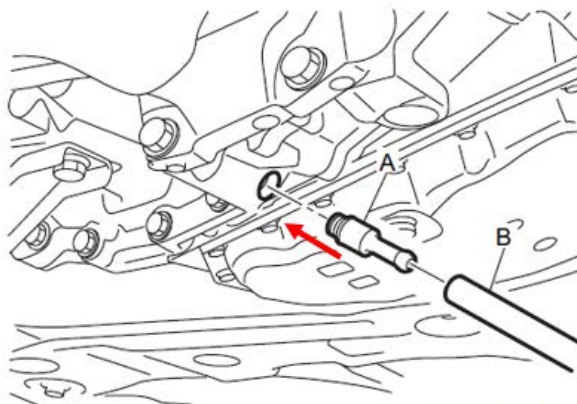
CF100A58AA00USA

- Install Stand Pipe Adapter Kit PN-J-52584 (A) into the overflow plug hole

(B) ATF Charger Hose
