SERVICE BULLETIN

Classification: FA19-002B	Reference: NTB19-105B	Date: June 30, 2021
------------------------------	--------------------------	------------------------

CLICKING/POPPING NOISE FROM FRONT AXLE AREA DURING TAKE OFF/ACCELERATION AND/OR DECELERATION

APPLIED VEHICLES: 2018-2021 LEAF (ZE1)

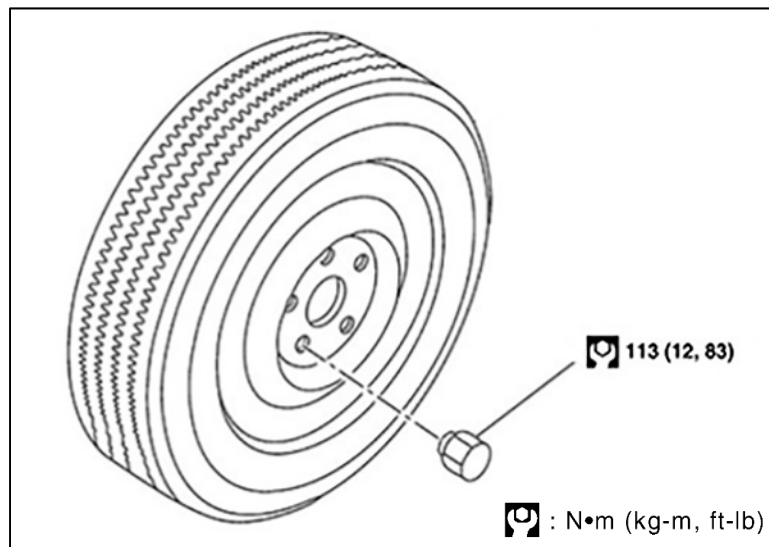
Figure 1

A clicking or popping noise is coming from the front axle area during take off/acceleration and/or deceleration.

Before performing diagnostic procedures, torque the lug nuts for all four (4) wheels to 113 N•m (12kg-m, **83 ft-lbs**), in a diagonal pattern.

- If the clicking/popping noise is still present after torquing the lug nuts, refer to the ESM for further diagnostic information.
