QUALITY ACTION

CAMPAIGN BULLETIN

Windshield Inspection Dealer Inventory

Reference: PM988

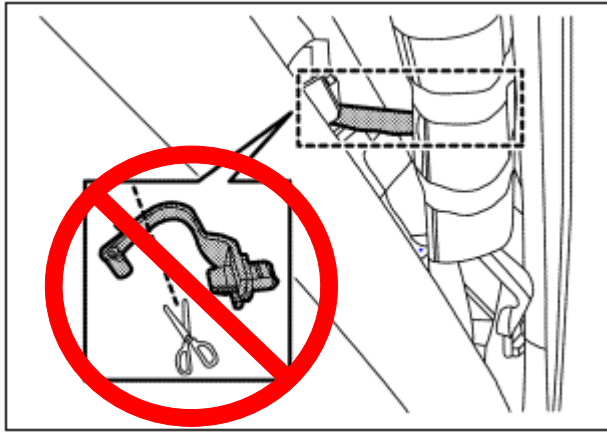
Figure 6

Do not cut or disconnect blue anchor clip from front pillar garnish (Figures 6 & 7)

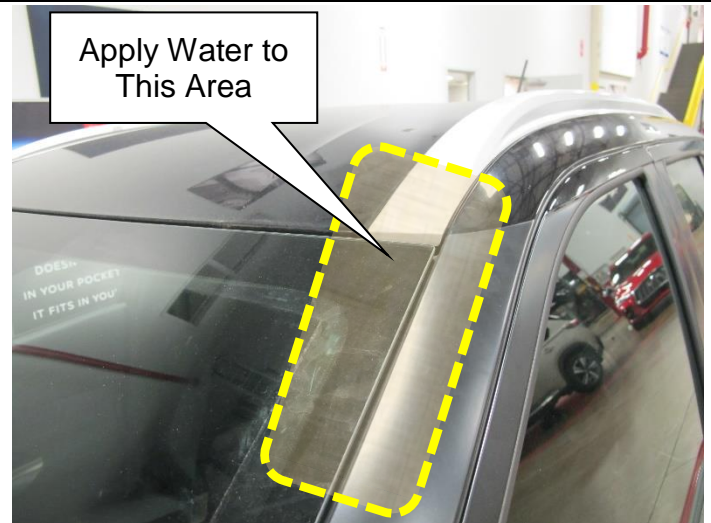
- Verify all windows, doors and sunroof are closed
- Apply full hose pressure water stream to area shown in Figure 9
- Apply water to this area for at least 2 minutes

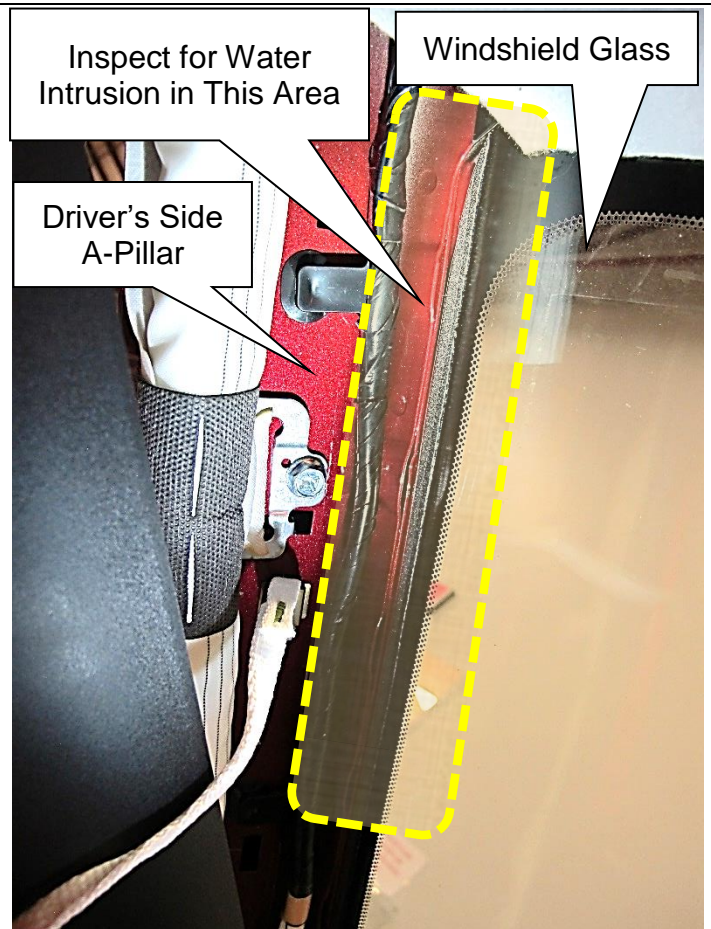
8. Inside the vehicle, inspect the left upper corner of the windshield seal area for water intrusion.

- Inspect the area shown in Figure 10 for water intrusion

9. Is water intrusion found at the upper left corner of the windshield seal?

- **YES** >> Proceed to Step 10 to replace the windshield.
- **NO** >> Proceed to Step 11 to reassemble the vehicle.

10. Replace the windshield per the Electronic Service Manual (ESM):
BODY EXTERIOR, DOORS, ROOF & VEHICLE SECURITY – GLASS & WINDOW SYSTEM – REMOVAL AND INSTALLATION – WINDSHILED GLASS – Removal and Installation
