Airstream Service Bulletin

Bulletin Number: #185

Product Line: Airstream Atlas & Interstate 19 with AGM Batteries

Subject: Magnum 1000W Inverter/Charger Settings, Battery Cable Inspection & Fuse Replacement

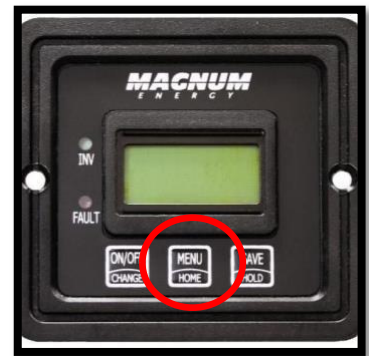
1. Press the "Menu" button. This will display the settings individually, starting with "AC IN."
2. If a setting is incorrect, change it by pressing the "On/Off Change" button. Once the correct setting is displayed, press the "Save/Hold" button until an arrow appears, indicating the setting has saved.

01 AC IN	30 Amps
02 Search Watts	5W
03 Battery AmpHrs	200 Ah
04 Battery Type	AGM1
05 Charge Rate	80% (Atlas); 50% (I-19)
06 Low Bat Cut Out	LBCO 11.0 Vdc
07 VAC Dropout	110Vac
08 Power Save	PwrSave ON (15 min)
09 Equalize	Disabled

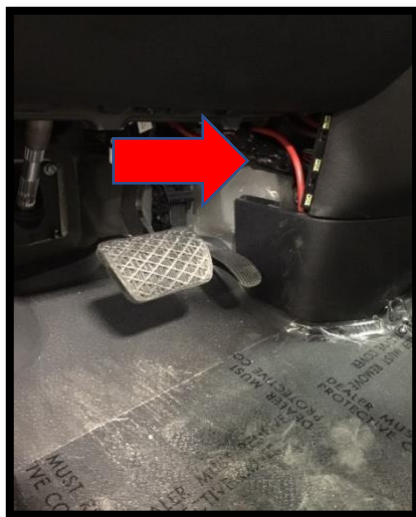
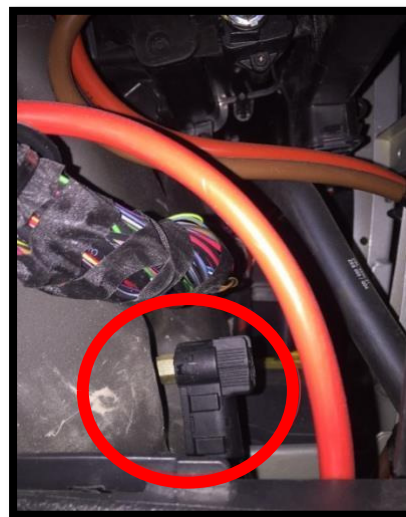
Step 2:

NOTE: Use extreme caution when performing these steps to prevent shorting the batteries to ground. For units with metal battery covers, removal of the covers should be performed.

Obtain two new 100A fuses (P/N 512660-100). Remove the Mercedes ground, located behind a plastic cover next to the foot pedals. Push the red button in while pulling the ground cable out, to disconnect.

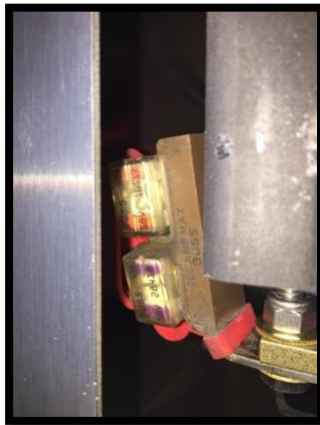
Step 4:

It has been discovered that if the 1000W Magnum Inverter/Charger is put into an overload condition, for a sustained period, there is a chance that one of the 90A fuses located near the battery's terminal can blow without the customer knowing. This would reduce the battery capacity down to a single battery. There are also instances in which the battery cables are wired incorrectly, causing one of the 90A fuses to blow as well.

NOTE: the 100A fuse must be closer to the battery terminal than the 50A fuse since it is of a higher rating.

By replacing the 90A fuse with a 100A fuse on both batteries, and inspecting the battery wiring, an inverter overload condition would allow the inverter to shut down prior to blowing a fuse.

- Locate the CS battery and remove the cross-car cable from the positive battery post with the 90A fuse.
- Remove the 90A fuse and replace it with a 100A fuse. Reinstall the cross-car cable and torque the battery terminal nut to 75 inch-lbs.
- Locate the RS battery and remove the cross-car cable and cable #14 from the positive battery post with the 90A fuse.
- Remove the 90A fuse and replace it with a 100A fuse. Reinstall the cross-car cable and cable #14, and torque the battery terminal nut to 75 inch-lbs.
- Locate the cable from the DC-DC converter, going up towards the driver's seat, and ensure it is connected to the 50A fuse in the fuse block, located under the driver's seat.
