Technical Service Bulletin

94 Adaptive light or suspension warning is shown in the instrument cluster, DTC C103404, C103407, C103415, or C103429

94 21 41 2056219/3 July 12, 2021. Supersedes Technical Service Bulletin Group 94 number 19-15 dated September 27, 2019 for reasons listed below.

Model(s)	Year	VIN Range	Vehicle-Specific Equipment
A6, A7	2019	All	Not Applicable

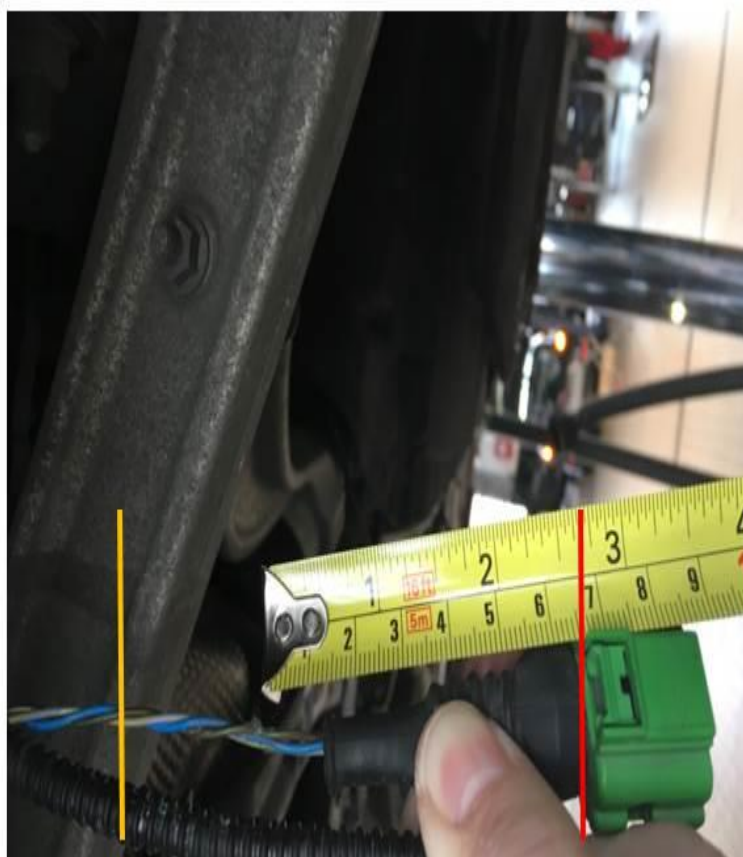
Damage to the left front level sensor (G78) wire harness may have occurred during production. This can result in the harness becoming oxidized underneath the protective corrugated tube.

Figure 1. The affected area located under the corrugated tube between the red and yellow mark.

2. If there is damage in this area, repair the wires with the VAS1978B.

Tip: If multiple wires are affected the repairs will need to be staggered to fit within the corrugated tube.

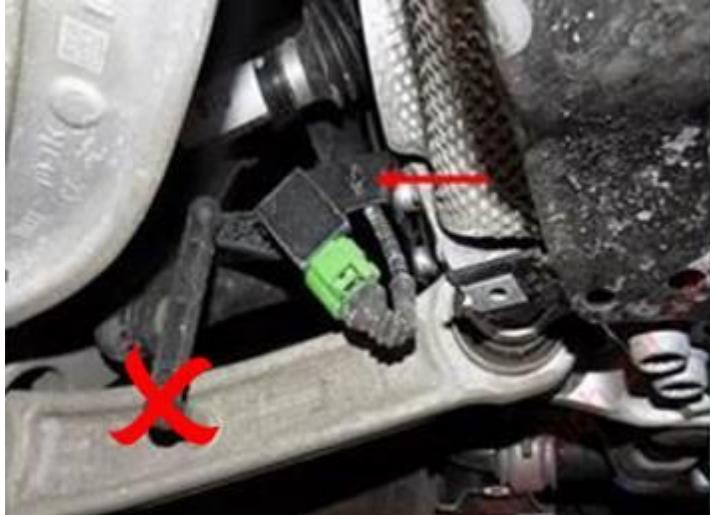
Figure 2. Incorrect position of the harness clip. The clip is mounted on the opposite side of the sensor bracket.

3. Once the repair is complete, wrap the harness from the rubber sleeve to the first mounting clip with tape **N 106 497 02** then refit the corrugated tube over the harness.
4. Check from which side of the sensor bracket the first mounting clip for the corrugated tube is attached. The first clip of the corrugated tube must be attached on the sensor side of the bracket. If the clip is incorrectly attached (Figure 2), refit the clip (Figure 3).

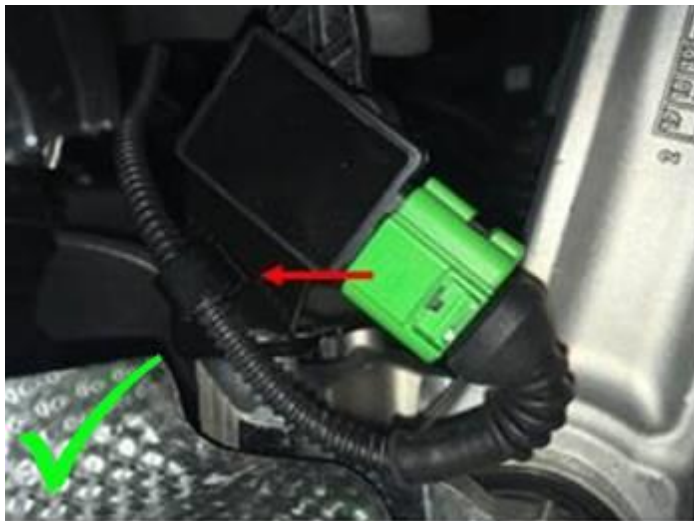
Figure 3. Correct positioning of the harness clip. The clip is mounted on the sensor side of the bracket.
