Service Bulletin

Bulletin No.: 21-NA-048

Subject: Black Screen in Reverse with Red Triangle and Red Camera with A Circle and Slash Through It

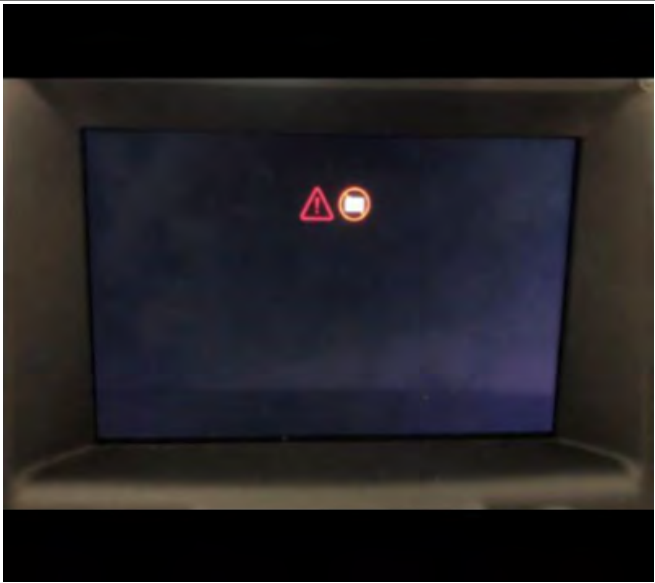
5758378
Cause	The cause of the condition may be that the crimping of the coaxial cable connectors to the cable is causing an excessive resistance that interrupts the video signal and causes the black screen.
Correction	Note: Verify the Condition, then depending on Model and Year, follow the appropriate repair in the list of Repair Procedures below.

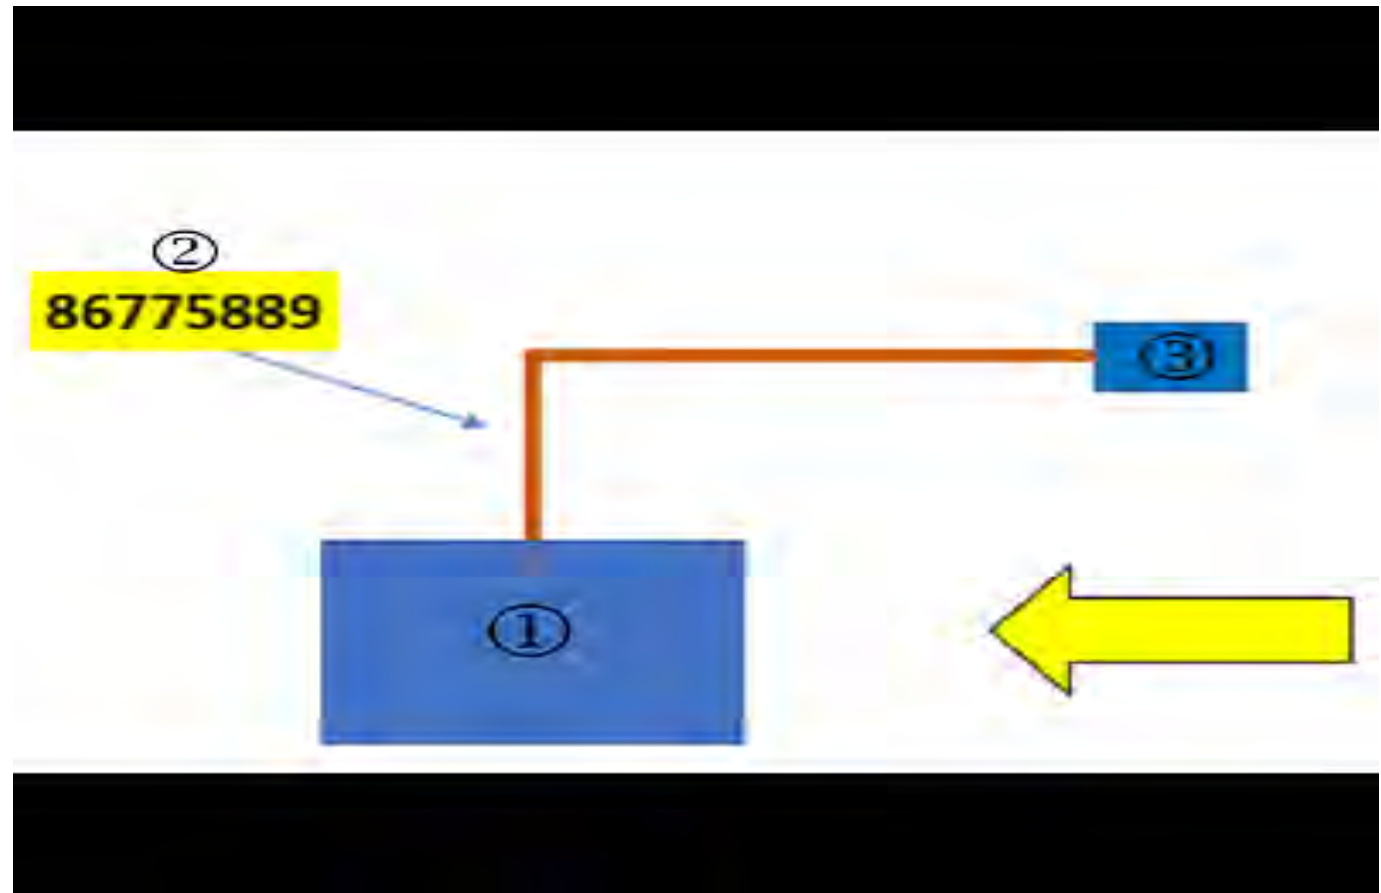
2020-2021 XT6 IP Coaxial Cable Routing (DRZ & UV2)

XT6 Models – Replace only the (IP) coaxial cable from the in-line connector to the A11 Radio.

Replace the short (IP) coaxial cable from the in-line connection to the A11 Radio, located behind the right kick panel.

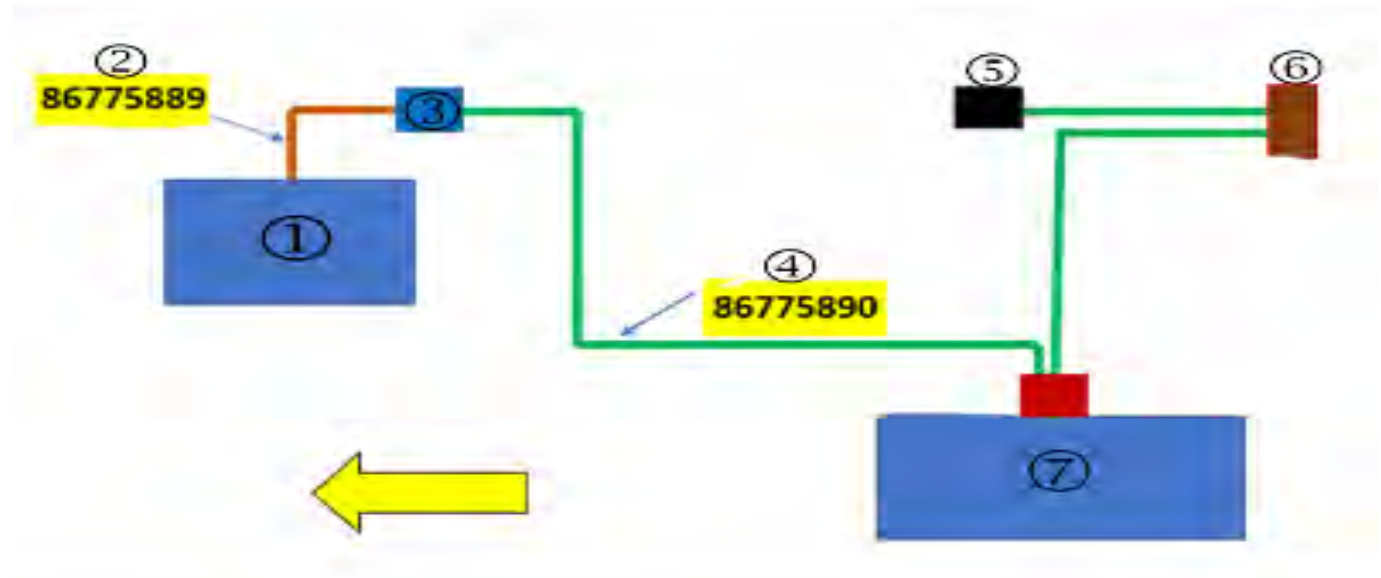
2020-2021 XT5 IP and Body Coaxial Cable Routing (DRZ & UV2)

Note: On XT5, the (Body) cable runs from the VPM to the In-line connection to the (IP) short cable behind the right kick panel. It also routes to the liftgate coaxial connector and to the coax at the top of the left "D" pillar headliner area for the rearview mirror.

1. Replace the long Coaxial cable (Body) from the VPM in the left rear of the vehicle, to the In-line connection to the (IP) short cable behind the right kick panel and to the liftgate connector and connect to the cable to the rearview mirror in the top left "D" pillar headliner area.
2. Replace the short (IP) coaxial cable from the in-line connection to the A11 Radio, located behind the right kick panel.

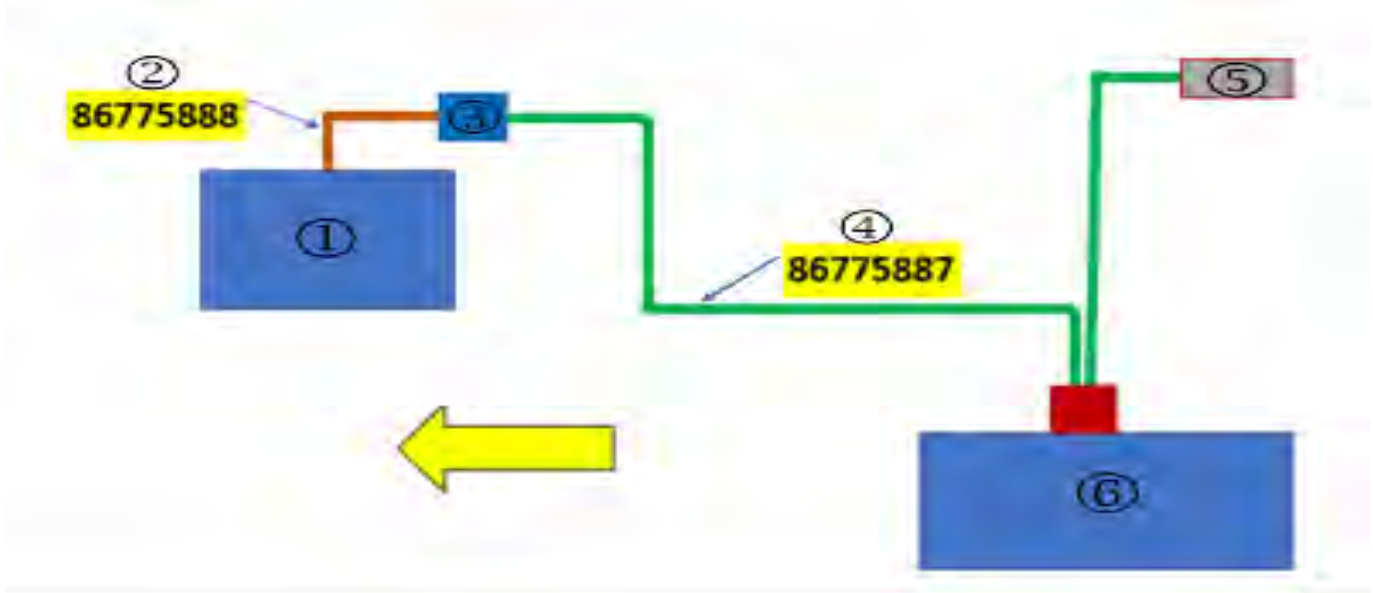
GMC Acadia
 2020-2021 GMC Acadia IP and Body Coaxial Cable
 Routing (UV2)

Note: On GMC Acadia, the (Body) cable runs from the VPM to the In-line connection to the (IP) short cable behind the right kick panel and to the liftgate coaxial cable connector.

1. Replace the long Coaxial cable (Body) from the VPM in the left rear of the vehicle, to the In-line connection to the (IP) short cable behind the right kick panel and to the liftgate coaxial cable connector.
2. Replace the short (IP) coaxial cable from the in-line connection to the A11 Radio, located behind the right kick panel.

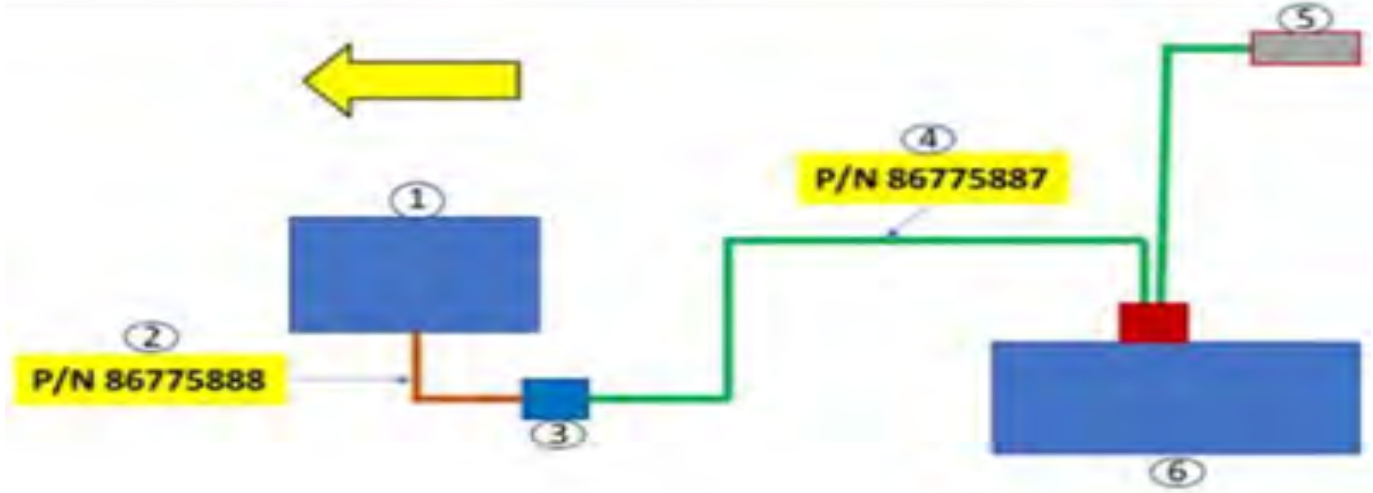
2020 Holden Acadia IP and Body Coaxial Cable Routing (UV2)

Note: On Holden Acadia, the (Body) cable runs from the VPM to the In-line connection to the (IP) short cable behind the left side of the IP near the glove box.

- 1. Replace the long Coaxial cable (Body) from the VPM in the left rear of the vehicle, to the In-line connection to the (IP) short cable behind the left IP near the glove box and to the liftgate coaxial cable connector.
- 2. Replace the short (IP) coaxial cable from the in-line connection to the A11 Radio, located behind the left IP near the glove box.
