# Service Bulletin

Bulletin No.: 21-NA-077

**Subject: Information on Aero Shutter Related Diagnostic Codes**

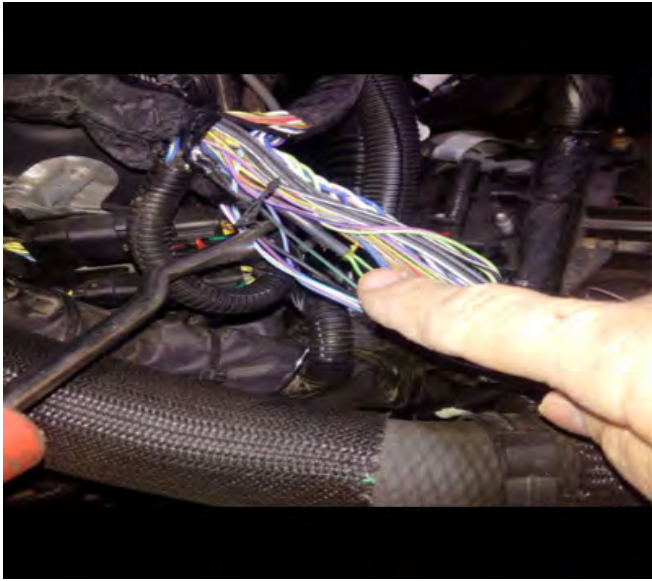
5821156

3. Check the integrity of the **J170 splice**. Moving this splice, even small amounts, can cause intermittent communication issues. If any issues are detected in the splice, repair the splice and report what was repaired.

**Note:** If the J170 splice is found to be an issue, replace the entire splice, do not attempt to repair it. Cut out the splice for part return and submit a photo, **taken prior to cutting the section where the issue has been detected**.

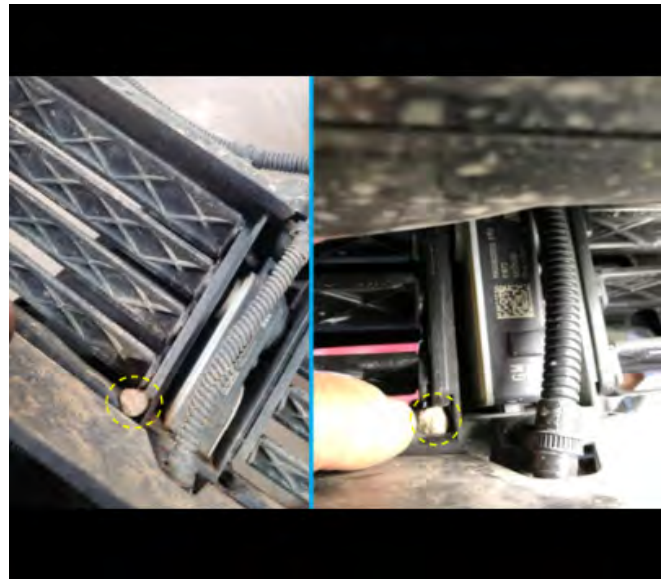
5821157

**Note:** For vehicles equipped with upper and lower shutters, the upper shutter, top passenger side louvre/vane is intentionally missing from the shutter assembly for airflow reasons. DO NOT replace the shutter for this reason.

1. Check for any debris in the upper and lower shutters. If found, please remove the debris.
2. If there is no debris evident, please look for a louvre/vane that is disengaged from the linkage. If the vehicle has a shutter with this condition, please engage the louvre/vane in the shutter assembly. If shutter is operational, DO NOT replace the shutter.
3. Check to see if the upper shutter in open position is binding on the air induction plenum. It is located on the driver's side upper behind the upper shutter. If this condition exists, secure the air induction plenum to structure behind, using a 2-stage push pin.
