# Service Bulletin

Bulletin No.: 21-NA-085

**Subject:** MIL Illuminated with DTC P16F3 Set

Brand:	Model:	Model Year:		VIN:		Engine:	Transmission:
		from	to	from	to		
Chevrolet	Colorado	2021	2021			LGZ	
GMC	Canyon	2021	2021			LGZ

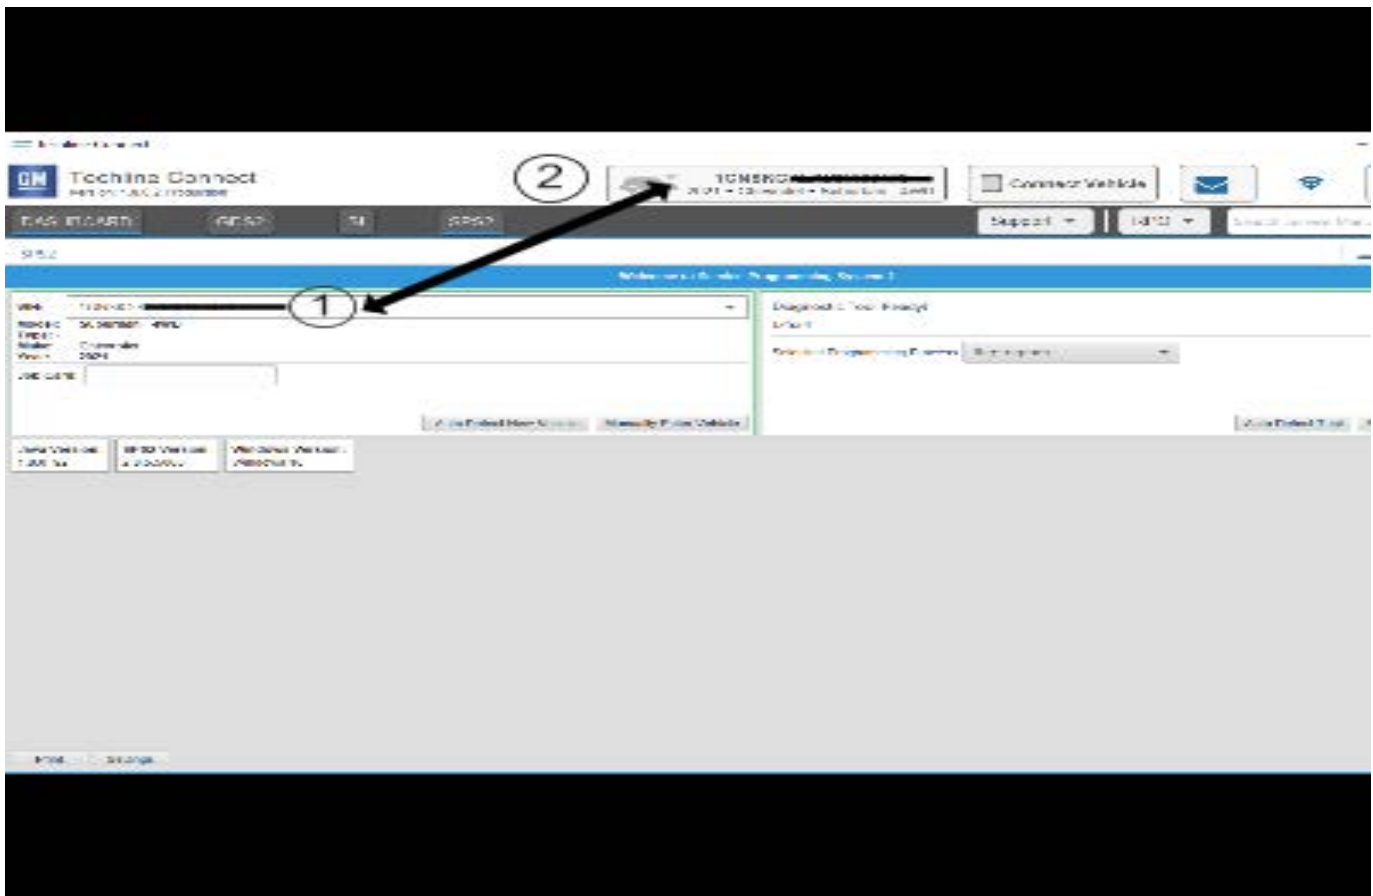
5743643

**Caution:** Be sure the VIN selected in the drop down menu (1) is the same as the vehicle connected (2) before beginning programming.
