SIB 52 09 20

## HEAD RESTRAINT AND/OR BACKREST OF 3RD ROW SEATS CANNOT BE FOLDED DOWN

E-Series	Model Description
G07	X7 Sports Activity Vehicle

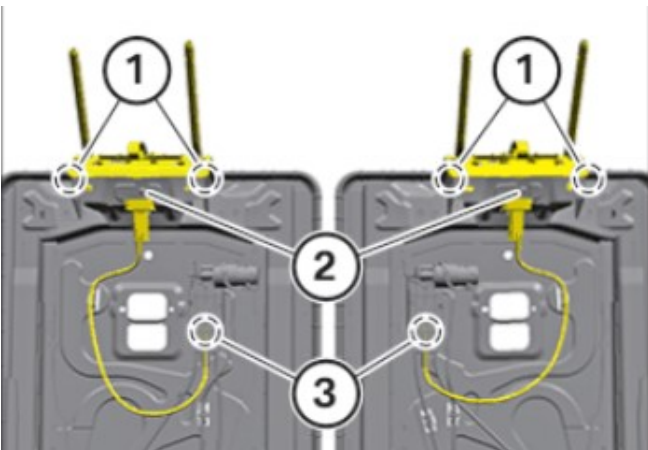
Can the head restraint be manually unlocked using the release loop beneath the headrest (see picture) and thus folded down?

**YES** = Head restraint mechanism is faulty.

Replace the folding module of the head restraint (#2 in picture).

See REP 52 30 118 Remove and install/replace folding module of left or right head restraint

**NOTE:** The head restraint cannot be removed without destroying the covering material. **A new cover (leather) will be required to perform this repair.**

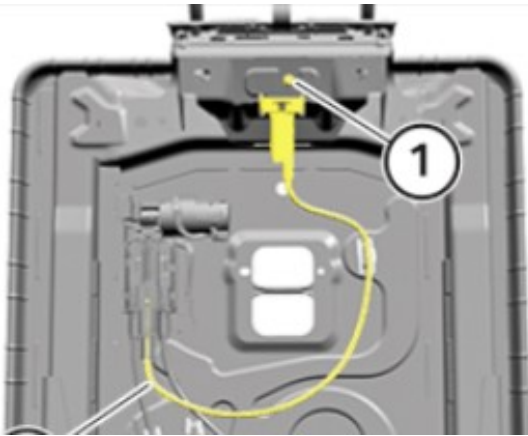
(Bowden cable unlocking device for head restraint).

**NO** = Check if the Bowden cable is correctly mounted and properly routed.

If the Bowden cable is mounted and correctly routed, replace the Bowden cable for the headrest (shown in yellow in picture).

See REP 52 30 253 Replace Bowden cable for left or right head restraint

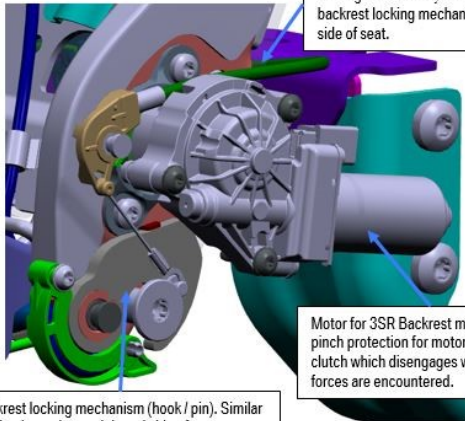
G07 3<sup>rd</sup> Row Seat – Overview Picture.

Bowden cable which originates at motor / worm gear assembly terminating at backrest locking mechanism on outboard side of seat.

Motor for 3SR Backrest movement. No pinch protection for motor, but has clutch which disengages when high forces are encountered.

Backrest locking mechanism (hook / pin). Similar mechanism exists on inboard side of seat.

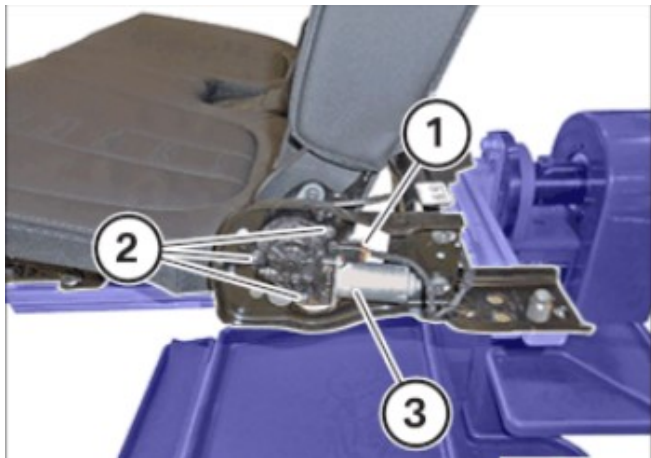
Check if the latch (the fastener on the left or right side) of the third row of seats is open or closed? (this is the hook/pin shown in green in picture)

If the head restraint stays in the seat position, the latch is closed.

If the head restraint falls into the folded position again, the latch is open.

**YES** (Latch is open) = Replace drivetrain of backrest tilt adjustment.

See REP 67 31 635 Remove and install/replace drivetrain for backrest tilt adjustment of third-row seating (left or right) (according to vehicle diagnosis)

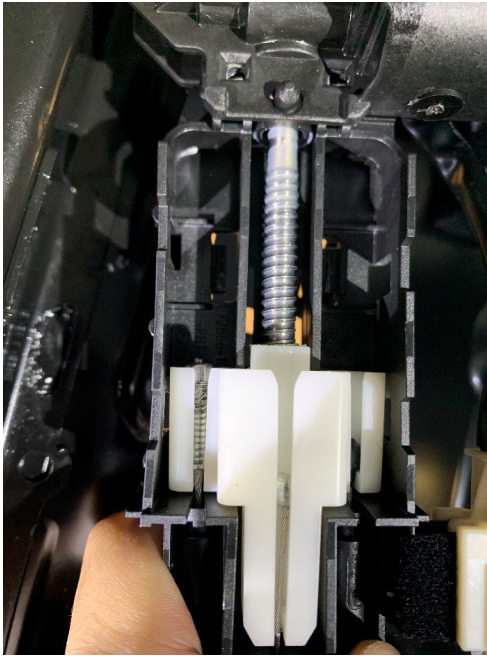
**NOTE:** The 3 Bowden cables are housed in a common housing that moves along a worm gear assembly.

When the electric motor activates, it spins the worm gear to pull up on the housing so that all

3 cables move simultaneously

One of the cables controls the head restraint folding. Once pulled, the headrest will release and pivot downwards. **Raising the headrest back into the upright position must be done by pushing up on it by hand.**

(The other two cables control the latch release at the seat pivot to enable the seat to fold.)

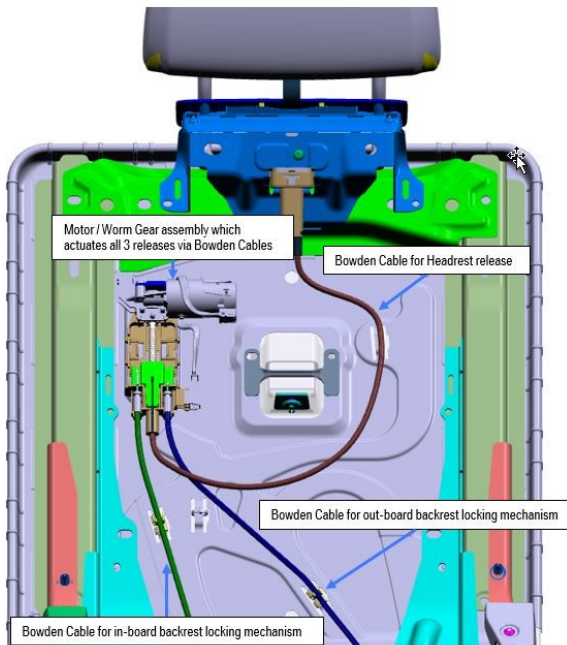
Is the drivetrain for the backrest release (actuator) broken?

**YES** = Replace only the drivetrain for backrest release (actuator).

See REP 67 31 645 Remove and install/replace drivetrain for backrest release of third-row seating (left or right) (according to vehicle diagnosis)

**NO** = Replace BOTH the Bowden cable(s) and drivetrain for backrest release (actuator).

REP 52 30 256 Replace Bowden cable for left or right rear seat backrest (Bowden cable for outer backrest release)

REP 52 30 255 Replace Bowden cable for left or right rear seat backrest (Bowden cable for inner backrest release)

REP 67 31 645 Remove and install/replace drivetrain for backrest release of third-row seating (left or right) (according to vehicle diagnosis)
