SIB 61 03 19

2021-05-25

## SERVICE ACTION: PROGRAM OR REPLACE DUAL STORAGE SYSTEM BATTERY

This Service Information Bulletin (Revision 2) replaces SI B61 03 19 **dated April 2019**.

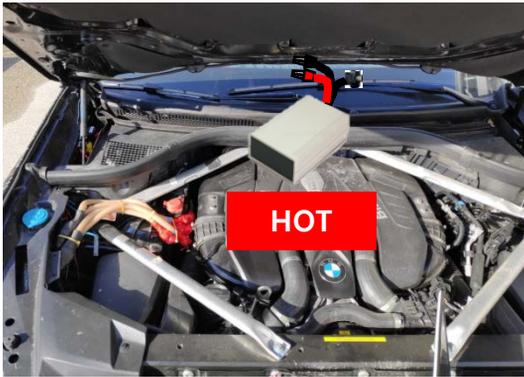
( X )

1) Engine compartment may be hot after driving. Wait until enough time to cool down and **DO NOT** put this flashing kit over **HOT** components during the software update.
