Service Bulletin

20-049

July 12, 2021 Version 6

2021 Odyssey: Popping or Crackling from the Speakers; No Sound from the Audio System; *Network Loss* Message and/or Display Issues

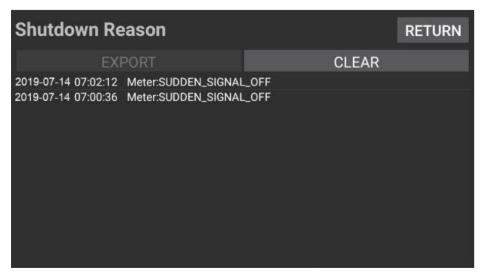
In this example, the cause of the failure can be identified as Meter:SUDDEN_SIGNAL_OFF.

Write down any failures; they will be collected on the warranty claim. Then, clear the data.
