MIL Is Flashing with Loss of Power

Supersedes 21-052, dated June 3, 2021, to revise the information highlighted in **yellow**.

Year	Model	Trim Level	VIN Range
2018–21	Accord	ALL 2.0L Turbo	ALL

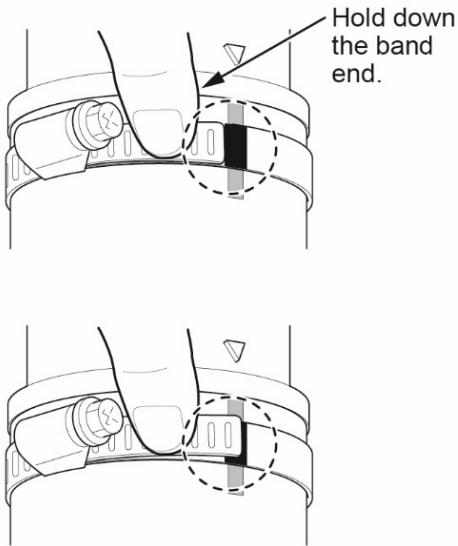
The hose band end is **AT** or **WITHIN** the paint or hash mark on the hose band.

- Install the new intercooler and gasket, and torque the two bolts mounting the intercooler to **22 N·m (16 lb-ft)** and the two bolts with brackets to **9.5 N·m (7 lb-ft)**.
- Tighten the hose bands to the specified condition below.

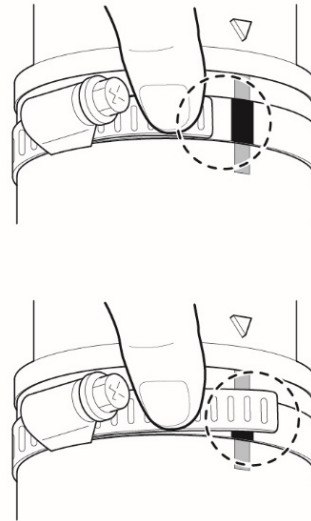
The hose band end is **NOT AT** or **EXCEEDS** the paint or hash mark on the hose band.
