07/15/21
CAL FTL 91-002

Subject: Replacement of Sears Driver Seat Metal Mounting Clip to Eliminate Seat Sensor Chaffing Issue

Models Affected: Freightliner New Cascadia vehicles built from June 2018 through June 2021.

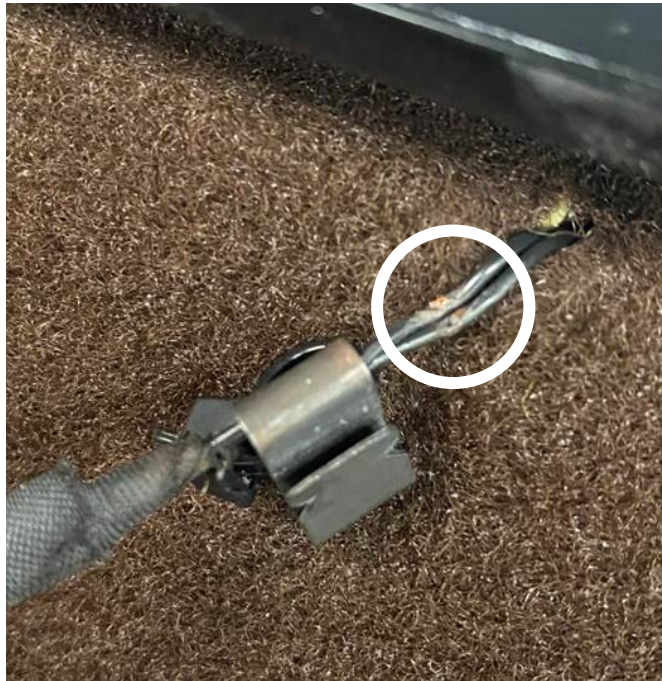
The seat sensor harness on New Cascadia vehicles ordered with a Sears driver seat (sales code 756-1H2) may experience chaffing due to the incorrect mounting of a metal clip edge; excessive chaffing may result in disabling adaptive cruise control. The metal clip edge needs to be replaced by a plastic clip edge to resolve this issue.

Fig. 1, Chaffed Driver Seat Sensor Harness

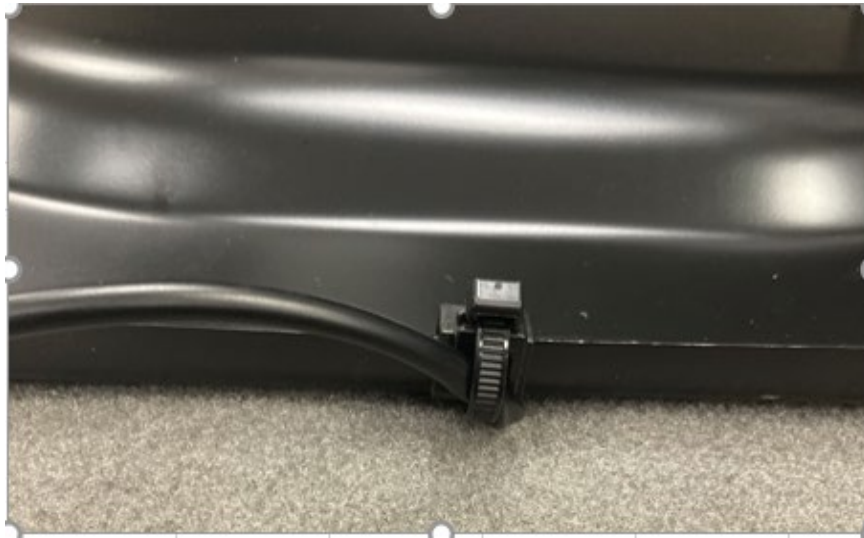
Fig. 2, Driver Seat Sensor Harness Fastened to Seat

1. Park the vehicle, shut down the engine, and apply the parking brakes. Chock the tires.
2. Access the cab and locate where the driver seat sensor harness is fastened to the right-hand side of the driver's seat. See **Fig. 2**.

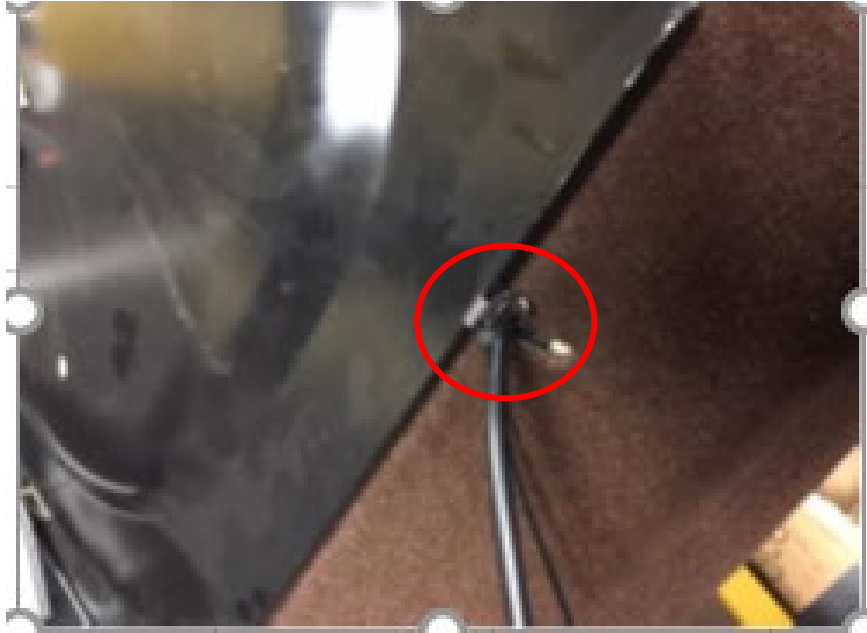
Fig. 3, Metal Clip on Driver Seat Sensor Harness

3. Remove the metal clip edge and wire tie from the seat sensor harness. See **Fig. 3**.

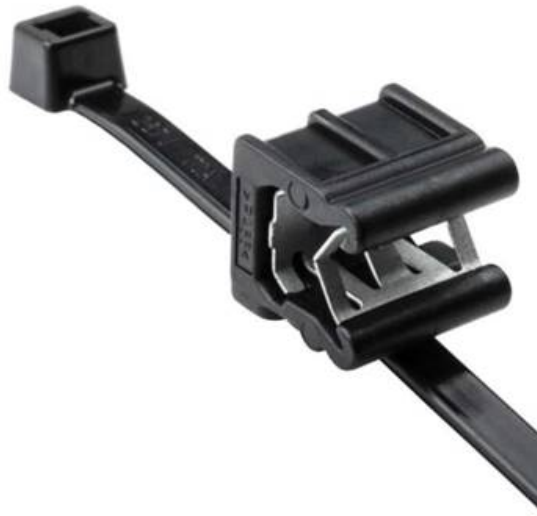
Fig. 4, Plastic Clip Edge (Tie Strap) Mounting

4. Install a new plastic clip edge (part number 23-13477-010) as shown in Fig. 4.

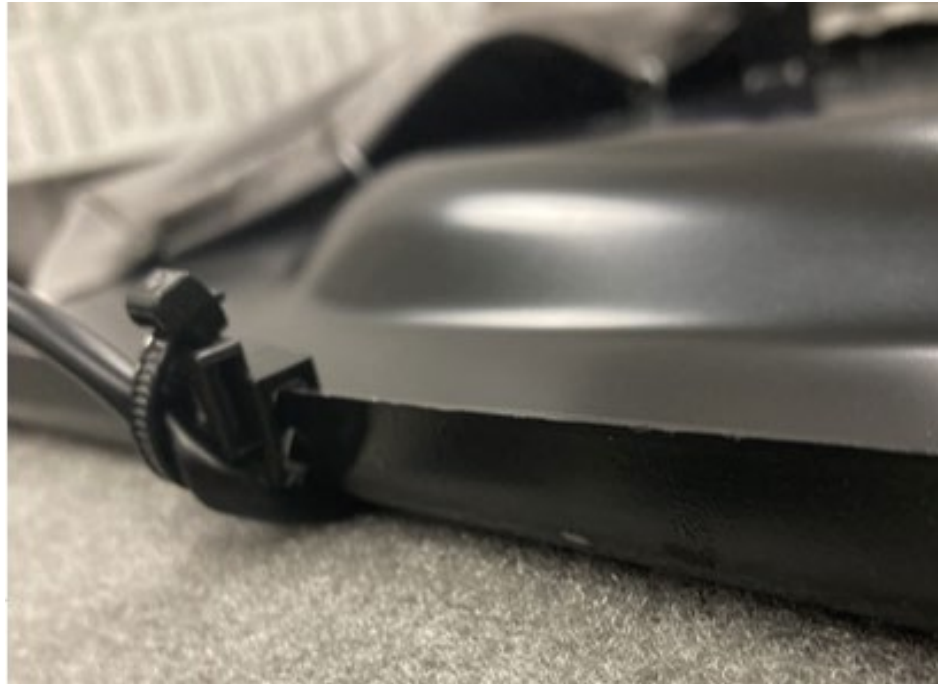
Fig. 5, Proper Clipping and Routing of Harness Driver Seat Sensor

5. Fasten the driver seat sensor harness using the new plastic clip edge. Clip any excess wire as shown in Fig. 5.
