Technical Service Bulletin

72 Rear backrest release in the luggage compartment is inoperative

72 21 35 2062113/3 July 16, 2021. Supersedes Technical Service Bulletin Group 72 number 21-33 dated February 25, 2021 for reasons listed below.

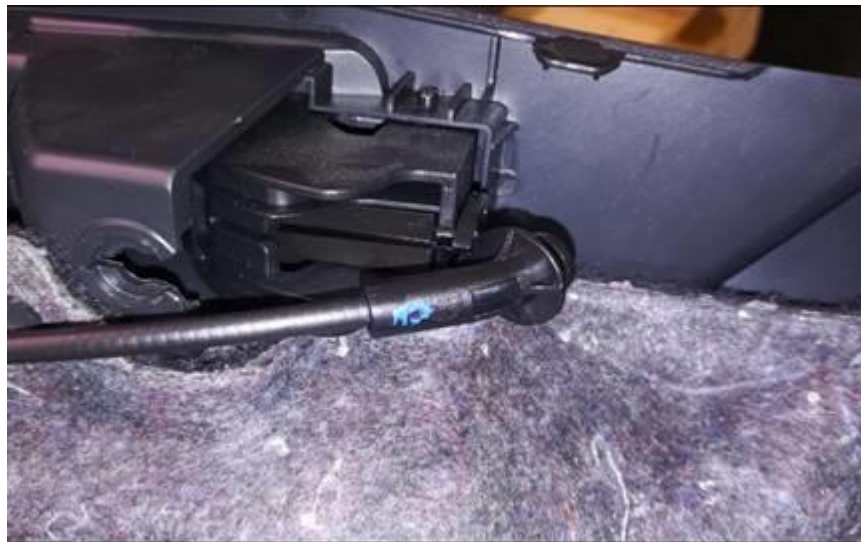
The Bowden cable disengages from its attachment point and does not release the backrest latch.

1. If the second row backrest release lever is without resistance or feels loose, the Bowden cable in the luggage compartment side trim has become disengaged (Figure 1).

Figure 1. Bowden cable is disengaged from the attachment point.

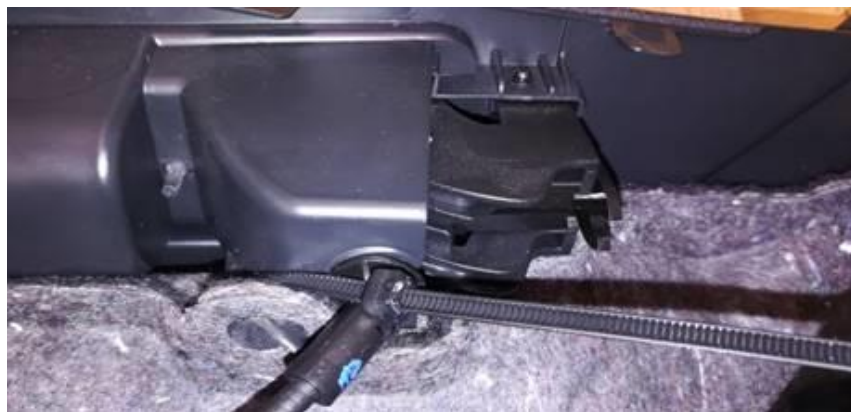
Figure 2. The Bowden cable reinstalled and secured with tie wrap.

2. Remove the luggage compartment side trim of the affected side according to the repair manual in Elsa.
3. Inspect the Bowden cable and the backrest release mechanism for any damage.
4. Reinstall the Bowden cable in the backrest release mechanism and secure it with a tie wrap (Figure 2).
