Campaign No. 2021060008 June, 2021

TO: ALL MERCEDES-BENZ & FREIGHTLINER CENTERS

SUBJECT: **Model 907 Sprinter, Model Year 2020**
Check Torque on Front Door Hinge Screws

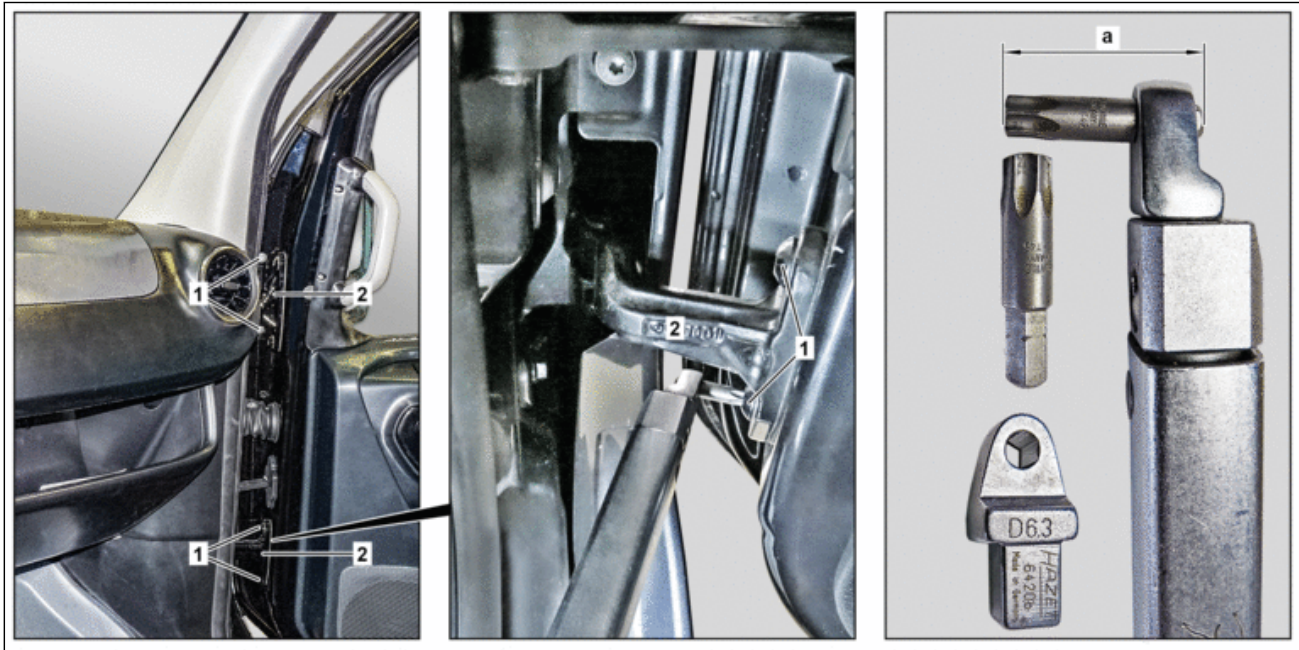
D72.10-A007-79

Shown on right side of vehicle

1 Bolts

2 Hinge

a Dimension (approx. 35 mm)

Check threaded connections of hinges (2) on **both** front doors.

To do so, move front door e.g. abruptly. If front door exhibits play on the screws (1) or hinges (2), ↓ Adjust front door. If front door does not exhibit any play on the screws (1) or hinges (2), ↓ continue with operation step 4.	AR72.10-D-0550TS
	Tighten threaded connection		
4	Tighten screws (1). Note on calculation of tightening torque when using insertion or socket tools with various effective lengths	If the respective front door does not exhibit any play on the screws (1) or hinges (2).

Use torque wrench attached at low eye-level height. Observe dimension (A).

Number	Designation	Model 907
BA72.10-N-1010-01TS	Screw/bolt, hinge to front door	Nm 23
