## TECHNICAL SERVICE BULLETIN

### 6.2L/7.3L - 10R140 - Illuminated MIL With DTCs P0132, P0135, P0138, P0141, P0152, P0155, P0158 And/Or P0161

21-2090

16 July 2021

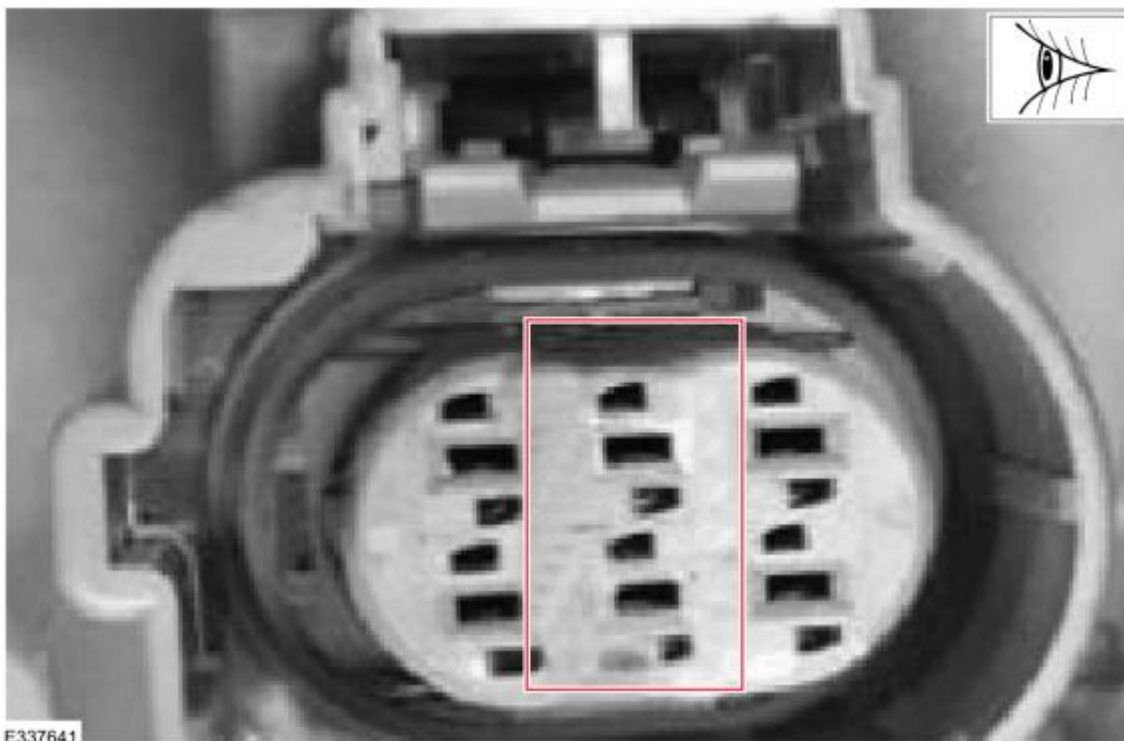
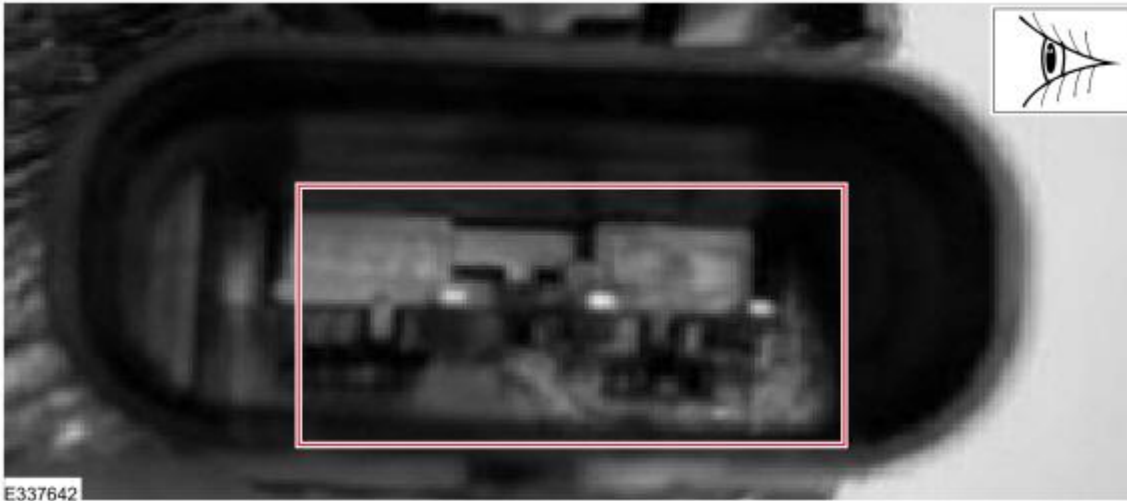
1. Disconnect the appropriate HO<sub>2</sub>S and/or the catalyst monitor sensor based on the DTC(s) received and inspect for moisture and/or corrosion on the pins of the sensor or the wiring harness. Are there any signs of moisture and/or corrosion present? (Figures 1-2)
  - (1). Yes - replace the affected HO<sub>2</sub>S and/or the catalyst monitor sensor. Refer to Workshop Manual (WSM), Section 303-14. Proceed to Step 2.
  - (2). No - this article does not apply. Refer to the Powertrain Control and Emissions Diagnosis (PC/ED) Manual for normal diagnostics.
