**SUBJECT:** **Customer Satisfaction Program 20N11 - Supplement #3**  
Certain 2016 - 2019 Model Year Explorer Vehicles equipped with *Satin or Chrome Plated* Roof Rack Covers  
Roof Rack Cover Inspection/Repair

**Customer Satisfaction Program 20N11 - Supplement #3**

Certain 2016 - 2019 Model Year Explorer Vehicles equipped with *Satin or Chrome Plated* Roof Rack Covers  
Roof Rack Cover Inspection/Repair

## CERTAIN 2016-2019 MODEL YEAR EXPLORER VEHICLES EQUIPPED WITH SATIN OR CHROME PLATED ROOF RACK COVERS— ROOF RACK COVER INSPECTION/ REPAIR

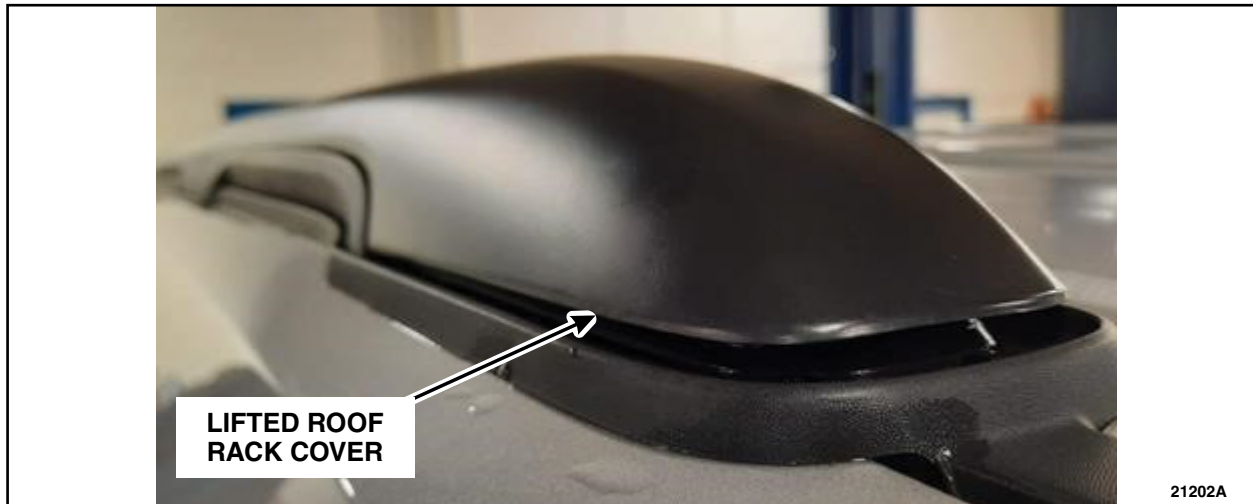
**FIGURE 1**

A loose or lifted roof rack cover in the front or rear does not indicate the need for parts to be replaced, the root cause needs to be identified in the inspection procedure. See Figures 1, 2 and 3.

**NOTE:** The roof rack base front end caps do not need to be replaced if the roof rack passes inspection. Only replace the roof rack base front end caps if damage has occurred during transfer of parts.

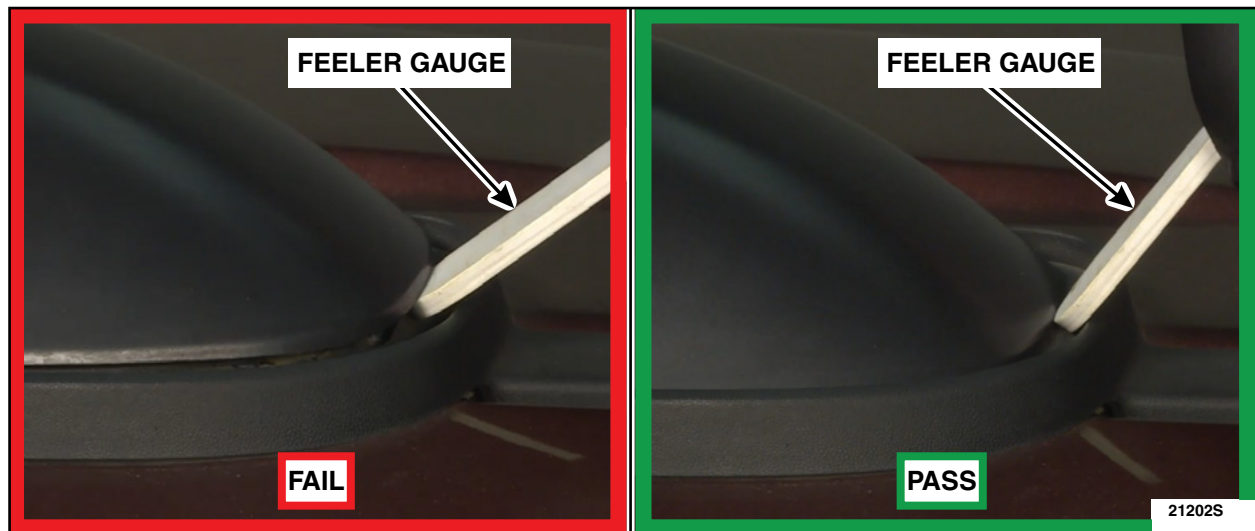
**FIGURE 4**

1. Using a 2 mm feeler gauge, check the spacing on the front and rear of both the RH and LH roof rack covers. See Figure 4. If the feeler gauge fits between the roof rack cover and the roof rack base then it fails inspection. Does the roof rack covers pass or fail?

**NOTE:** A failing roof rack cover does not require replacement at this time, further investigation is required.

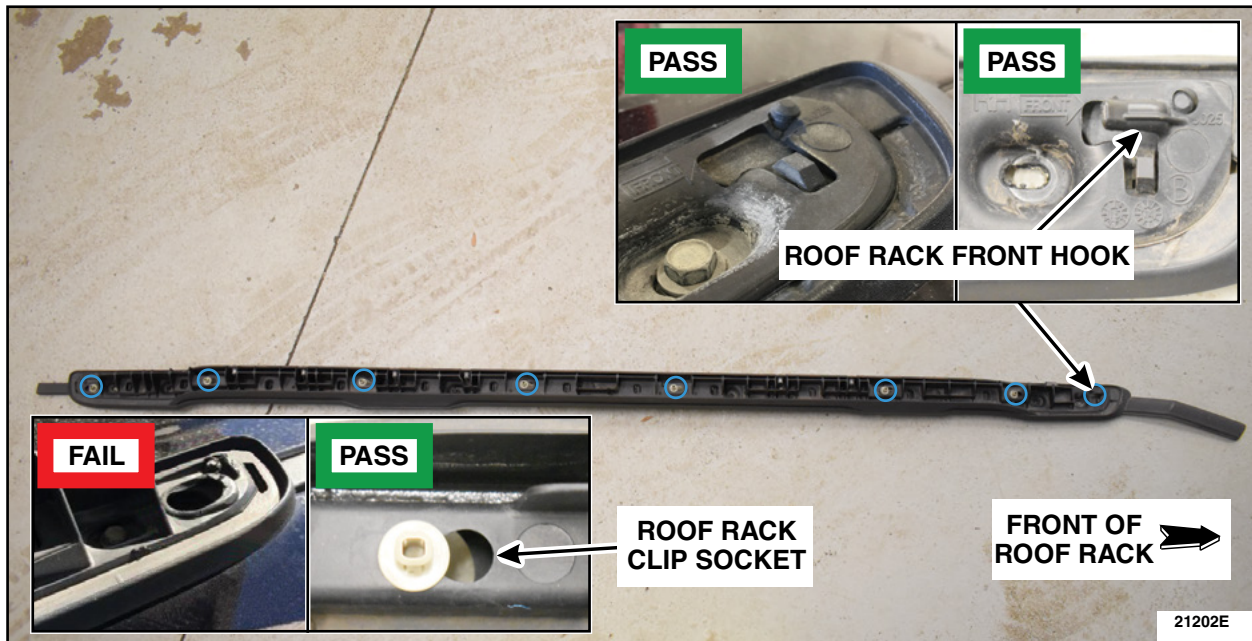
**FIGURE 6**

**NOTE:** A broken roof rack base hook does not need to be replaced.

b. Inspect the affected roof rack base. See Figure 6.

i. If broken, take photos of roof rack base for both the RH and LH.

1. Photos must be clearly labeled RH or LH.

2. Damaged roof rack bases must be clearly identified with a bright highlighter or similar.

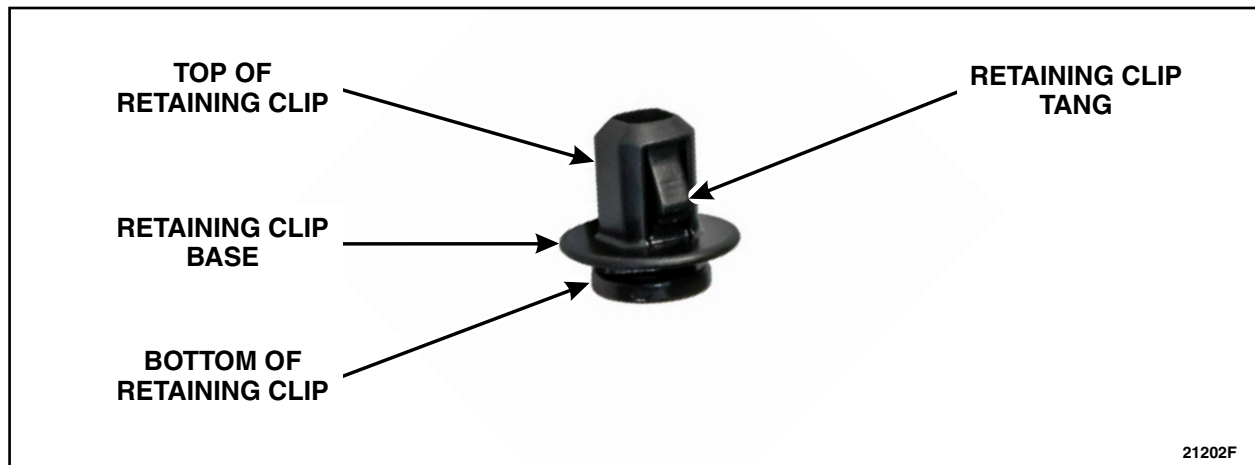
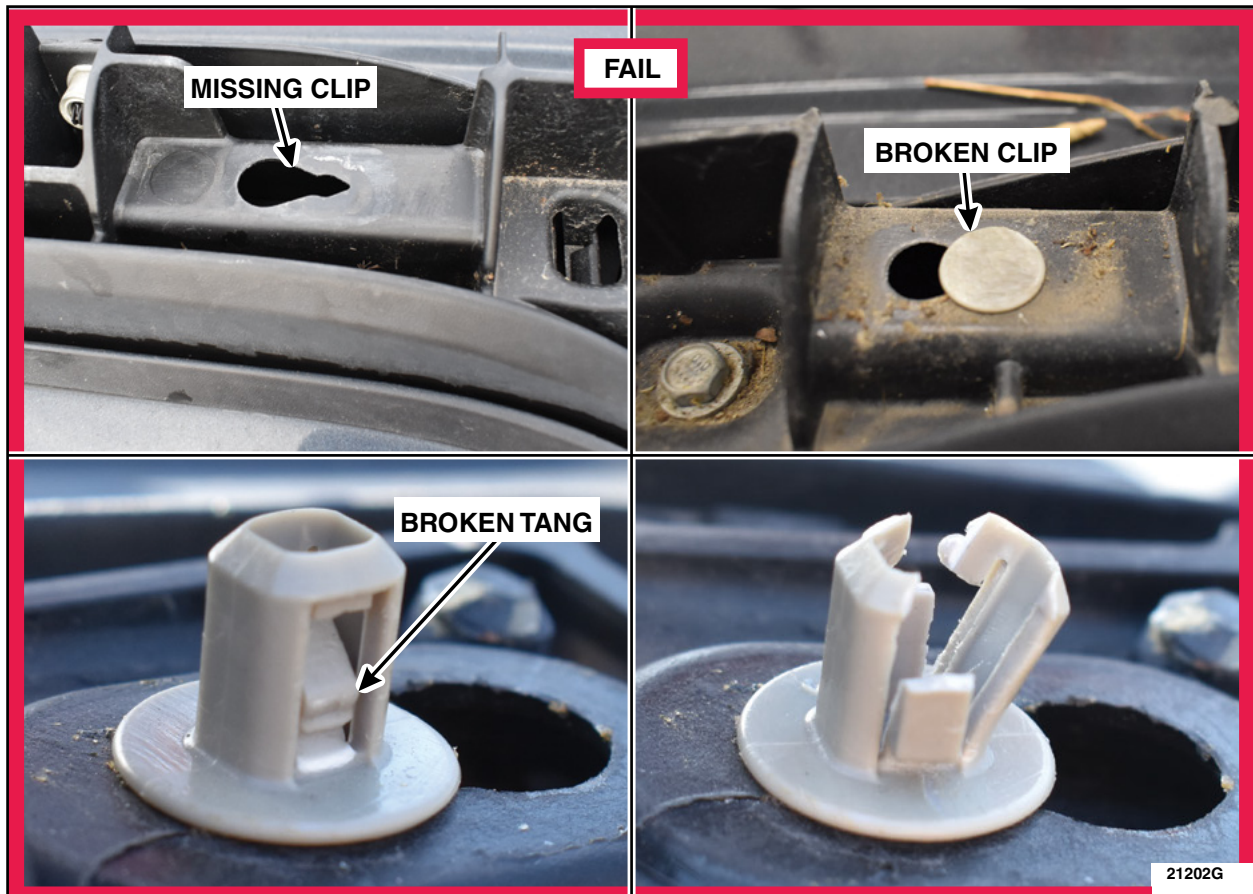
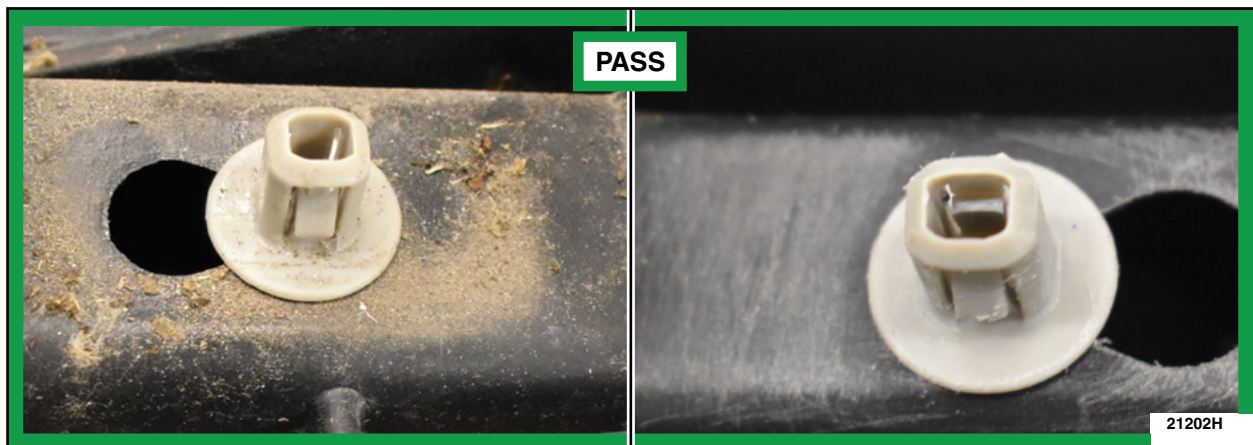
c. Inspect the retaining clips (7 per side) on the affected side without removing them from the roof rack base. See Figures 7, 8 and 9.

i. Clips that are reusable:

- Different colors.
- Different styles.
- No major damage identified.

ii. Clips that cannot be reused:

- Missing.
- All or partial of the top missing from the clip base.
- Broken retaining tang.
- Covered in epoxy from a previous repair.

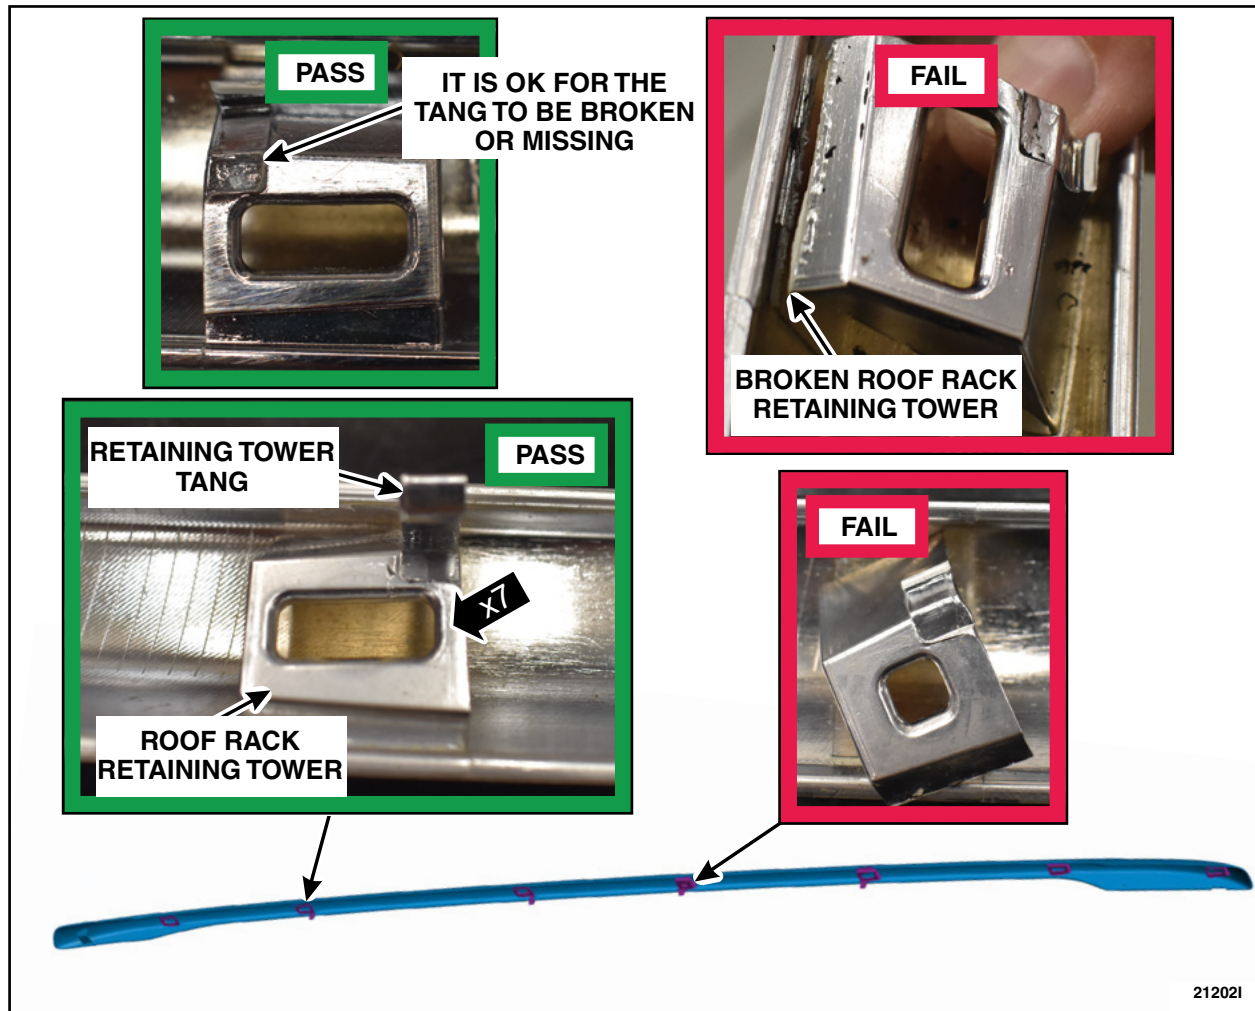
FIGURE 9

i. Broken tangs do not require replacement.

ii. If broken, take photos of retaining towers on the roof rack covers.

1. Photos must be clearly labeled RH or LH.

2. Broken retaining towers must be clearly identified with a bright highlighter or similar.

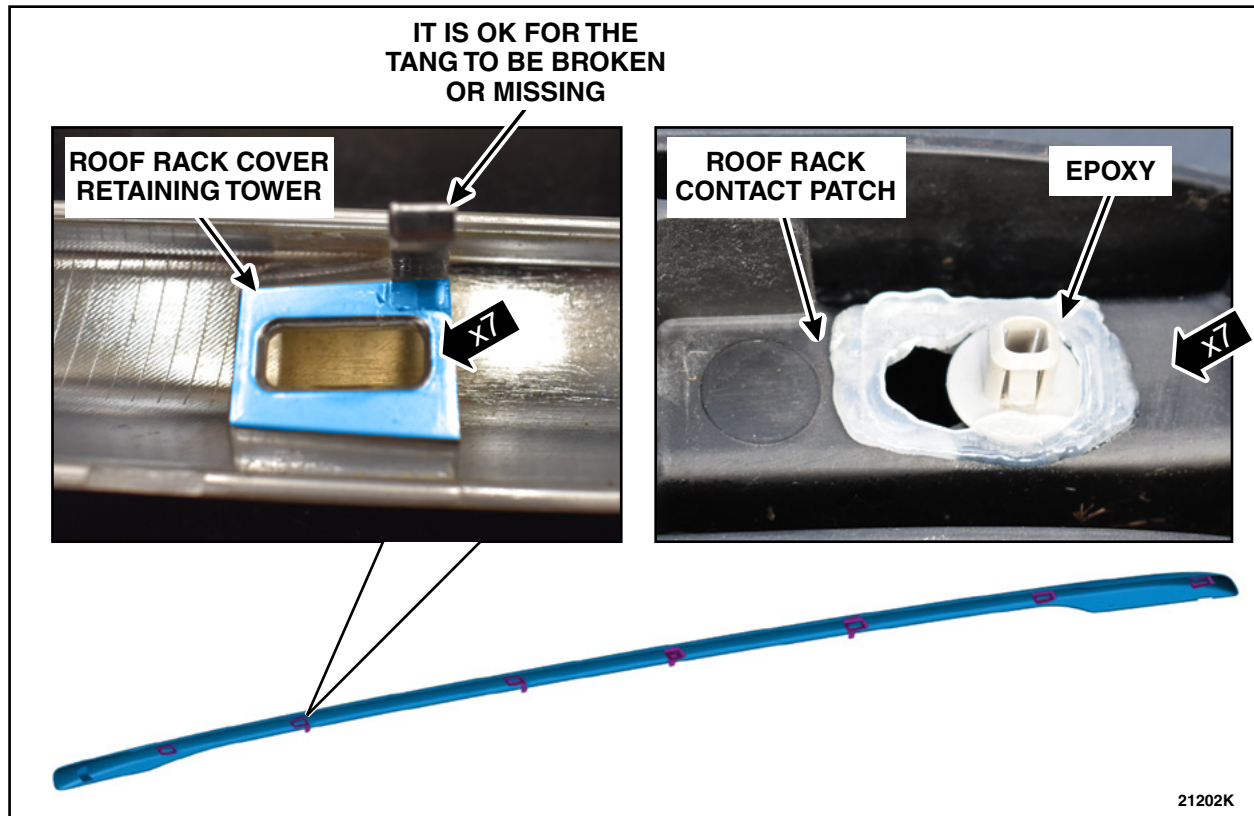
**FIGURE 11**

1. If Technical Service bulletin (TSB) 19-2364 or 20-2154 was performed, evidence of RTV or expoxy will be seen on the roof rack cover and or roof rack contact patch. Inspect the roof rack cover retaining tower and roof rack contact patch for signs of RTV or epoxy adhesive. See Figure 11. Was evidence of RTV or epoxy found?

If **YES** - Replace all the roof rack clips on the affected side, then proceed to Step 2 on Page 11.
