TECHNICAL SERVICE BULLETIN

Seat Pan Looseness, Lateral Movement, Or Clunk/Thump Noise On Turns

21-2236
21 July 2021

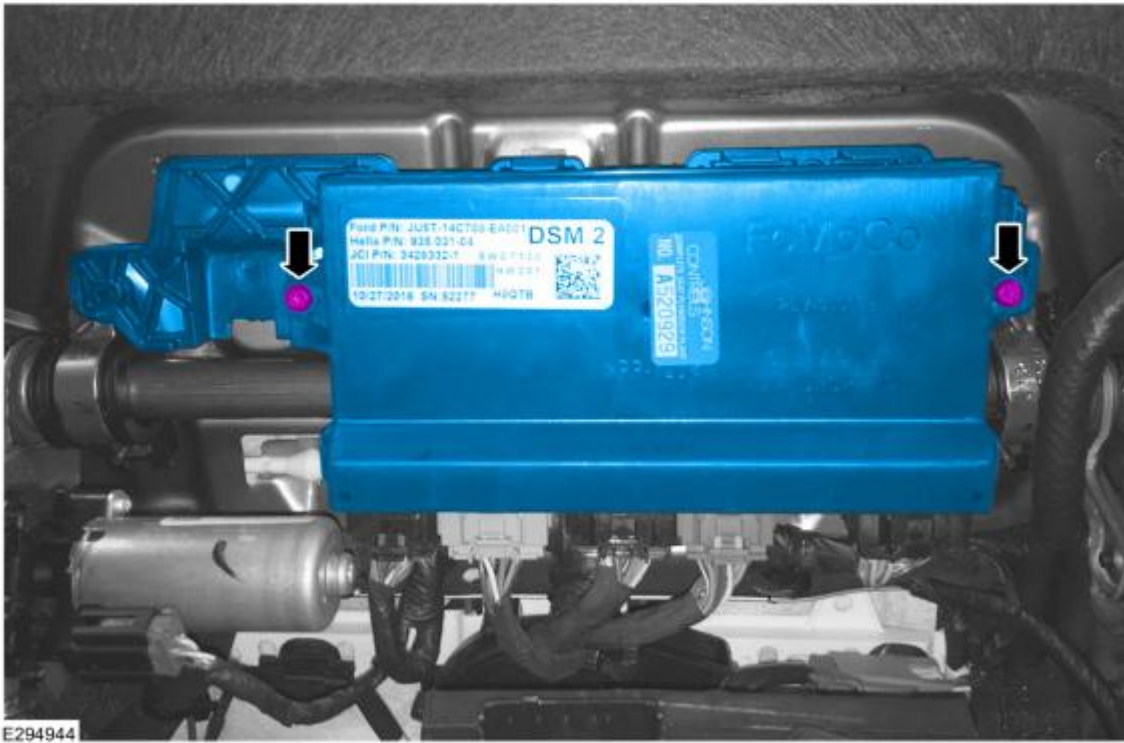
Figure 1

4. Is the vehicle equipped with a power seat control module under the seat? (Figure 1)

(1). Yes - remove the 2 power seat control module retaining screws and remove the power seat control module.
