Technical Service Bulletin

57 Bonded outer door seal is detached from the door

57 21 81 2064183/1 July 28, 2021.

Model(s)	Year	VIN Range	Vehicle-Specific Equipment
Audi e-tron quattro, Audi e-tron Sportback	2020 – 2022	All	Not Applicable

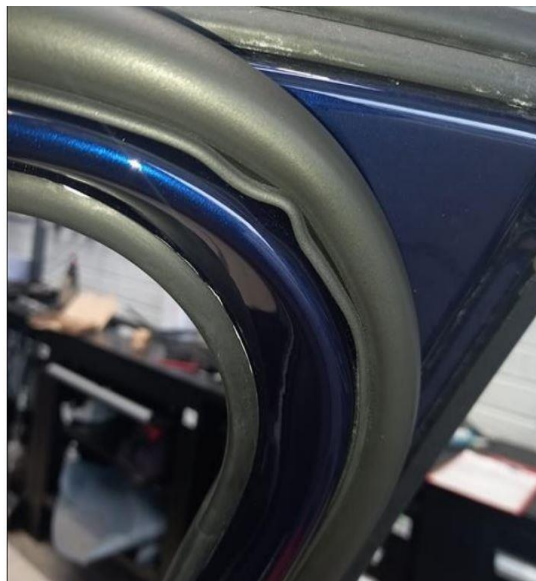
Various factors such as pressure, temperature, and contamination in the bonding area can influence the adhesive bond between the outer door seal and the door.

The adhesive bond for the outer door seal can come loose in the entire area where the outer door seal makes contact with the door (Figures 1 - 4).

Figure 1. Outer door seal detached from the door.

1. Replace affected door seals as described in the Elsa Repair Manual.

- The vehicle and the seal must be at room temperature.
- The bonding surfaces must be free of dirt and grease.
- Do not stretch the seal during installation.
- To prevent the outer door seal from becoming detached or misaligned, the door must not be closed for at least 30 minutes.
- If the door seal has been removed, use the routing of the outer door seal on the opposite side as a guide when positioning the outer door seal.
- Remove any remaining adhesive tape from the door using adhesive strip remover VAS 6349.

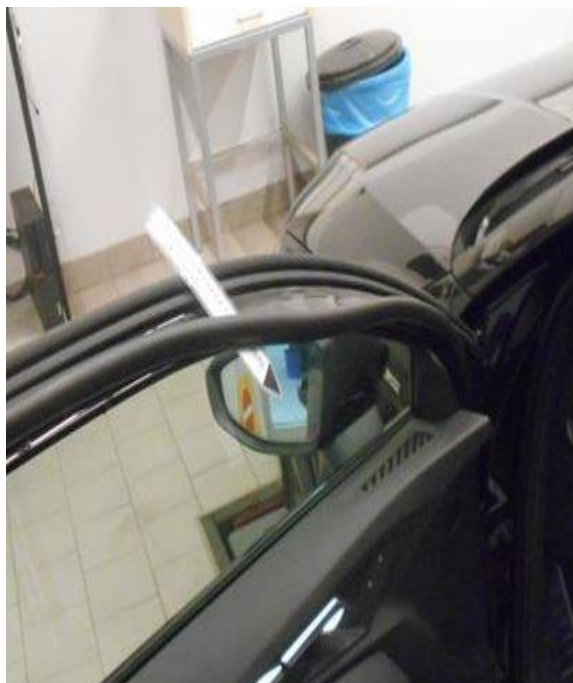
Figure 2. Outer door seal detached from the door.

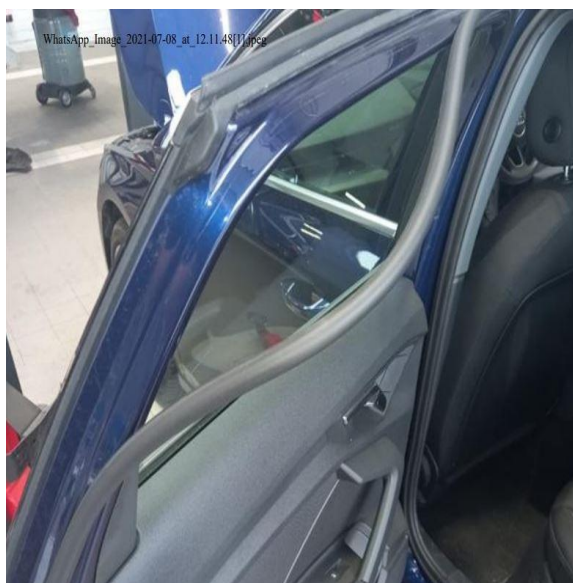
Figure 3. Outer door seal detached from the door.

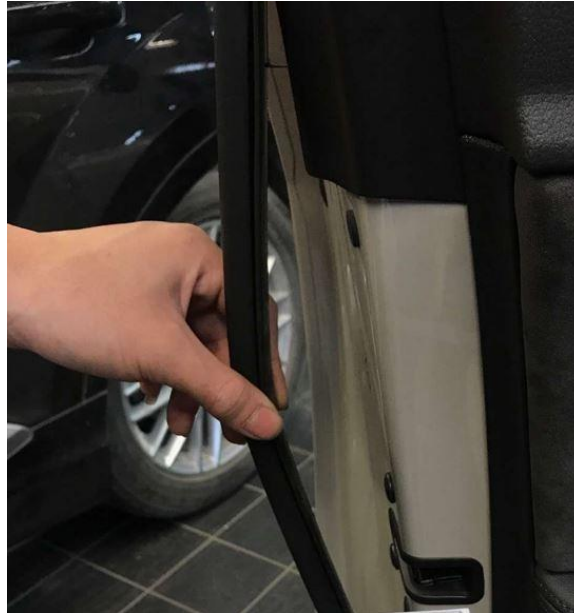
Figure 4. Outer door seal detached from the door.
