# TECHNICAL SERVICE BULLETIN

Technical Service Bulletin: 410-1371

Forest River is alerting you to an issue involving certain 2021 – COLUMBUS - CMF390RL, CMF390RLW, CMF392MB AND CMF392MBW fifth wheel travel trailer recreational vehicles. Please see the information below which describes the issue and provides you with details on the steps you should take to have your vehicle repaired.

Possible poor seal insulation at the return air portion and/or air duct or trunk line of the air conditioner.

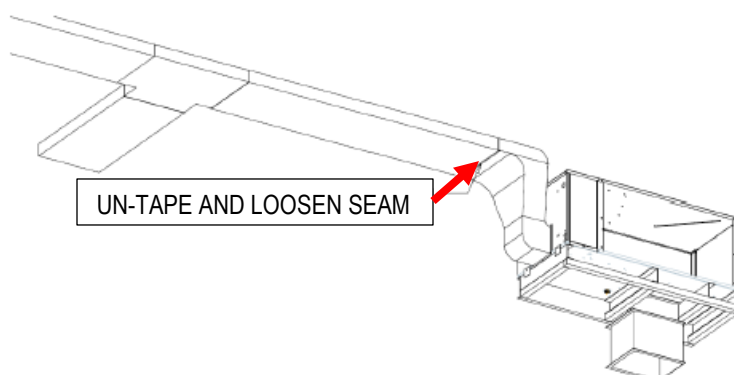
STEP 7: CHECK TO SEE IF AIR IS ESCAPING OUT OF THE DUCTING IN THE AREA SHOWN. THERE HAVE BEEN ISSUES WITH BUCKLING AT THE TOP AND AIR LEAKING. IF AIR IS LEAKING, SEE STEP 8 TO RESEAL;

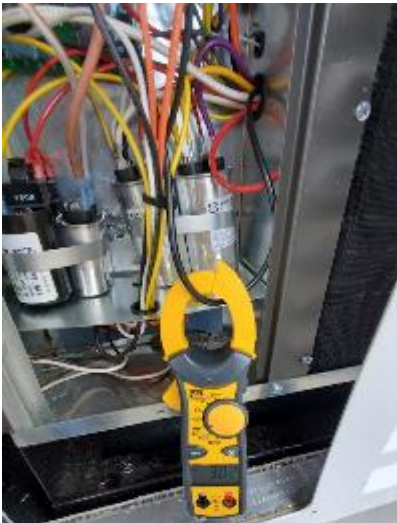
STEP 13: GET AN AMP DRAW FROM THE BLOWER MOTOR TO SEE IF THE BLOWER IS BEING RESTRICTED. ANYTHING BELOW 2.8 AMPS WOULD INDICATE THAT THE BLOWER MOTOR RPMS ARE LOW, INDICATING RESTRICTIONS TO AIRFLOW.
