Throttle lift-off clunking noises at drive shafts of front axle

Topic number	LI33.30-P-056665
Version	6
Function group	33.30 - Final drive, differential, drive shaft
Date	7/7/21
Validity	Models: All Mercedes-Benz cars with front-wheel drive and 4x4 vehicles
Reason for change	Validity for new model series updated.

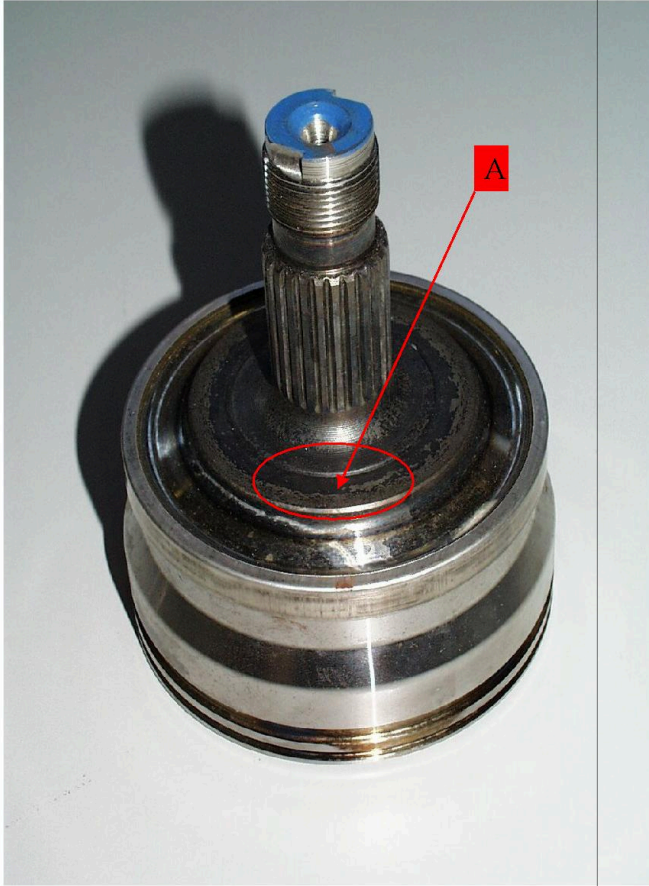
vor.jpg

If the complaint is eliminated by experimentally loosening the outboard collar nut (by 1 turn), the concern is due to micromovement in the connection between the wheel bearing inner race and the joint housing of the side shaft.

Before coating with Molykote paint

1. Remove outboard side shafts (extract outer joint gearing from wheel hub)
2. Clean contact surface A (see image file in attachment "Outer joint housing before") before coating with Molykote paint (free of dust and grease)
3. Coat contact surface A (see image file in attachment "Outer joint housing after") with Molykote and leave to dry for one hour in removed condition
4. Reinstall side shafts

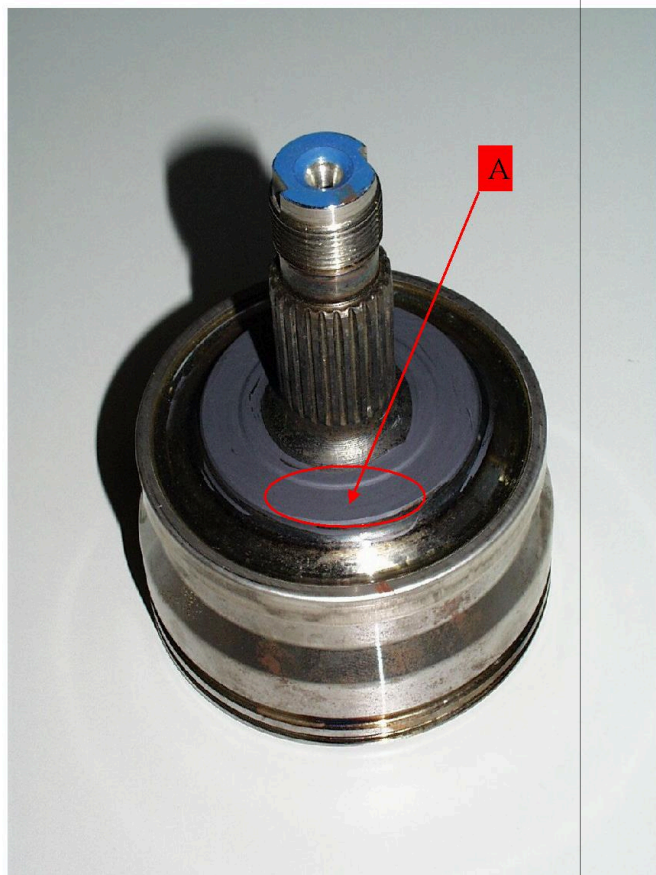
nach.jpg

After coating with Molykote paint
