**WMA5 - Updating Software for Various Control Units (Workshop Campaign)**

Revision: This bulletin replaces bulletin Group 9 15/21 WMA5, dated May 28, 2021.

Model Line: **Taycan (Y1A)**

Concerns: **Software update (software version VR12.1.1)**

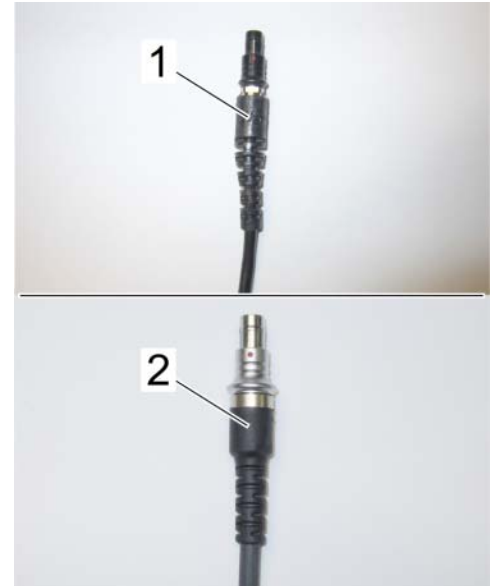
*PIWIS Tester data cable*

Use the **new** PIWIS Tester data cable to carry out the campaign. The difference between the old ⇒ *PIWIS Tester data cable -1-* and new ⇒ *PIWIS Tester data cable -2-* data cable is shown in the illustration.

If the connection between the vehicle and PIWIS Tester is interrupted, check the data cable for the PIWIS Tester for signs of damage. If the data cable is damaged, it **must** be **replaced**. To do this, follow the instructions in the PPN for "Returning faulty USB cable caps" (PPN portal > Dr Ing. h.c. Porsche AG > Aftersales > Workshop > PIWIS > Documents).

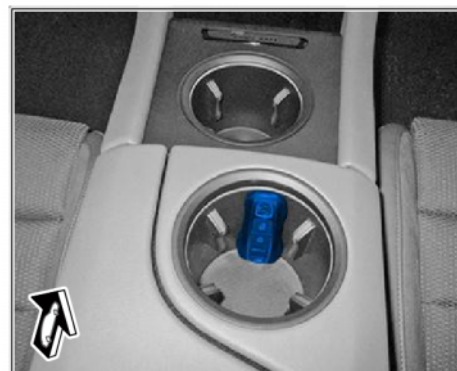
*Emergency start tray*

**Control unit programming will be aborted if the driver's key is not recognized**

- **If the driver's key is not recognized in the vehicle, programming cannot be started or will be interrupted.**
- ⇒ **Position the driver's key with the back facing forward upright between the holding struts in the rear cupholder (emergency start tray) to ensure a permanent radio link between the vehicle and remote control.**
