Mack Chassis - Model GR/GU - Hood Warpage

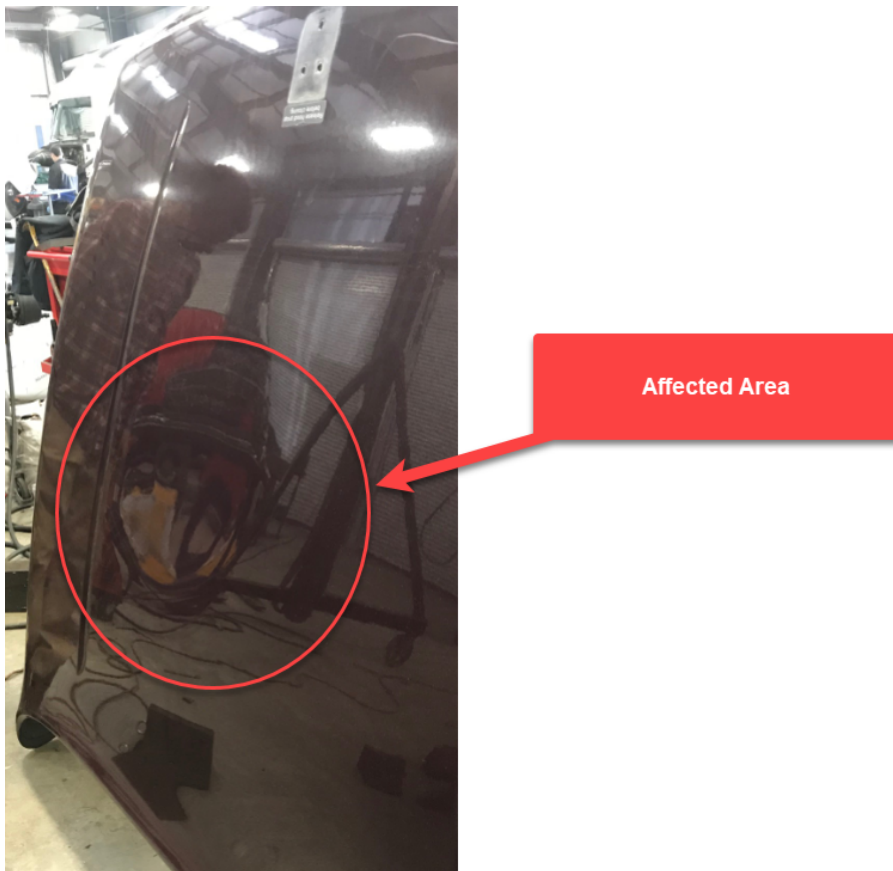
Affected models will have an appearance similar to the one shown in the circled area in the example below.

It has been determined that an increase of lateral structural hood support is required to correct this issue.
