# Technical Service Bulletin

Subject:			
RUST OR PAINT PEELING AT INSIDE EDGE OF FRONT DOOR(S)	Bulletin No.: 09-016/21		
	Last Issued : 07/12/2021

2017-2020 CX-5 vehicles with VINs lower than JM3KF\*\*\*\*\*869654 (produced before Aug. 24, 2020) 2021 CX-5

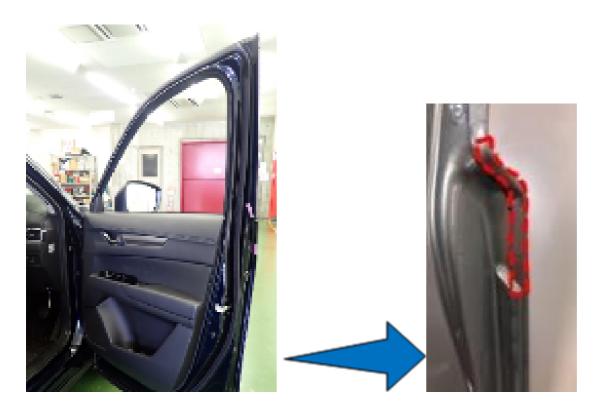
Some vehicles may exhibit rust or paint peeling at the inside edge of the front door(s). This may be caused by dust adhering between the front door edge and the rear door weatherstrip, which rubs/damages the paint during vehicle operation (door opening/closing and vibration while driving).

NOTE: If the rust/paint peeling is seen on the outer side of the door, this service bulletin does not apply.

- 1. Verify the customer concern.
- 2. Repair the paint peeling and/or rust on the vehicle according to normal body shop procedures.
- 3. Attach the protector tape to the front door(s) according to "Procedure to attach the protector tape" below. **NOTE:** Replace both rear door weatherstrips as necessary.
