Technical Service Bulletin

Subject: WATER ENTRY FROM THE REAR DOOR	Bulletin No.: 09-020/21
	Last Issued : 07/07/2021

2019-2021 Mazda3
2020-2021 CX-30

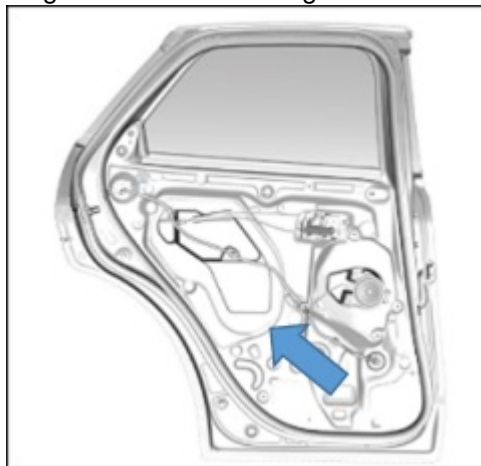
Some vehicles may exhibit water leaking into the passenger compartment from the rear door through the bottom of the service hole behind the rear door trim during rain or when washing the vehicle.

This is caused by one of the following:

- Since the material of the seal rubber is not resistant to surfactants, the rubber deteriorates when the vehicle is washed and allows water to penetrate into the seal rubber of the service hole cover.
- The lower tabs of the service hole cover may not have been completely engaged at the factory.

To eliminate this concern, the service-hole cover has been modified.

Customers having this concern should have their vehicle repaired using the following repair procedure.

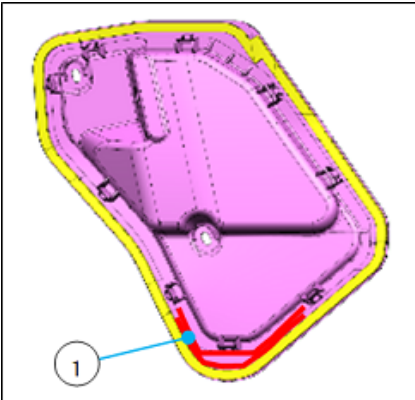
Modified service-hole cover with seal material (1)
B0J8-72-973 / B0J8-73-973

- Modified service-hole cover with seal materials: Replace the service-hole cover with a modified one.
- Non-modified service-hole covers: Apply butyl tapes as follows.

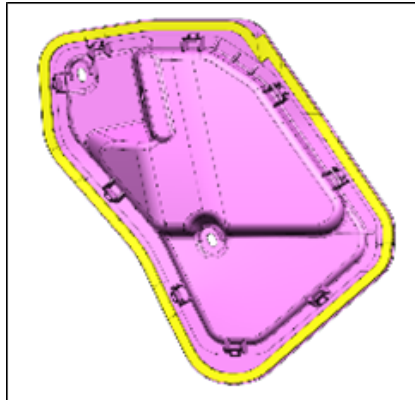
Non-modified service-hole covers
BCJH-72-973E / BCJH-73-973E
BDTS-72-973E / BDTS-73-973E

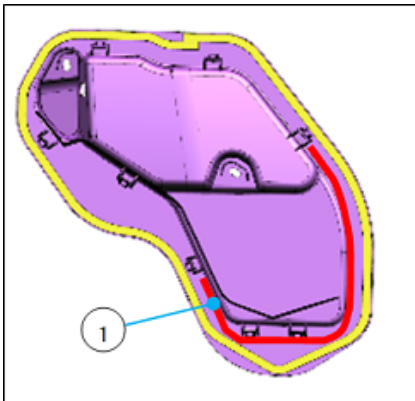
Modified service-hole cover
with a seal material (1)
DFR5-72-973 / DFR5-73-973

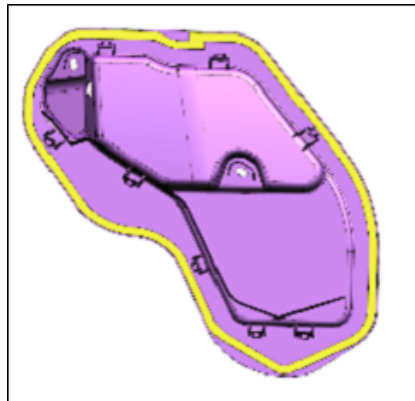
Non-modified service-hole cover
DFR5-72-973 / DFR5-73-973
DGH9-72-973 / DGH9-73-973
