Technical Service Bulletin

Subject: REAR CONSOLE / CUP HOLDER WARMING	Bulletin No.: 09-023/21
	Last Issued : 07/19/2021

2016-2021 CX-9

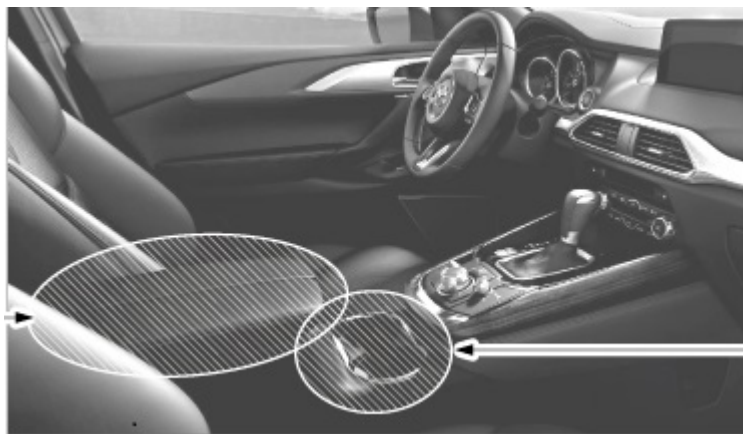
Some customers may complain that the rear console / cup holder area is warming.

The warming is caused by heat radiating from the rear heater core, which is located under the console. The warm air created by the heater core escapes through small gaps and carries heat along the inner walls of rear console / cup holder, causing an increase in temperature.

Customers having this concern should have their vehicle repaired using the following repair procedure.

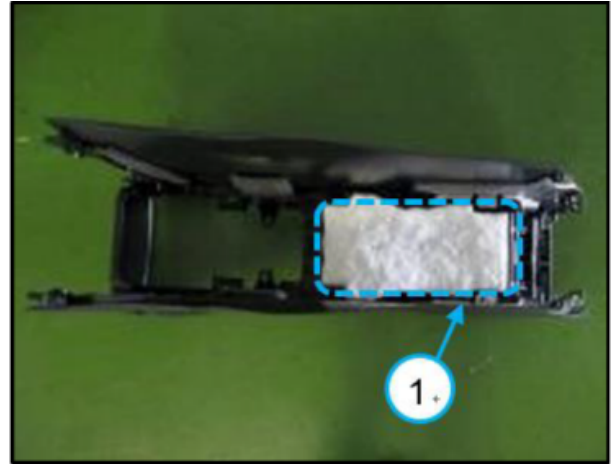
Rear Console Bottom, (1) White Insulator

2. Thoroughly remove all the white insulator (1) from the bottom of the rear console.

NOTE: Make sure there are no leftover pieces of insulator. Use parts cleaner to remove any stuck insulator remains.

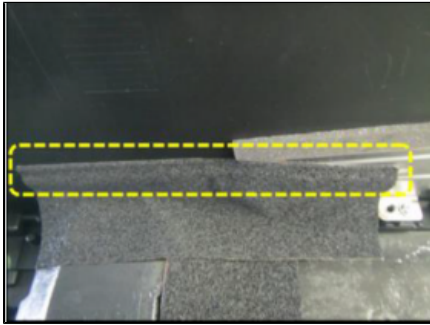
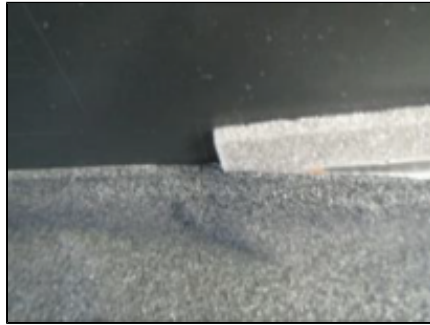
Step Between Side Cover
And Sponge Tape

NOTE: Carefully place each seal to completely eliminate any existing gaps (as shown below). Fit the seals into the irregular surfaces as well as possible.

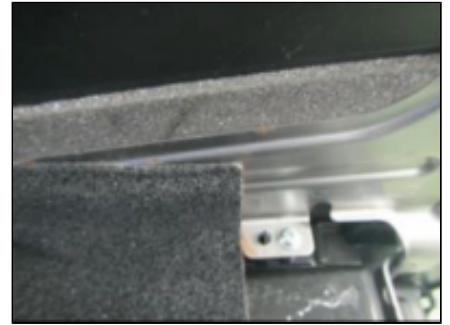
Irregularities Of Console Bracket
