## Turbo-Compound Engines - P049D00 EGR Valve Exceeded Learning Limit - US21+OBD20 And US21+OBD21 Emissions

Newer US21+OBD20 and US21+OBD21 turbo-compound engines may display this DTC. In all cases when the truck has set code P049D00, the following steps should be performed.

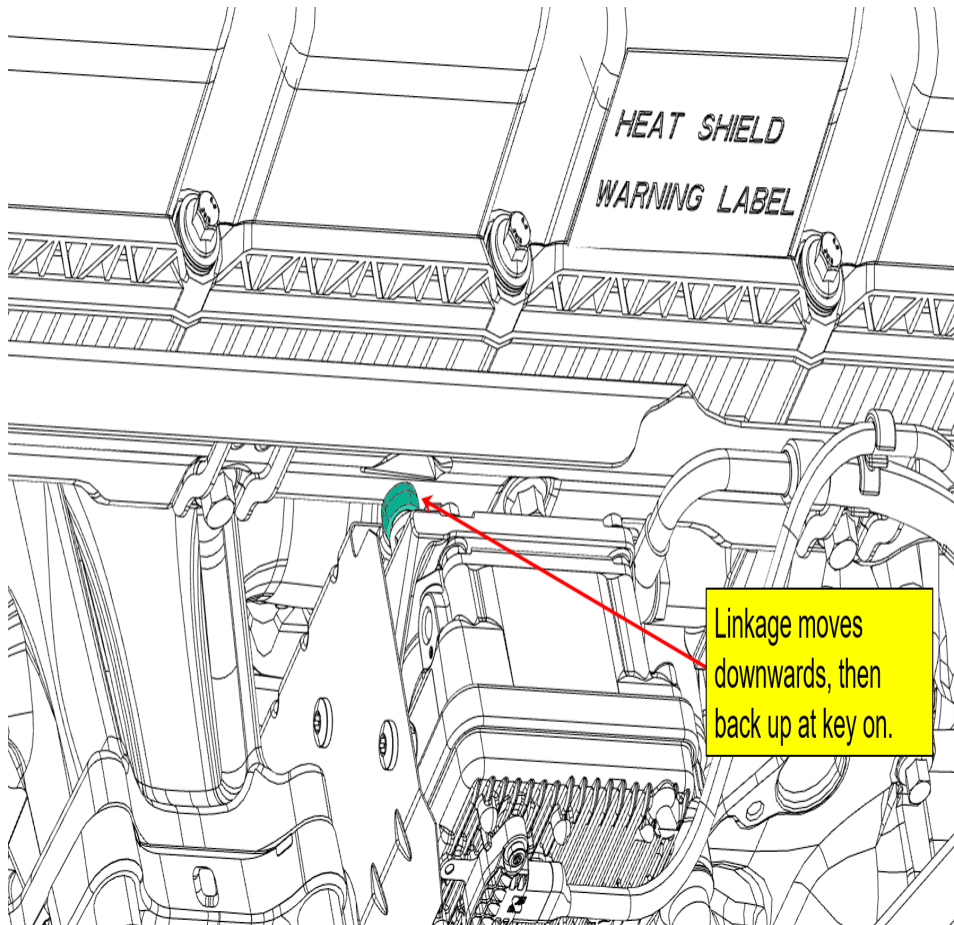
The following process requires 2 people, one in the cab and one observing the valve linkage (see the diagram of the EGR valve linkage at the bottom of this solution).
