Service Bulletin

20-058

July 26, 2021 Version 7

2021 Passport/Pilot: Popping or Crackling from the Speakers; No Sound from the Audio System; *Network Loss* Message and/or Display Issues Supersedes 20-058, dated June 17, 2021. See REVISION SUMMARY.

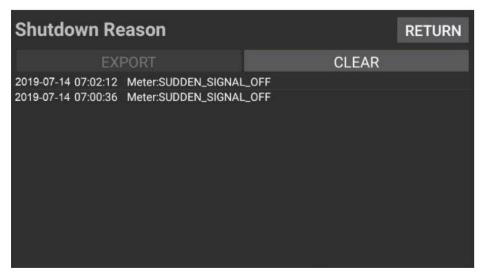
In this example, the cause of the failure can be identified as Meter:SUDDEN_SIGNAL_OFF.

Write down any failures; they will be collected on the warranty claim. Then, clear the data.
