JLRTB02087NAS1

TECHNICAL BULLETIN

Air Conditioning (A/C) Not Blowing As Cold As Expected

MODEL:	MODEL YEAR:	VIN:	ASSEMBLY PLANT:
I-PACE (X590)	2020	F80716-F90426	Graz (Austria)
I-PACE (X590)	2020-2021	600001-608281	Graz (Austria)

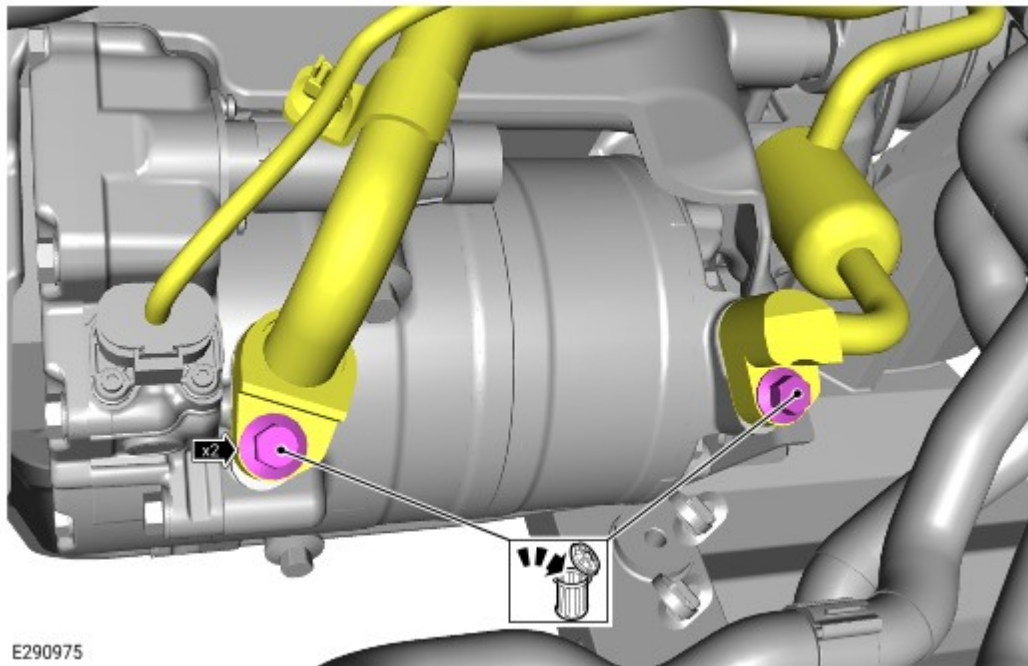
4.

The bolts retaining the Low Pressure (LP) and High Pressure (HP) pipes to the A/C compressor are too long.

Release the 2 pipes from the A/C compressor.

- Remove and discard the 2 bolts.
