Tips&Tricks – All models

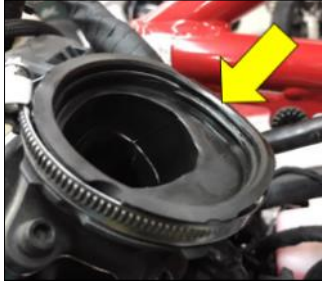
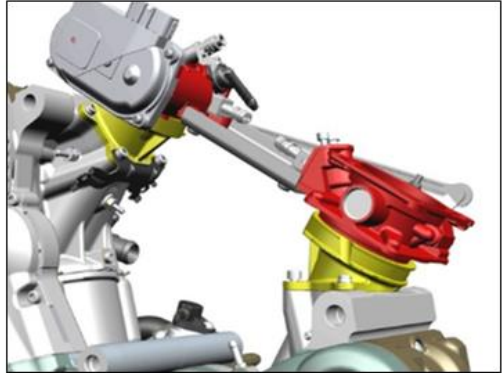
no.	Symptom	Subject	Photo	Notes and Indications - Corrective action
1	<p><u>ONLY</u> <u>Monster 821</u> <u>Monster 1200</u> <u>SuperSport</u></p> <p>Possible engine popping sound during deceleration and/or irregular idling</p>	Airbox

<p>We have received some complaints about a possible engine popping sound during deceleration. The performed analyses have shown that this symptom could be caused by an incorrect installation of the throttle bodies in the relevant intake manifolds (possible deformation of the rubber profile).</p> <p>Therefore, if you find any similar symptoms, we kindly ask you to check the correct installation of the Airbox on the motorcycle and in particular that:</p> <ul style="list-style-type: none"> - throttle bodies are correctly inserted inside rubber intake manifolds, along the whole perimeter; - the rubber profile of the intake manifolds is not deformed. - the 2 fastening ties are correctly positioned in the seat on the intake manifolds <p>Please be reminded that, in order to make throttle body insertion easier on rubber intake manifolds, the use of silicone lubricant or similar product is absolutely necessary.</p> <div data-bbox="1137 676 1608 1050">

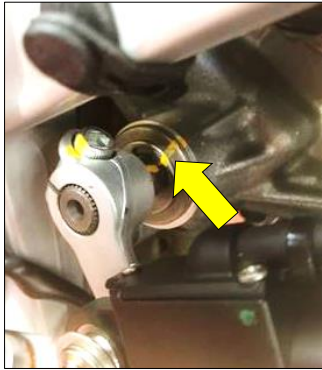
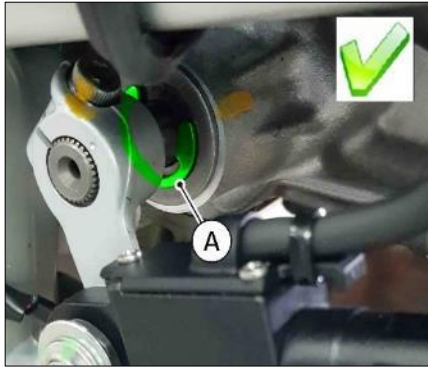
2	<p><u>ONLY</u> <u>Panigale V4</u> <u>(all versions)</u> <u>Streetfighter V4</u> <u>(all versions)</u></p> <p>Introduction of gear selector shaft certification</p>	Gear selector

<p>We have received some isolated reports of a possible loss/absence of the snap ring (A) of the gear selector shaft. We would like to inform you that an additional certification on all Desmosedici Stradale engines between snap ring, washer and crankcase at the outlet of the gear selector shaft has been added along the production line.</p> <p>The first engine serial number with this new certification is ZDM1100WC #001513#.</p> <p>Upon the first workshop service, you are thus invited to check for the presence of the snap ring (A) on all engine serial numbers preceding the one specified above.</p> <div data-bbox="1771 1078 2197 1449">

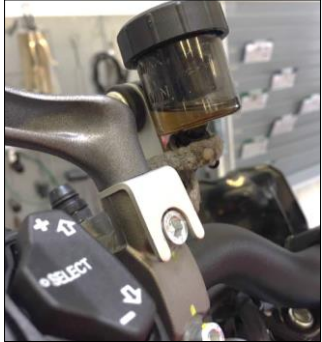
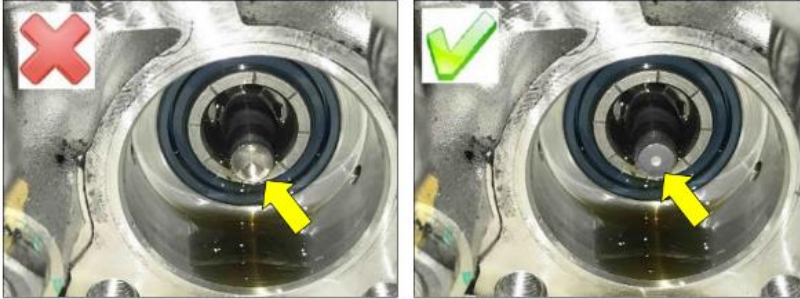
no.	Symptom	Subject	Photo	Notes and Indications - Corrective action
6	<p><u>ONLY</u> <u>Panigale V4</u> <u>StreetFighter V4</u> <u>(all model versions)</u></p> <p>Possible reduction of the clutch fluid level inside its reservoir</p>	Hydraulic clutch control

<p>We received a few claims concerning a reduction of the clutch fluid level inside its reservoir. We would like to inform you that it is not sufficient to carry out the bleeding procedure or top up the clutch fluid inside the reservoir. We suggest, at a preliminary stage, to check:</p> <ul style="list-style-type: none">• the play between the clutch master cylinder and the lever• if the clutch pushrod is worn or damaged in the area of contact with the clutch slave cylinder (ball)• the condition of the clutch slave cylinder protective diaphragm, which must not be torn. <p>According to our analyses, this phenomenon is due to a DOT4 leakage from the primary seal of the clutch slave cylinder (missing fluid in the reservoir builds up in-between the clutch slave cylinder diaphragms); in some cases, this phenomenon is also accompanied by wear of the clutch pushrod. We therefore ask you to replace the slave cylinder with a new part no.19540091D featuring a new gasket in order to prevent the phenomenon described above.</p> <p>If the clutch pushrod is damaged as shown in the figure, replace it as well.</p> <div data-bbox="1227 719 2024 1018">

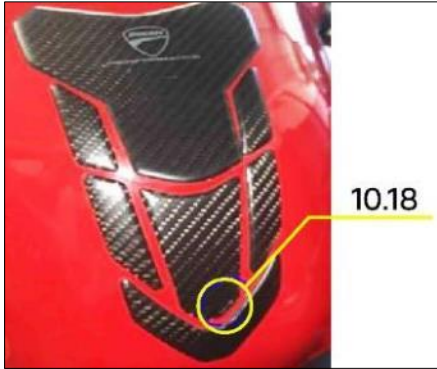
no.	Symptom	Subject	Photo	Notes and Indications - Corrective action
7	<p><u>ONLY</u> Panigale V4 StreetFighter V4 (all model versions)</p> <p>Possible detachment of the carbon adhesive protection part no. 97480161A from the fuel tank</p>	<p>Tank carbon adhesive protection part no. 97480161A</p>

<p>We have received some reports about the detachment of the carbon adhesive protection from the fuel tank. We inform you that the supplier of the component has introduced improvements to avoid the detachment of the protection, since year of manufacture 2019. The lot and the year of manufacture XX-19 (week-year of manufacture) can be identified on the component, like in the example shown in the figure.</p>

<p>In case you still have in stock some carbon tank protectors produced in 2018 you can still sell them to Customers and install them. Should any anomaly occur on the latter, you can manage the replacement of the protection through an accessory warranty. The spare parts in stock have been reclaimed.</p> <p>In any case, it is essential to follow the accessory instructions ISTR-892 ed.01 published in DCS for the application of the tank protection. The cleaning of the tank surface and the use of the template supplied with the protection are essential for a successful application.</p>

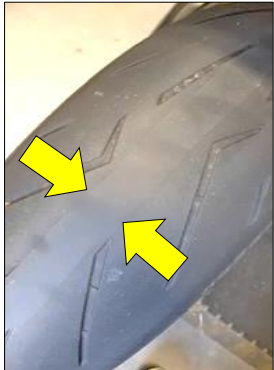
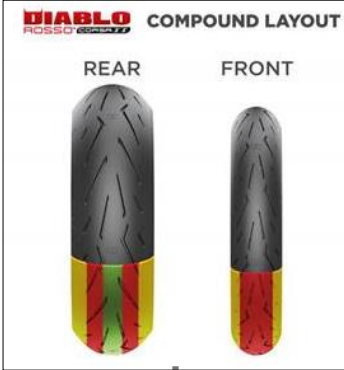
8	<p>Possible formation of a well-marked "band" in correspondence with the central area of the Pirelli Diablo Rosso Corsa II rear tyre</p>	<p>Pirelli Diablo Rosso Corsa II rear tyre</p>

<p>We have received some isolated reports of the appearance of a "band" in correspondence with the central area of the Pirelli Diablo Rosso Corsa II rear tyre.</p> <p>We would like to inform you that, since these are extremely sporty tyres with 5 different compound zones at the rear, it can happen that, depending on the type of use of the motorcycle, they wear out in a different way causing the above mentioned phenomenon to occur; sometimes this occurs on the shoulder area, sometimes in the central area but, in general, it is a purely aesthetic phenomenon that does not affect the performance of the tyre itself.</p>

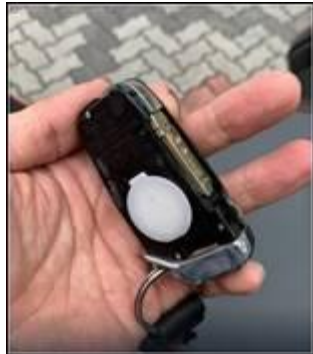
Model	Model Year	Part no.	Streetfighter V4	20	40611781C	Panigale V4 25° Anniversario 916	20	40611351I	Panigale V4 / Panigale V4 S	18-19	Panigale V4 S Corse	20	40611351H	Panigale V4 / Panigale V4 S	Panigale V4 S Corse	Superleggera V4		
Model	Model Year	Part no.																					
Streetfighter V4	20	40611781C																					
Panigale V4 25° Anniversario 916	20	40611351I																					
Panigale V4 / Panigale V4 S	18-19																						
Panigale V4 S Corse		20	40611351H																				
Panigale V4 / Panigale V4 S																							
Panigale V4 S Corse																							
Superleggera V4																							
13	<p><u>ONLY</u> Diavel Model Year 21 XDiavel Model Year 21 Multistrada 1260 Model Year 18-20 Multistrada 1260 Enduro Model Year 19-21 Multistrada 950S Model Year 19-21</p> <p>Possible loss of the active key rear cover</p>	Active key Part no.59810361F

<p>We have received some isolated reports about the possible loss of the rear cover of the active key Part no.59810361F. Analyses have shown that this phenomenon occurs after repeated opening/closing of the cover itself, resulting in the deterioration of the shell.</p> <p>We would like to inform you that the new rear cover Part no.4601L831A, avoiding the phenomenon described above, is now available.</p>

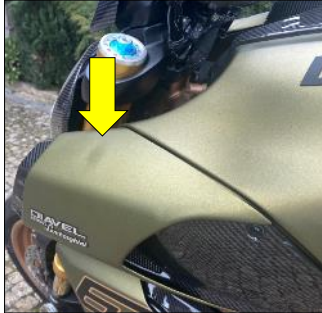
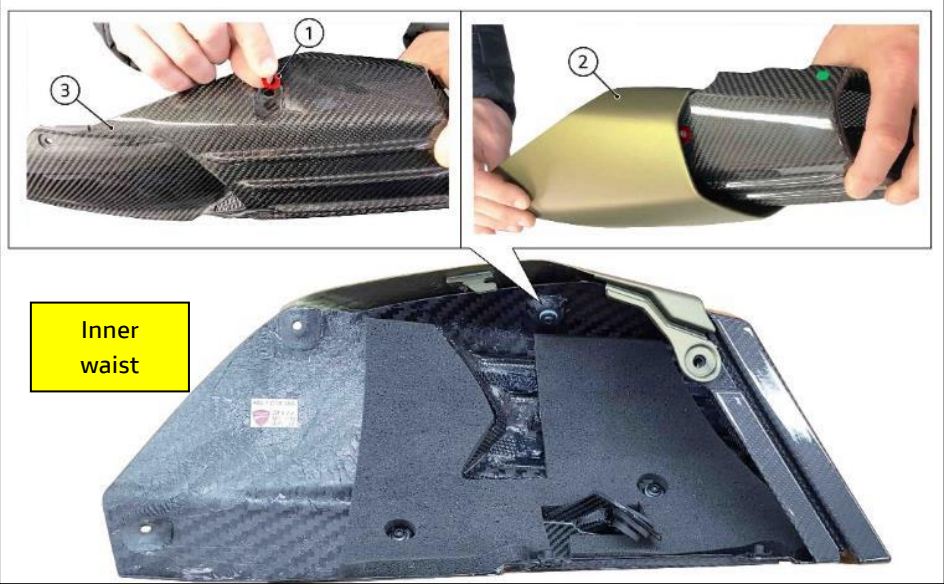
no.	Symptom	Subject	Photo	Notes and Indications - Corrective action
1	<p><u>ONLY</u> <u>Diavel Lamborghini</u></p> <p>Possible indentation of RH and/or LH outer cover of the air conveyor</p>	RH and LH air conveyor covers

<p>We have received some isolated reports about a possible indentation of the RH and/or LH outer cover of the air conveyor.</p> <p>To avoid this phenomenon, it is necessary to position washer (1) 4x14x1 Part no.85240171A between outer cover (2) and carbon air conveyor (3) in the upper fixing point, as shown in the figure.</p>

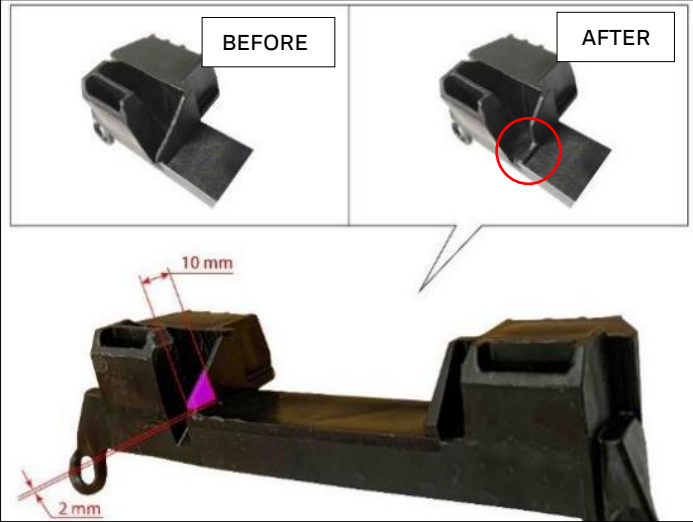
no.	Symptom	Subject	Photo	Notes and Indications - Corrective action
1	<p><u>ONLY</u> <u>Multistrada 1260</u> <u>(all model versions)</u></p> <p>Possible wrong coupling between rider's seat lower riser and RH side body panel in seat "high configuration"</p>	Rider seat

<p>When mounting the rider seat in "high configuration", an excessive gap can be seen between the lower trim and the RH side panel. This is due to interference between the central riser and its support. To avoid such interference and therefore improve the coupling between the rider seat and the side panel, it is necessary to:</p> <ol style="list-style-type: none"> 1) Remove the centre riser from the seat; 2) Working on the RH side support, remove the excess material with a cutter, as shown in the figure. 3) Reinstall the centre riser to the seat.

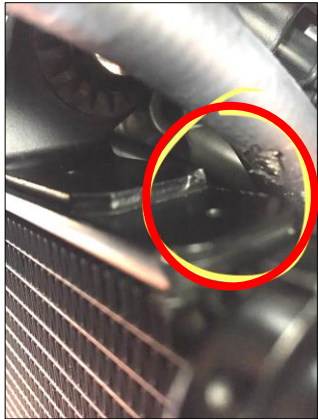
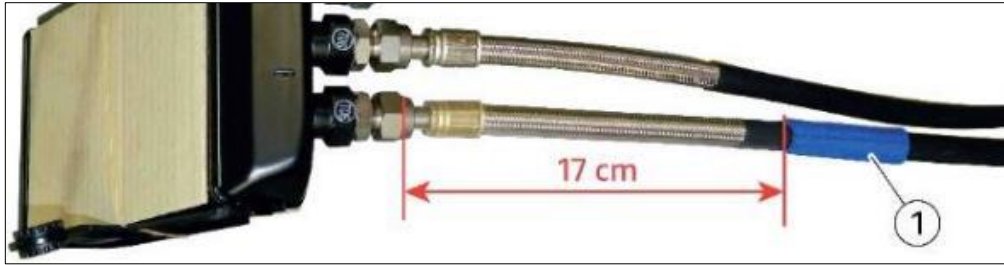
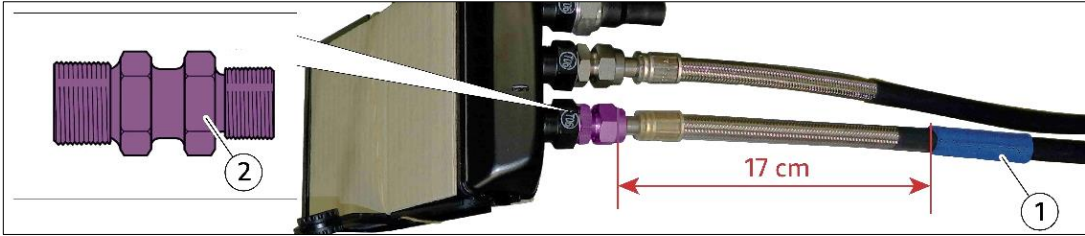
no.	Symptom	Subject	Photo	Notes and Indications - Corrective action
3	<p><u>ONLY</u> Multistrada 950 MY 17-20 Multistrada 1200 MY 15-17 Multistrada 1260 MY18-20 (all model versions)</p> <p>Possible superficial damage to the oil cooler return pipe</p>	Oil cooler pipes

<p>We have received some isolated reports of possible surface damage to the oil cooler return pipe due to rubbing with the top of the coolant radiator, over time. <u>This phenomenon is purely aesthetic and does not affect the correct operation of the system.</u> We inform you that for the models:</p> <p>a) <u>Multistrada 1260:</u> starting from the frame number ZDMAC03AAAKB011354 (on 27/05/2019) the anti-abrasion sheath (1) part no.4601H701A has been introduced on the oil cooler return pipe, positioned at a distance of 17 cm measured from the upper end of the fitting. (This solution is also applicable to all Multistrada 1200 versions Model Year 2015-2017).</p>

<p>b) <u>Multistrada 950:</u></p> <ul style="list-style-type: none"> - starting from the frame number ZDMAD00AAAKB002259 (on 10/05/2019) the anti-abrasion sheath (1) part no.4601H701A has been introduced on the oil cooler return pipe, positioned at a distance of 17 cm measured from the upper end of the fitting; - starting from the frame number ZDMAD00AALB005691 (on 12/03/2020) the longer fitting (2) part no.81510391A has been introduced at the oil return pipe outlet from the cooler.

<p>We ask you to always check the condition of the oil cooler return pipe, and to replace it ONLY if the rubber sheath is damaged and the metallic braided hose can be seen. Follow the assembly notes indicated above according to the reference model. The spare part catalogue has been updated.</p>

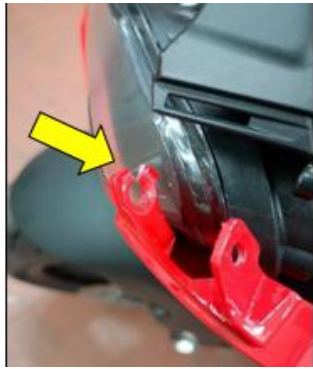
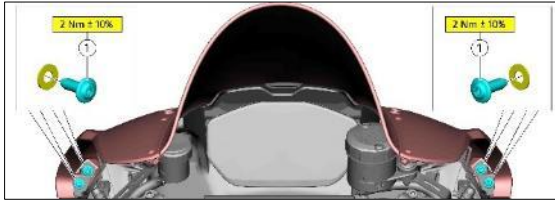
no.	Symptom	Subject	Photo	Notes and Indications - Corrective action
1	<p><u>ONLY</u> <u>Panigale V2</u></p> <p>Precautions during PDI: installation of the side half-fairings</p>	Side half-fairings

<p>We received some isolated claims about the possible breakage of the top fastener retaining the LH side half-fairing to the headlight fairing.</p> <p>During PDI and whenever removing the side half-fairings, we remind you to pay utmost attention to the tightening of the 2 screws M5x0.8 (1) retaining the upper LH and RH half-fairings to the headlight fairing; always comply with the specified tightening torque of 2 Nm ± 10%.</p>

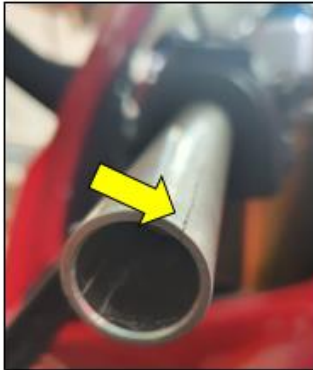
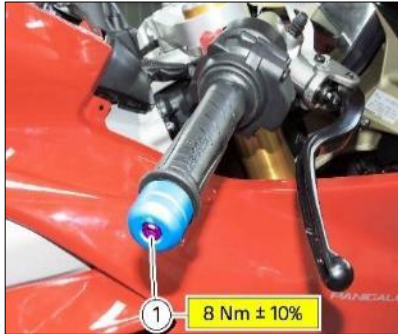
2	<p><u>ONLY</u> <u>Panigale V4</u></p> <p>Precautions during PDI: installation of the balancing weights on the handlebar</p>	Balancing weights on handlebar

<p>We received some isolated claims about the possible triggering of a longitudinal crack on the handlebar, on balancing weight side. Our laboratory analyses found that said crack is due to an excessive tightening torque applied when installing the balancing weights.</p> <p>When installing balancing weights on the handlebar, please comply with the tightening torque specified for the M6x55 screw of 8 Nm ± 10%, as indicated on the bulletin introducing the model and on the Workshop Manual.</p>

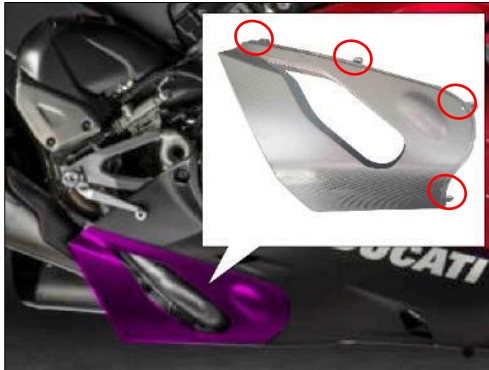
no.	Symptom	Subject	Photo	Notes and Indications - Corrective action
14	<p><u>ONLY Superleggera V4</u></p> <p>Possible mismatch between the silencer covers and the side half fairings if the complete Akrapovic racing titanium exhaust system is installed</p>	Coupling of the silencer cover and side half fairings

<p>We have received some isolated reports about an incorrect coupling between the silencer covers and the side half fairings in case the complete Akrapovic racing titanium exhaust system, supplied with the motorcycle, is installed. In fact, it is possible to find a misalignment between the mounting holes of the components.</p> <p>To improve this coupling, it is possible to slot-drill the 4 mounting holes of the silencer covers by using a column drill with a <u>6 mm drill bit</u> and setting a high rotation speed to prevent the fibre from flaking off.</p>

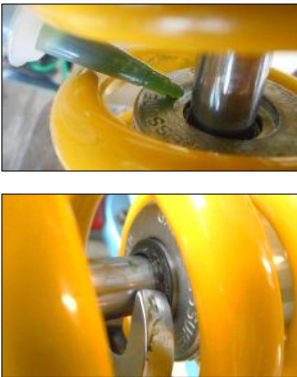
15	<p><u>ONLY Panigale V2</u></p> <p>Possible popping out of the dust seal on the Sachs rear shock absorber buffer support plug</p>	Sachs rear shock absorber

<p>We have received some isolated reports about the possible popping out of the dust seal on the rear shock absorber buffer support plug.</p> <p><u>Do NOT replace the rear shock absorber.</u></p> <p>To avoid the phenomenon described above it is necessary to:</p> <ul style="list-style-type: none"> - apply a few drops of LOCTITE 638 on the plug, at the dust seal seat; - place the dust seal on the plug using an open-end wrench and hold it for a few seconds; - carefully clean any residues of LOCTITE 638 that may have fallen accidentally on the rod and on any other surface. <p>Please note that the supplier, Sachs, has introduced LOCTITE 638 during the assembly stage from <u>week 29-2020</u> (this information can be found on the sticker on the shock absorber body).</p>

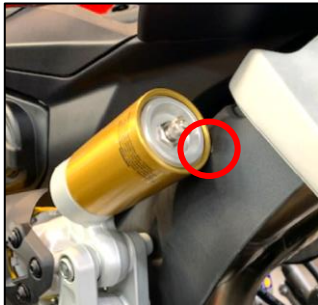
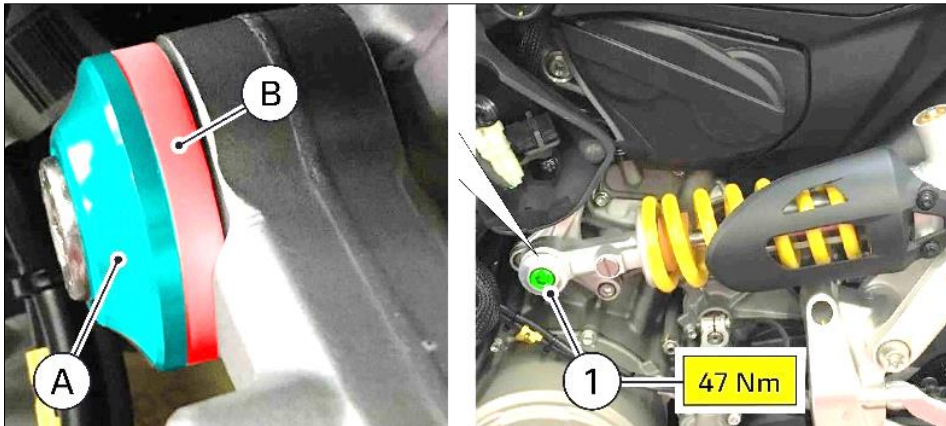
no.	Symptom	Subject	Photo	Notes and Indications - Corrective action
17	<p><u>ONLY</u> <u>Panigale V2</u></p> <p>Possible contact of Sachs rear shock absorber reservoir with vertical head manifold heat guard</p>	Sachs rear shock absorber reservoir

<p>We would like to inform you that starting from the frame number ZDMHAATW2MB003762, a spacer and a Teflon anti-rotation washer have been introduced at the front fixing screw of the shock absorber to prevent possible contact between the rear shock absorber reservoir and the vertical head manifold head guard.</p> <p>In case of complaints from the Customer, it is possible to proceed with the installation of spacer part no.7111D981AA (A) and washer part no.7131E352A (B), as shown in the figure.</p> <p>We remind you to always smear the screw M10x45 (1) with Shell GADUS S2 V220 AD 2 grease and to tighten the screw to the new torque of 47Nm (the previous tightening torque was 45Nm).</p>

<p>The components are available as spare parts and can be ordered.</p>

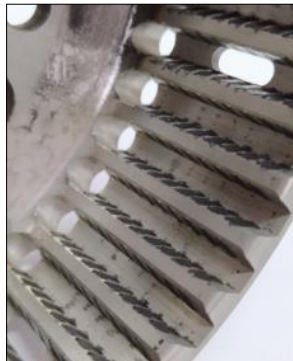
18	<p><u>ONLY</u> <u>Panigale V4R</u></p> <p>Introduction of clutch housing with deep anodising</p>	Housing clutch

<p>We have received some isolated reports of possible clutch slipping, due to clutch housing indentation, which does not allow the drive and driven plates to come back into contact with each other correctly. This phenomenon depends on the use of the motorcycle and the user, therefore for racing use we suggest replacing the plates approximately every 5000km.</p> <p>We would like to inform you that the new clutch housing with deep anodising part no.19810671C, replacing the natural grey one, is available as a spare part; this treatment improves the reliability of the clutch housing reducing the damaging of the drive plates on its contact surface.</p>

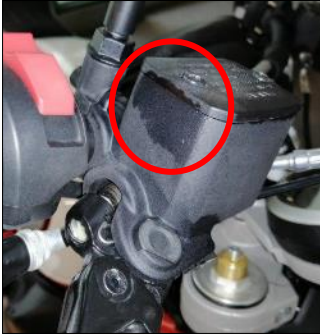
no.	Symptom	Subject	Photo	Notes and Indications - Corrective action
3	<p><u>ONLY</u> Scrambler Desert Sled Scrambler ICON Scrambler Full Throttle Model Year 2019 - 2020</p> <p>Possible oozing out of brake fluid from reservoir cover</p>	Front brake fluid reservoir

<p>We inform you that in case of complaints from Customers about a possible oozing out of front brake fluid from the relevant reservoir, it is possible to order the following kit part no.89340331A as spare part to avoid the symptom in question.</p> <p>The kit part no.89340331A includes:</p> <ul style="list-style-type: none"> • 2 screws (1) • Cover (2) • Membrane (3) • Baffle (3)

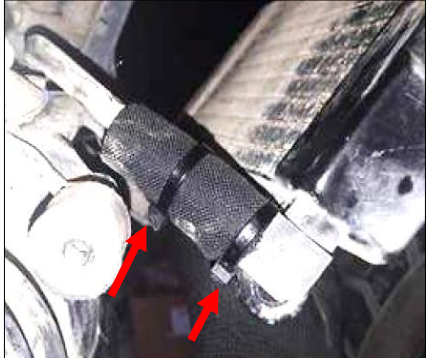
4	<p><u>ONLY</u> Scrambler 1100 PRO (all versions)</p> <p>Irregular operation at idle speed and engine power loss</p>	Vertical cylinder LH spark plug cable	-	<p>As a result of continuous quality tests on the product, we have found a possible irregular operation at idle speed and engine power loss. This phenomenon is due to a settling of the vertical cylinder LH spark plug cable on the coil caused by the contact with the fitting of the oil return pipe from cooler (visible on motorcycle RH side). The MIL light does not come on.</p> <p>We ask you to always check the conditions of vertical cylinder LH spark plug cable and to apply the protective sheath Part no.4601C581A (cut in half and secured in place with two small self-locking ties) on the fitting of the oil return pipe from cooler so as to avoid the above-described phenomenon.</p>

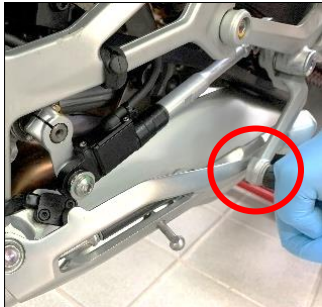
no.	Symptom	Subject	Photo	Notes and Indications - Corrective action
2	Interference between gearchange lever and side stand	Gearchange lever/ side stand

<p>As a result of continuous quality tests on the product, we have found a slight interference between the gear shift control lever and the side stand. This contact is very slight, does not give rise to functional or aesthetic problems and can only occur in the overtravel phase, when engaging the first gear.</p> <p>We inform you that no corrective actions are available so far.</p>
3	Assembly precautions for the complete titanium exhaust system part no.96481652AA	Complete titanium exhaust system part no.96481652AA

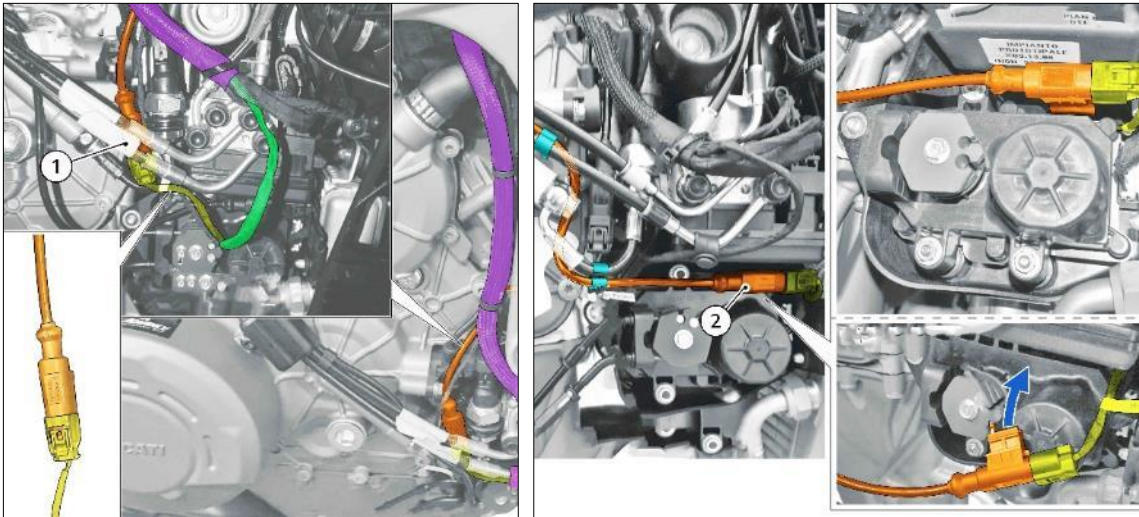
<p>We have received some isolated reports of vehicle speed limitation at values below 50 km/h due to the excessive traction control (DTC) intervention resulting from the installation of the complete titanium exhaust system part no.96481652AA. The performed analyses have shown that the front and rear speed sensor connections were reversed.</p> <p><u>In case of interventions on the front (1) and rear (2) speed sensor connectors, please take the utmost care to their assembly, as shown in the figure, making sure not to reverse the connections.</u></p>
