Bulletin #: 2116

Red Warning in the Instrument Cluster: Occupant Seat Belt not Fastened

Vehicles Affected

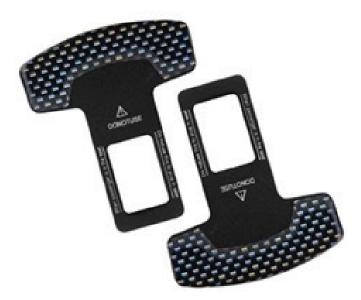
- 1. The belt buckle is faulty,
- 2. The vehicle is moving at a speed greater than 18 mph (30 km/h) and an occupant does not have their seat belt fastened, or
- 3. The vehicle detects improper use of the seat belt by the driver (e.g., use of a dummy belt buckle).

1. Document the presence of any "dummy" seat belt buckles in the vehicle with pictures.

Figure 2: Example of dummy seat belt buckles
