**Porsche Connect Cannot Function if SOS LED is Not Lit Green**

**Vehicles Affected**

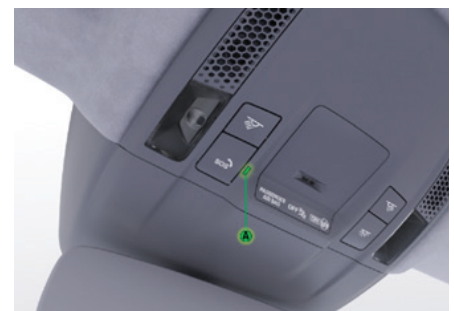
**Figure 1**

- Porsche Connect services do not function
- SOS LED in the overhead console is off or flashes red
- The Breakdown Call button does not function
- The News and Weather tiles are missing in the PCM Central Display
- The navigation satellite map view cannot be activated
- Log in button grayed out on the Taycan when attempting to log in with Porsche ID and Password with red SOS.
- Add account button displayed grayed out with red SOS
