**Forced neutral interrupter for  
throttle advance**

**Date:** July 13, 2021  
**Bulletin Name:** FEL-TSIB-058  
**Model:** Meridian Front Loader 78  
**Model Year:** All model years for Meridian 78  
**Units Affected:** Units with work brakes

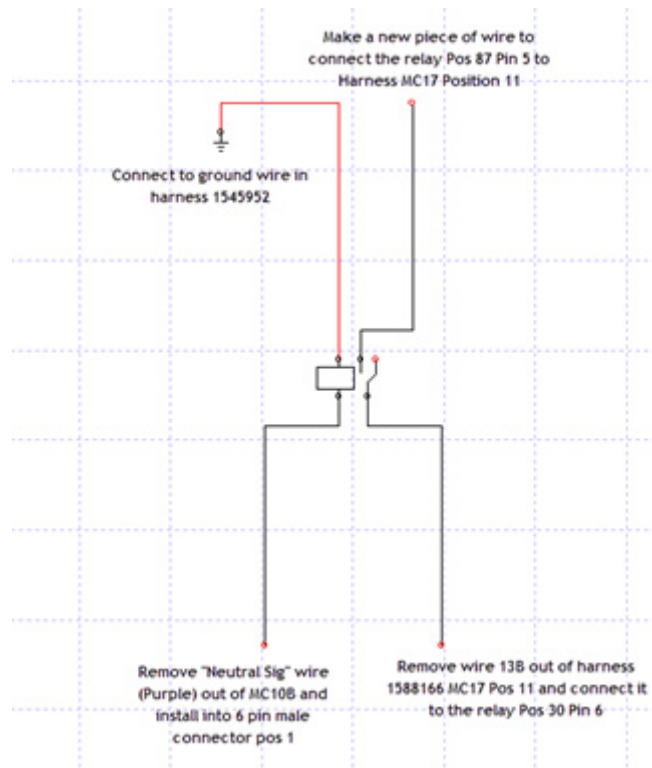
Currently, trucks with work brakes do not cut out the throttle advance when the work brake is released. The driver must wait for the function to complete and throttle to drop below 900 RPMs, allowing the transmission to go into gear, or they must stop the function to get the transmission to go into gear. With this update, the throttle will be cut out without stopping the function and allow the transmission to go into gear for a more efficient operation of the unit.

2. Open the dash covers in the cab. Retain all hardware and parts.
3. Locate the RP170 and the cab harness connections.
4. On MC10B, remove the "neutral sig" wire (purple).

- a. Cut off the male pin and crimp a new socket on.
  - b. Install into 6-pin male connector for relay position 1.
5. Located available ground wire in harness PN 1545952 and crimp a new socket on.

- a. Install into 6-pin male connector for relay position 3.
6. Remove the throttle advance wire #14 from MC17 position 11.
  - a. Install into 6-pin male connector for relay position 6.

7. Cut 12" long piece of 18 gauge wire.
  - a. Crimp sockets on both ends.
  - b. Install end 1 into MC17 position 11.
  - c. Install end 2 into 6-pin male connector for relay position 5.
