Technical Service Bulletin

48 DTC B116831 is stored in the ABS control module

48 21 08 2063526/1 August 2, 2021.

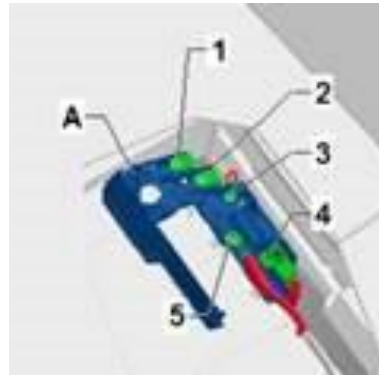
- This can be caused by a voltage drop in the power steering control module, J500 (address word 0044).
- The main fuse carrier may be the cause.

1. When the vehicle is started, the voltage should not drop by more than 1 Volt at contact 4 on the fuse carrier. This is power supply to the power steering control module, J500 (address word 0044) (Figure 1).

Figure 1. Fuse carrier's power supply to the power steering control module, J500 (address word 0044).

2. If the voltage drops more than 1 Volt then the fuse carrier must be replaced. Replace the fuse carrier according to the instructions in the Elsa Repair Manual.
3. If this procedure does not lead to an improvement, continue the diagnosis on other components of the power supply for the power steering. Review the battery history data to help find the voltage drop.
