SERVICE INFORMATION BULLETIN

APPLICABILITY: 2020-2021MY Outback
 2019-2021MY Forester
 2019-2021MY Ascent

NUMBER: 07-199-21
DATE: 07/30/21

SUBJECT: Measurement of Dark Current
 (Standby Current Draw)

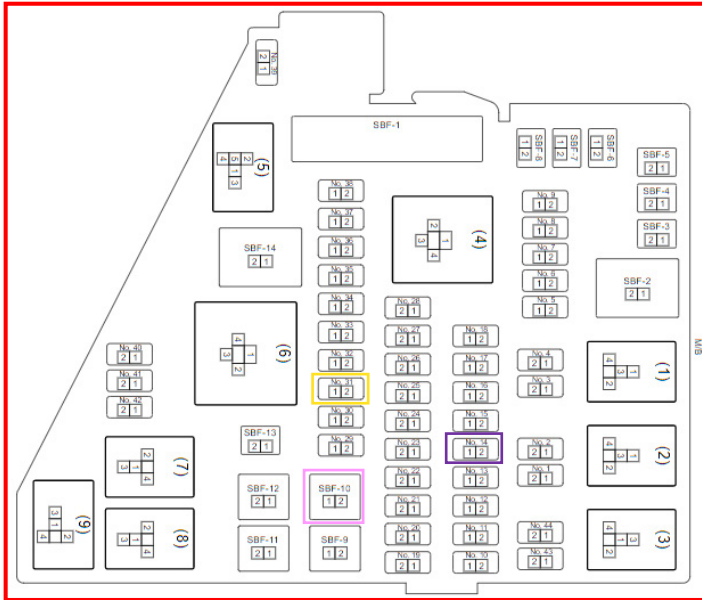
Ascent & Forester

VDC Fuse

Fuse No.31

SBF No.10

Power Rear Gate Fuse

Fuse No.14

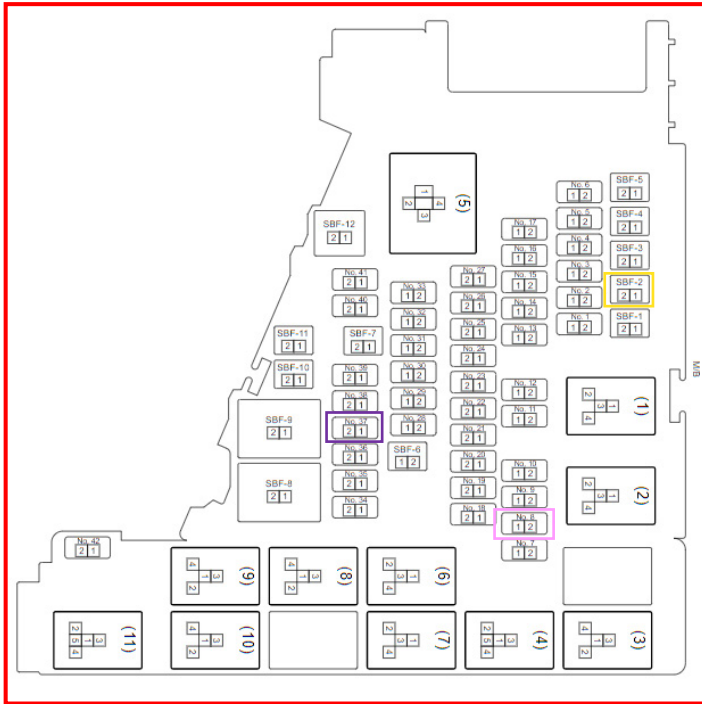
Outback

VDC Fuse

Fuse No.8

Power Rear Gate Fuse

SBF No.2

Fuse No.37

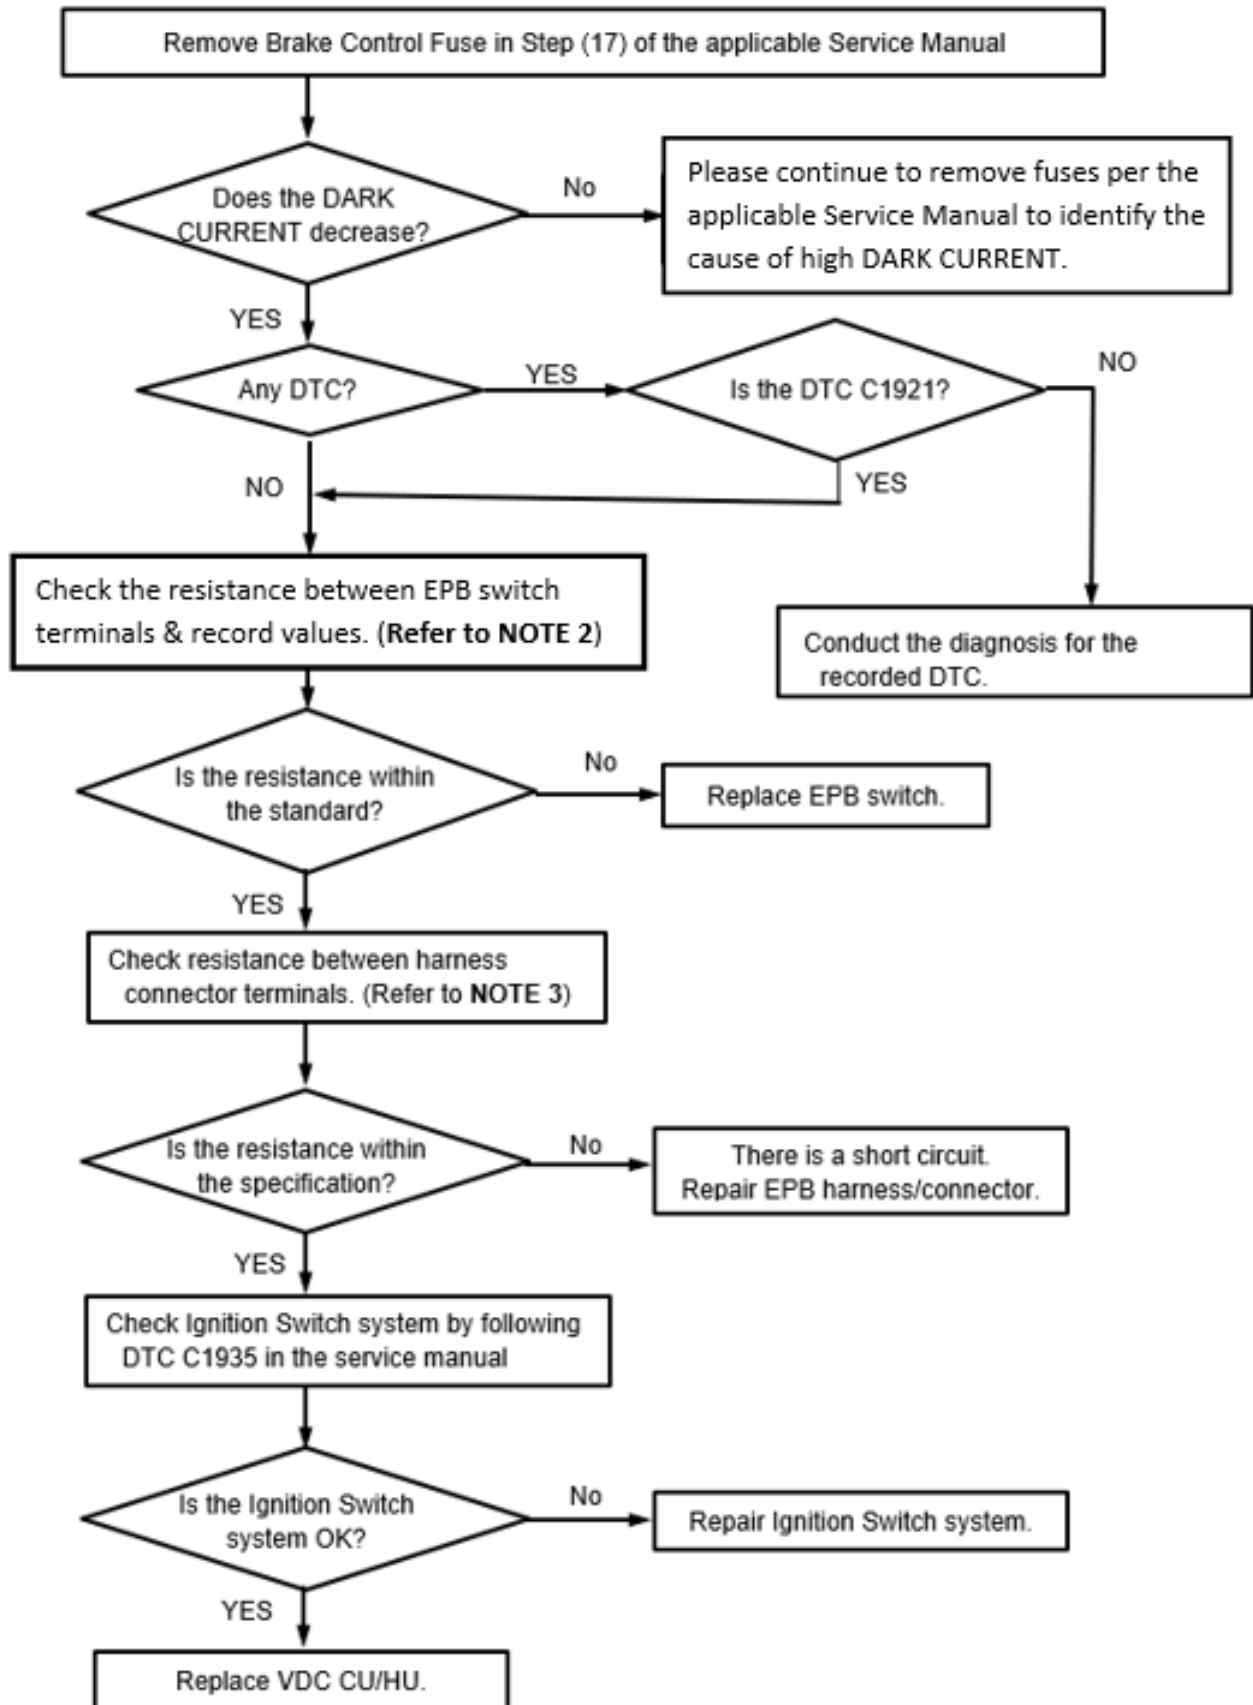
NOTE 1) Troubleshooting Tree for Dark Current (Standby Current) draw from VDC system.

When a dead battery condition is experienced due to excessive Dark Current (Standby Current) draw and the source is traced to the VDC and/ or Power Rear Gate Control Module, **it is IMPORTANT** to follow the procedures outlined in the applicable Service Manual: Engine > STARTING/CHARGING SYSTEM > Battery > INSPECTION, in conjunction with the additional diagnostic information provided below.

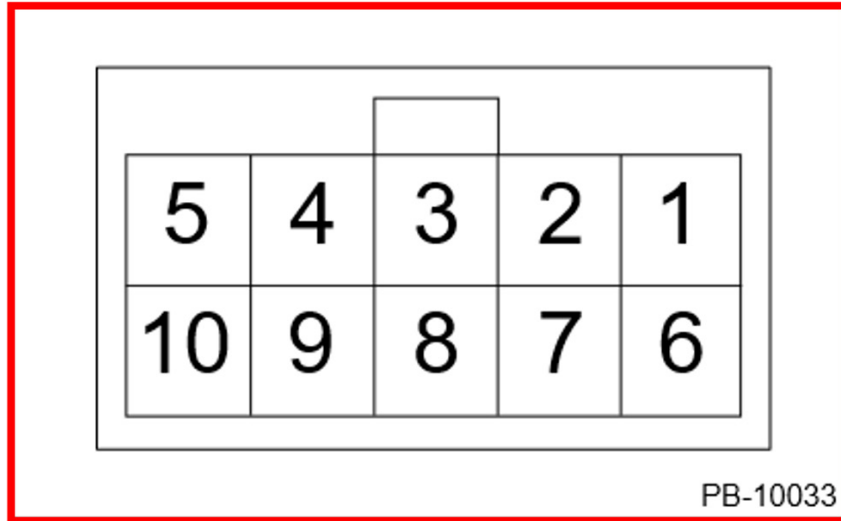
NOTE 2) How to check resistance between EPB switch terminals.

Switch Position	Terminal No.	Standard
Neutral	1-2 4-5	1MΩ and higher
	1-5 2-4	Less than 1Ω

- Confirm the ignition is switch OFF:
- Disconnect the EPB switch connector, and check if Dark Current decreases. If Dark Current decreases by disconnecting the EPB switch connector, replace EPB switch and continue diagnosis.
- Check resistance between terminals per the illustrations below.

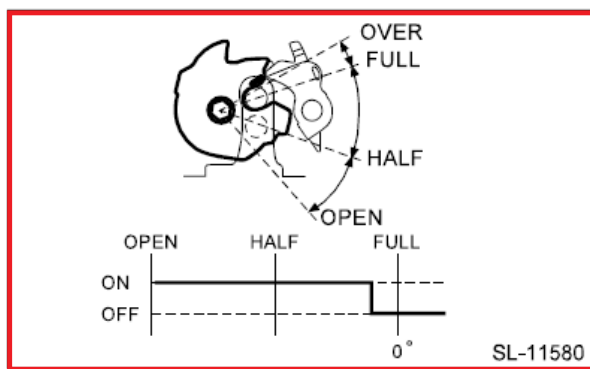
NOTE 5) How to check resistance between terminals for Courtesy Switch.

Terminal No.	Inspection Conditions	Specification
7 to 8	Open	Less Than 1 Ω
7 to 8	Half	Less Than 1 Ω
7 to 8	Full	1MΩ or More

- Using the illustrations below, check the resistance between terminals No.7 and No.8.
