SERVICE BULLETIN

NUMBER: 16-132-20R

SUBJECT: Diagnostic Information for Alleged Chain Slip Condition on TR580 / TR690 Transmissions

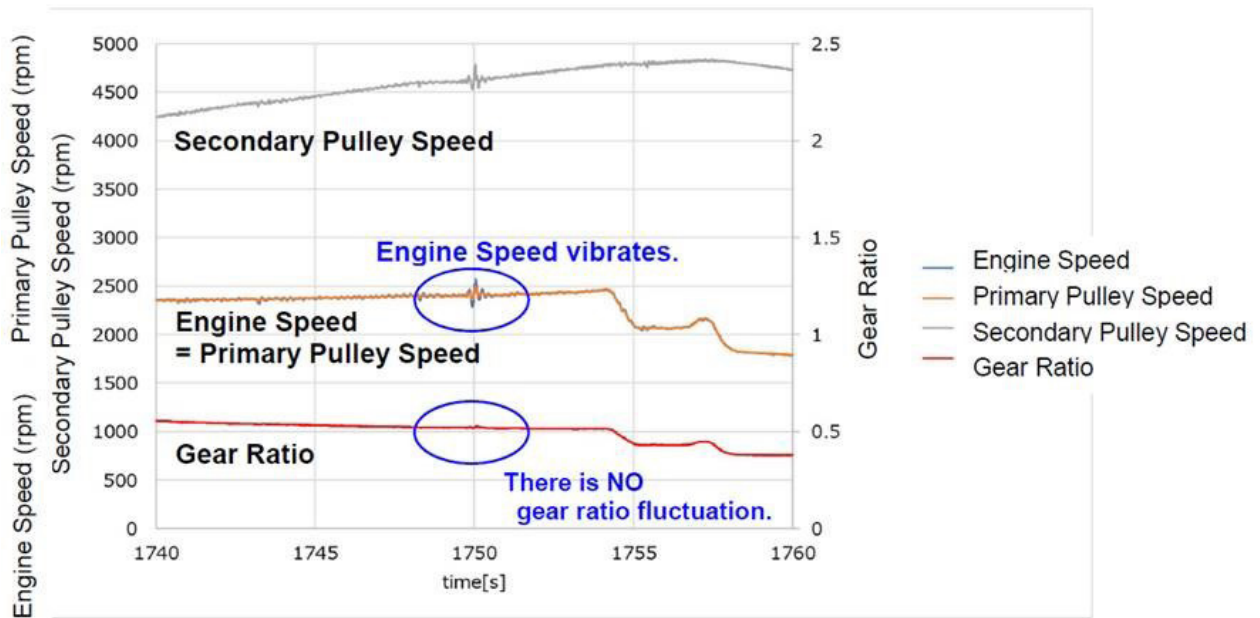
FIG. 8

The graph above is an example of recorded SSM data showing the torque fluctuation is NOT being caused by the transmission but by torque fluctuation of the engine.
