Clicking Noise From Front Hub

18 – 21MY RR Velar

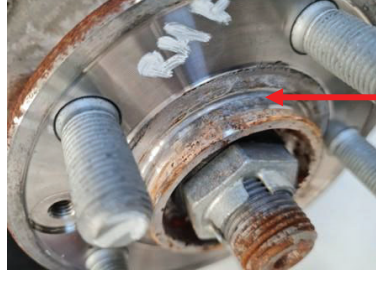
- This may be caused by the brake disc to wheel hub flexing/moving during cornering loads allows stick-slip movement of the disc along the wheel hub spigot.

Remove corrosion from wheel hub spigot
