SERVICE BULLETIN

Communication #: L-21-01

SUBJECT: FAST CHARGER WIRE HARNESS

2016-2021 GEM E2, E4, E6, EL XD BUILT WITH FAST CHARGER (3 KW OR 6 KW)	
Bulletin #	L-21-01
Claim Type	SB (Service Bulletin)
Labor Allowance	0.8 hours (48 minutes)
Part Number / Description	2416229 (QTY 1) HARNESS-CHARGER,FAST,MAIN,FSD 7080492 (QTY 7) CABLE TIE, 11 IN
Parts Availability	Available to order
University of Polaris Video Training Required	NO

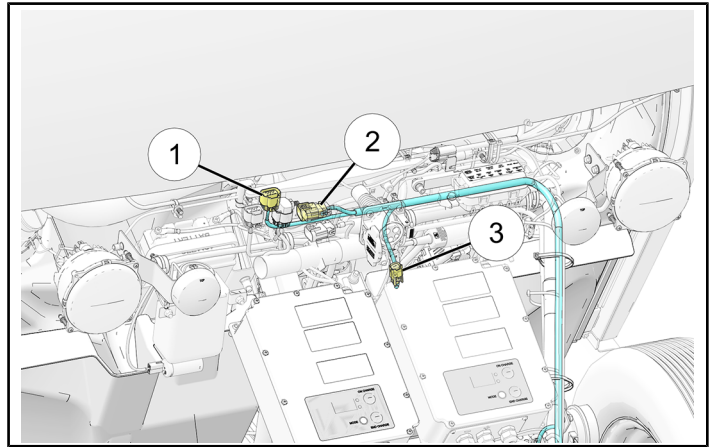
2. Disconnect the diagnostic connectors ① and ②, and disconnect the charge port connector ③.

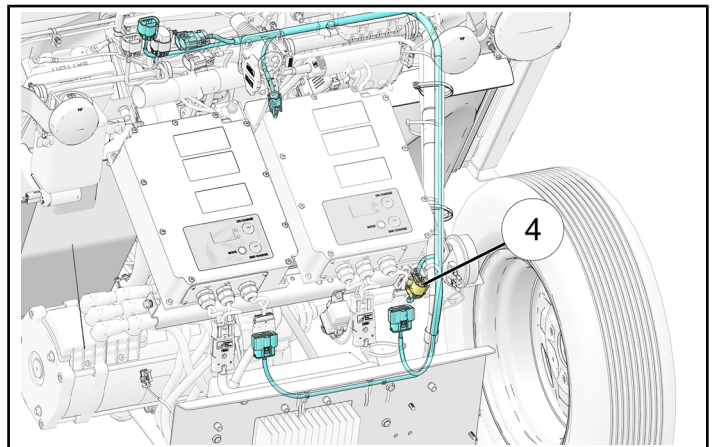
3. Disconnect the standard charger connector ④, and remove the fast charger harness from the vehicle. Discard the harness.

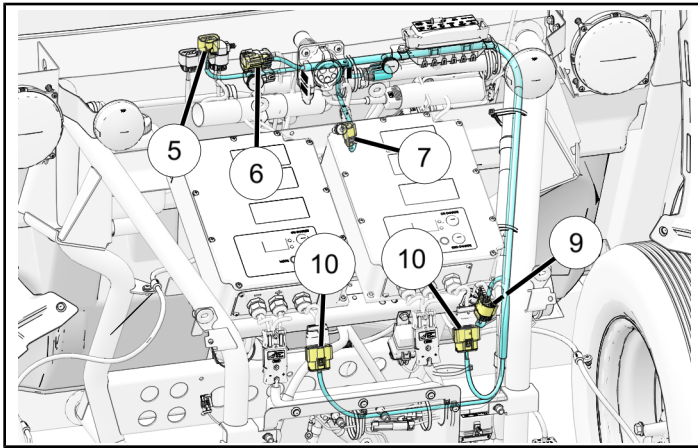
1. Install the *NEW* Fast Charger harness by connecting the diagnostic connectors ⑤ and ⑥, the charge port connector ⑦, the standard connector ⑨, and the 16-pin connectors ⑩.

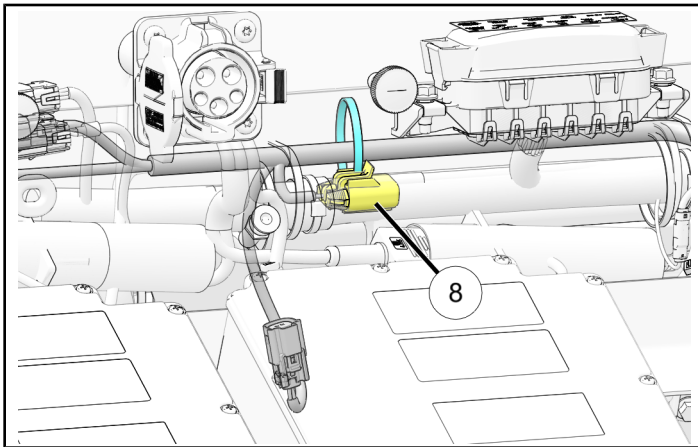
2. Secure the harness with the new cable ties in the previously noted locations. Retain the new inline fuse holder ⑧ by looping a cable tie through its mounting hole and securing it to the fast charger harness, itself.
