SERVICE BULLETIN

Classification: AN21-017	Reference: NTB21-067	Date: July 29, 2021
-----------------------------	-------------------------	------------------------

HIGH FREQUENCY NOISE WITH AUDIO SYSTEM DISPLAY ON

APPLIED VEHICLES: 2021 Sentra (B18)
APPLIED DATE: Built after March 17, 2021
APPLIED TRIM LEVEL: SR and SV

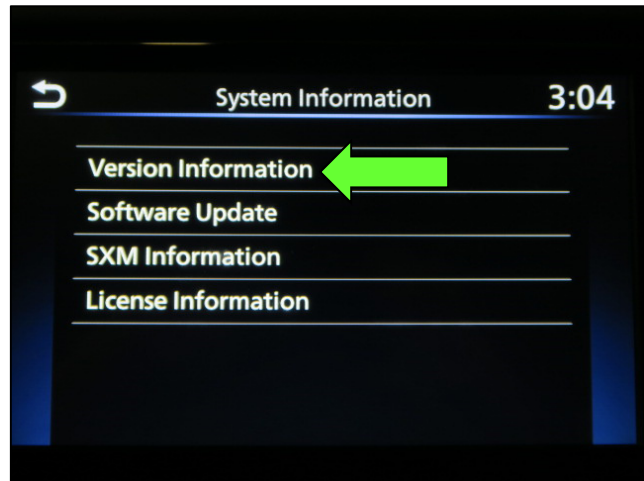
Figure 5

5. Verify the Software Version is **321** or **420**.

- If the software version is 321 or 420, proceed to step 6 on page 5.
- If the software version is not 321 or 420, the service procedure is complete. Proceed to **CLAIMS INFORMATION** on the last page of this bulletin.

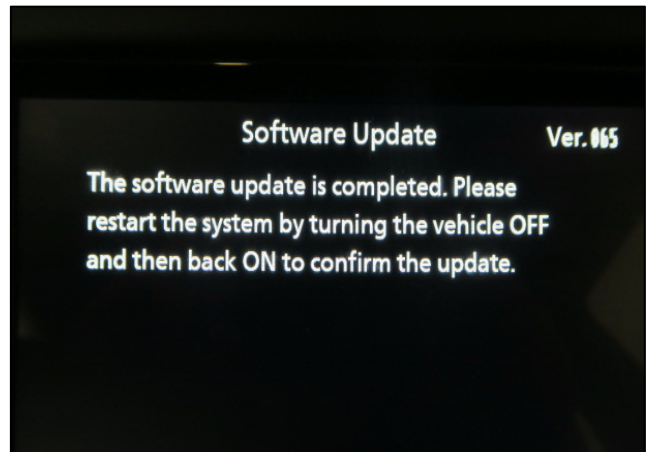
Do not remove the USB drive until the screen in Figure 15 is displayed. If removed prior to this screen being displayed, the Audio Control Unit may be damaged.

20. When the message shown in Figure 15 is displayed, remove the USB drive from the USB media port.

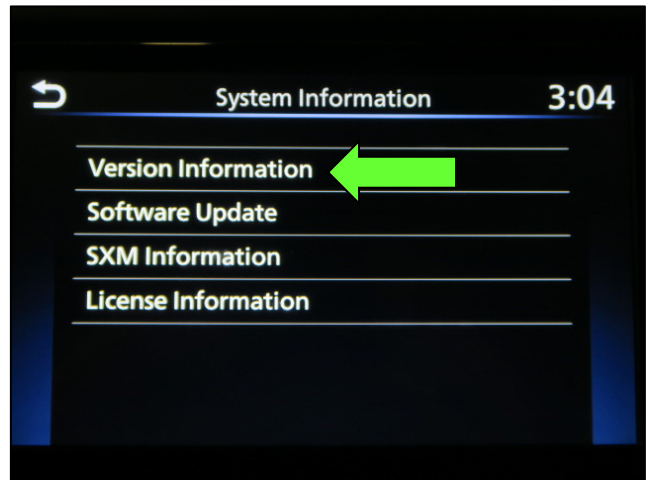
Figure 20

29. Verify the Software Version is now **423**.
- If the software version is NOT 423, start this procedure over and verify that the correct software shown in step 9 on page 6 is downloaded.
 - If the software version is 423, the reprogramming is complete.
