QUALITY ACTION

CAMPAIGN BULLETIN

Rear Door Hinge Bolt Dealer Inventory

Reference: PC817

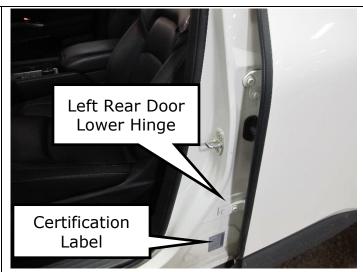
Figure 1

- 2. Locate left rear door lower hinge (Figure 1).
 - Located above the Certification label (Applies to left side only, there is not a certification label on right side)
