QUALITY ACTION

CAMPAIGN BULLETIN

Secondary Hood Latch Dealer Inventory

Reference: PC818
Date: July 29, 2021

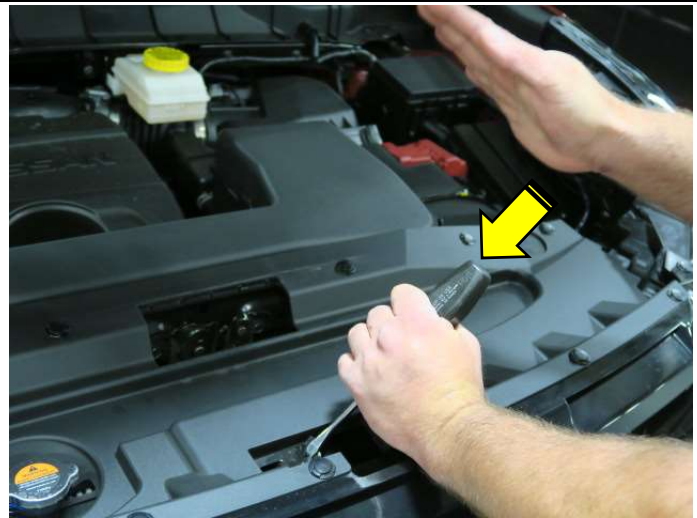
Figure 3

5. Did the secondary hood latch bracket become detached from the front bumper retainer bracket?
- **NO** – No further action is needed, close the hood and see claims information.
 - **YES** – Proceed to Step 6 for front bumper retainer bracket replacement

4. Check weld condition of the secondary hood latch bracket.
- Using the palm of hand, with moderate pressure, tap on the end of the screwdriver handle 3-5 times. (Figure 3)
