Terex Utilities**PRODUCT NOTICE****PN695****DATE:** 7/21/2021**REVISED:****TO:** Owners, Users, Dealers, and Installers**MODELS AFFECTED:** LT40**SUBJECT:** Positive Attachment Lanyard (PAL) Device Alarm**Issue:**

Terex LT40 aerial devices equipped with the Positive Attachment Lanyard (PAL) device, produced from March 2020 to February 2021, may have an alarm indication that is difficult for the operator to hear.

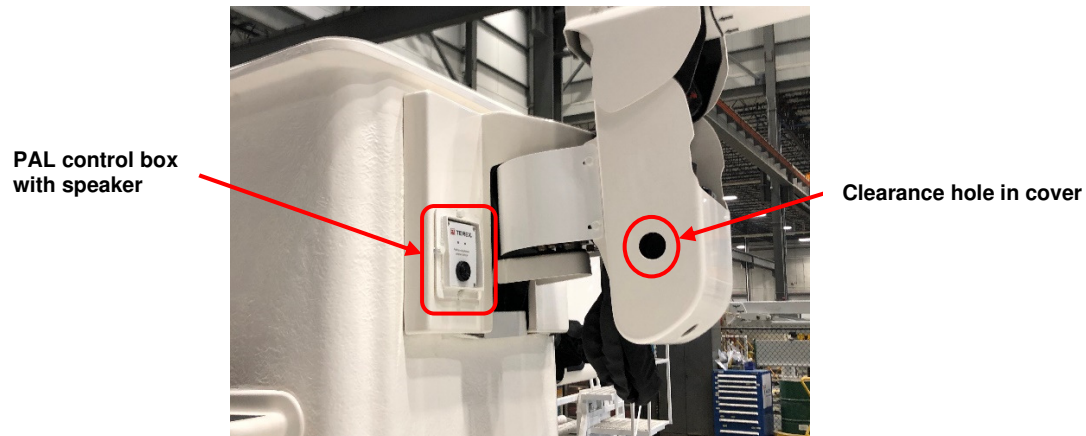
3. Inspect the unit to determine if it has a clearance hole in the rotator bracket cover for the PAL control box speaker as shown in Figure 1.

Figure 1. Clearance hole in cover

4. If the alarm indication is 1 beep every 10 seconds or there is not a clearance hole in the cover, see the continued use section for further instructions.
5. If the alarm indication is 6 successive beeps followed by a 5 second pause and then repeated, and there is a clearance hole in the cover; this bulletin does not apply. The unit can be used following all operator, maintenance, and inspection requirements as specified in the manuals.

Terex will provide Field Service Kit Z1630, parts and labor, at no cost to the customer for a period of one (1) year from the release date of this bulletin.
