Technical product information

Topic	Driver/Passenger door creak on close - 21 Model Year
Market area	Russische Föderation (5RU),Australia E04 Bentley rest Asia and Australia (6E04),China 796 VW Import Comp. Ltd (Vico), Beijing (6796),Germany E02 Bentley rest Europe (6E02),Japan E03 Bentley Japan (6E03),Korea, (South) E08 Bentley South Korea (6E08),United Arab Emirates E06 Bentley Middle East and Africa (6E06),United Kingdom E01 Bentley UK (6E01),United States E05 Bentley USA and rest America (6E05)
Brand	Bentley
Transaction No.	2061605/2
Level	EH
Status	Approval
Release date

New Continental GT - New Continental GTC and New Flying Spur

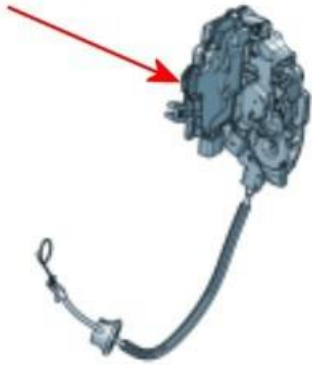
Driver or Passenger door creak during the "Close" function

- Only replace the door latch which is exhibiting the symptom Figure 1 shows an example of the door latch

- 1) Obtain video's clearly showing the date of manufacture or take a photograph of the manufacture date of each applicable door latch that is faulty. The operative MUST save each video and/or picture as they will be required later within this procedure
- 2) Referring to the applicable Repair Group - Rep.Gr57 (Front) or Rep.Gr58 (Rear) - Replace only the faulty door latch (as detailed in the Technical background section)
- 3) Open a Non-technical/For information only DISS query
 - Attach the applicable videos/photo to the open DISS query (No evidence of the latch date of manufacture will result in claim refusal)
 - Submit the DISS query
