## Technical product information

| <b>Topic</b> | Driver/Passenger door latch creak on close |
| <b>Transaction No.</b> | 2052394/13 |

### New Continental GT/GTC - New Flying Spur and Bentayga

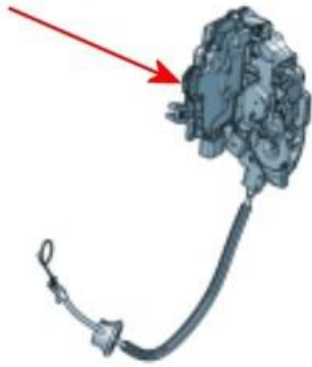
Driver or Passenger door creak during the "Close" function

Figure 1 shows an example of the door latch

2) Replace the faulty/creaking latch - Refer to Rep.Gr 57 (Front) or Rep.Gr 58 (Rear)
