# Technical product information

<b>Topic</b>	Engine warning light illuminated within the DIP during acceleration - DTC P029900 evident - W12 TSI only
<b>Market area</b>	Russische Föderation (5RU),Australia E04 Bentley rest Asia and Australia (6E04),China 796 VW Import Comp. Ltd (Vico), Beijing (6796),Germany E02 Bentley rest Europe (6E02),Japan E03 Bentley Japan (6E03),Korea, (South) E08 Bentley South Korea (6E08),United Arab Emirates E06 Bentley Middle East and Africa (6E06),United Kingdom E01 Bentley UK (6E01),United States E05 Bentley USA and rest America (6E05)
<b>Brand</b>	Bentley
<b>Transaction No.</b>	2063954/1
<b>Level</b>	EH
<b>Status</b>	Approval
<b>Release date</b>

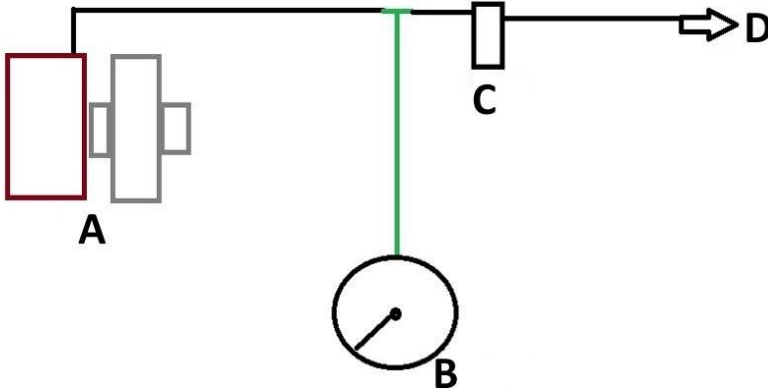
3) Referring to Figure 2 - Attach a manual vacuum gauge (B) between the following components: (Depending on the bank which is suspected to

- Turbocharger wastegate (A) and (C) Boost pressure valve vacuum solenoid

N249 (Bank1)

N547 (Bank 2)

NOTE: Point (D) refers to the engine vacuum system

The manual vacuum gauge must be connected as shown, the hose must be long enough to allow the gauge/readings to be viewed from inside the cabin

4) The vehicle should be driven whilst the second operative monitors the gauge to confirm if the Boost pressure valve vacuum solenoid is being actuated in a plausible manner For example: Vacuum supplied to build boost pressure/vacuum supply closed when the target boost pressure is achieved

If vacuum supply to the wastegate is not plausible the operative must check the vacuum supply to the Boost pressure valve vacuum solenoid

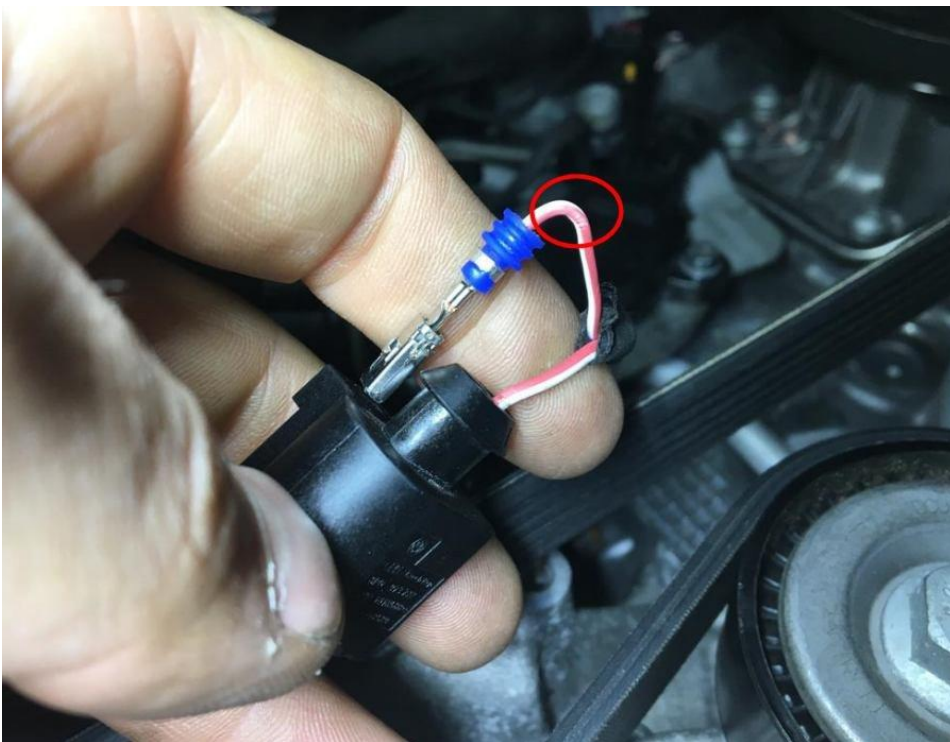
- Figure 3 shows a location which should also be checked for damage/kinks *NOTE: The disconnected pin is shown for photographic purposes only*

5) Carry out a wiring integrity check between the applicable ECM and the applicable solenoid circuit - Refer to the applicable Rep.Gr wiring diagram

7) In the event an issue is suspected, for test purposes the operative should overlay the suspected wiring as follows:

The overlay MUST not be left in place under any circumstances, the operative should repair the wiring as per Rep.Gr 97
