# Technical product information

<b>Topic</b>	Bentayga - DTC C103129 - Air suspension warning displayed in Driver Instrument Panel
<b>Market area</b>	Russische Föderation (5RU),Australia E04 Bentley rest Asia and Australia (6E04),China 796 VW Import Comp. Ltd (Vico), Beijing (6796),Germany E02 Bentley rest Europe (6E02),Japan E03 Bentley Japan (6E03),Korea, (South) E08 Bentley South Korea (6E08),United Arab Emirates E06 Bentley Middle East and Africa (6E06),United Kingdom E01 Bentley UK (6E01),United States E05 Bentley USA and rest America (6E05)
<b>Brand</b>	Bentley
<b>Transaction No.</b>	2063891/1
<b>Level</b>	EH
<b>Status</b>	Approval
<b>Release date</b>

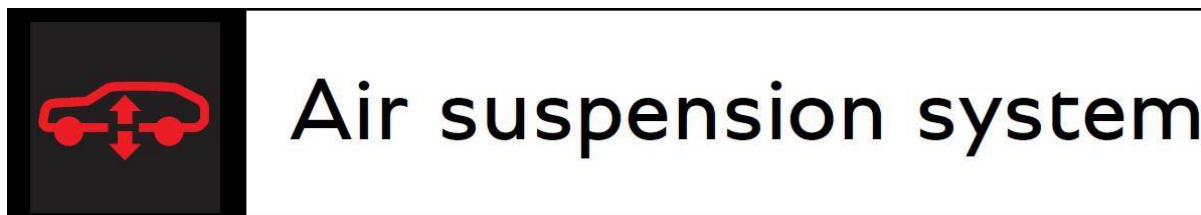
Air suspension system warning displayed in the Driver Instrument Panel (DIP)
