Technical product information

Topic	Creaking noise from the front suspension when manoeuvring
Market area	Bentley: worldwide (2WBE),Hongkong-Macau (5HK)
Brand	Bentley
Transaction No.	2048616/9
Level	EH
Status	Approval
Release date

Creaking noise from the front suspension when manoeuvring

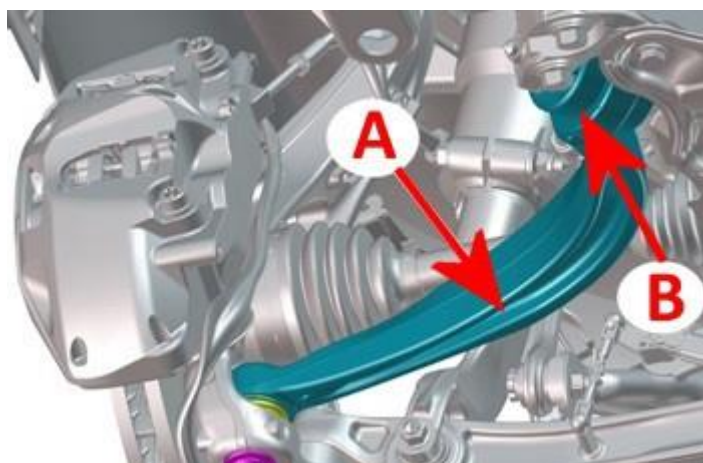
The noise present in the sound file is caused by defective Lower suspension lever - Rear - Hydraulic mounts. In order to reproduce the noise this bush must be twisted, therefore the noise can appear in the following circumstances

Figure 1 shows for example the left hand front rearmost lower suspension lever (A) the hydraulic mount which must be changed is located at (B)

1) Replace the right hand front and left hand front rearmost lower suspension lever inner hydraulic mounts - Refer to Repair manual Rep.Gr.40 front suspension, lower suspension lever bushes – to remove and fit

NOTE: Ensure the right and left hand side hydraulic mounts are replaced
