## Technical product information

| <b>Topic</b> | Loss of the EV Mode Active Pedal 'Detent' Feature |
| <b>Transaction No.</b> | 2064093/1 |

### Bentayga Hybrid

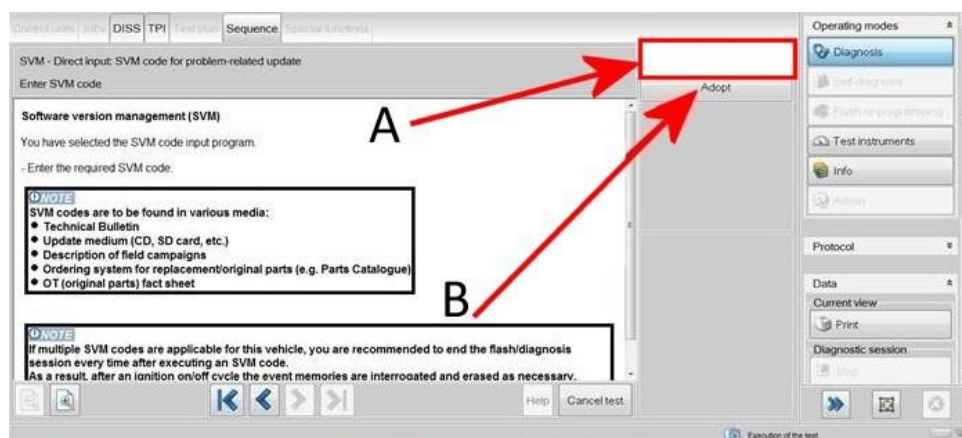
### 2. Referring to Figure 1 (Point A) enter the SVM code 4V0FFP01

- Select Adopt (Point B)
