Technical product information

Bentayga

Fuel tank internal fuel pump replacement - W12 TSI

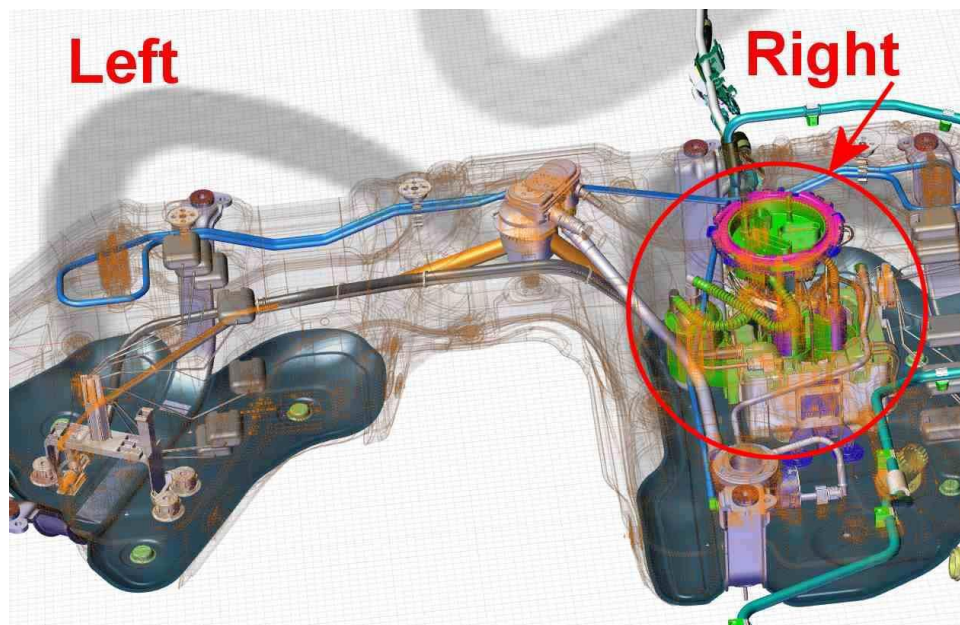
Figure 1

The twin fuel pumps which are part of the fuel delivery module (located on the right hand side of the fuel tank as Figure 1) have changed to an improved Diamond Like Coated (DLC) fuel pump

In the event the incorrect configuration of the fuel delivery module and control units are fitted the retailer/customer can experience a low fuel pressure too low DTC

OR

low fuel pressure too high DTC depending on the incorrect configuration.

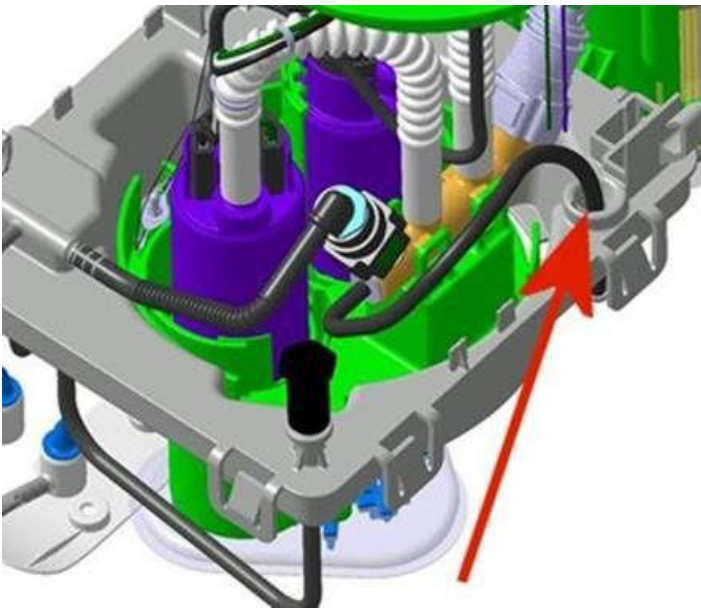
Figure 2

Fuel delivery module with bypass tube (Figure 2)

36A 919 087F - Fuel pump assembly without auxiliary heater

36A 919 087G – Fuel pump assembly with auxiliary heater Fuel

pump control units

36A 906 093B – Master

36A 906 093C - Slave

Should the vehicle require a fuel delivery module the DLC type pump assembly will be supplied 36A 919 087H or 36A 919 087J. Both fuel pump control units 4M0 906 093K should also be replaced to ensure correct configuration/compatibility

Should a fuel pump control unit require replacing the DLC fuel pump will also require replacement as control units with the part number 4M0 906 093K will only be available, In this scenario (due to potential mismatch) both control units should be replaced
